Pit, Below-Grade Tank, or  
Proposed Alternative Method Permit or Closure Plan Application

**Burlington Resources Oil & Gas Company, LP**  
**San Juan Basin**  
**Below Grade Tank Closure Report**

**Lease Name: ANGEL PEAK B 30**

**API No.: 30-045-24530**

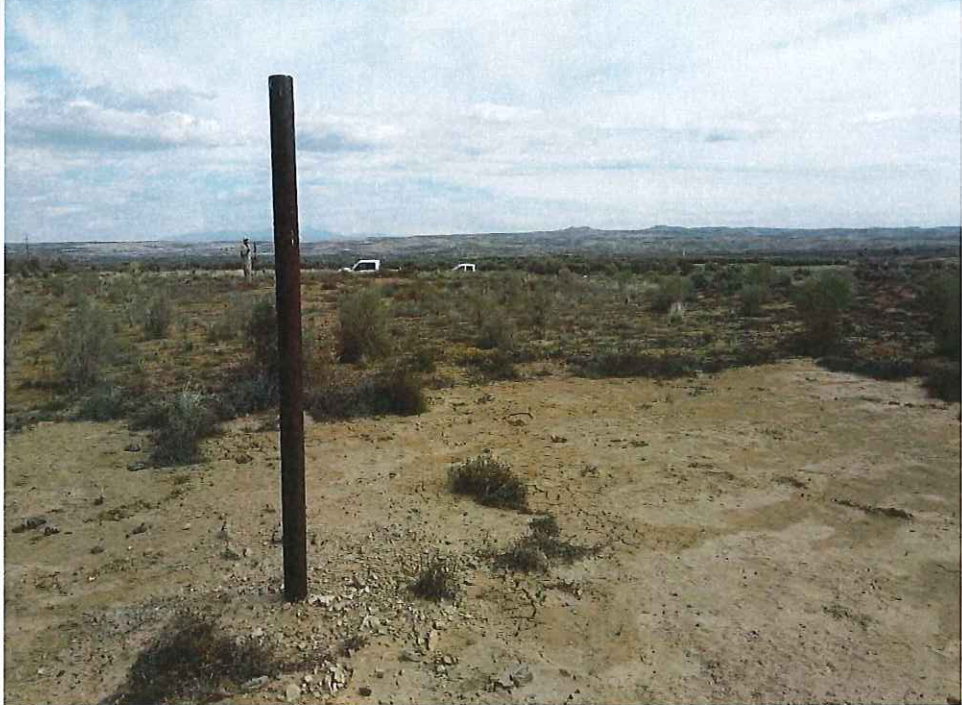
Photo #1

Client: ConocoPhillips	
Project Name: Angel Peak B 30  San Juan County, NM	
Date Photo Taken: April 25, 2016	
BGT GPS and Location: 36.66758, -107.95216  NW¼ NE¼, Section 13, T28N, R11W	
Taken by: Delilah Dougi, AES	
Subject: BGT sampling, April 2016	
Description: Facing N, overview of entire location.

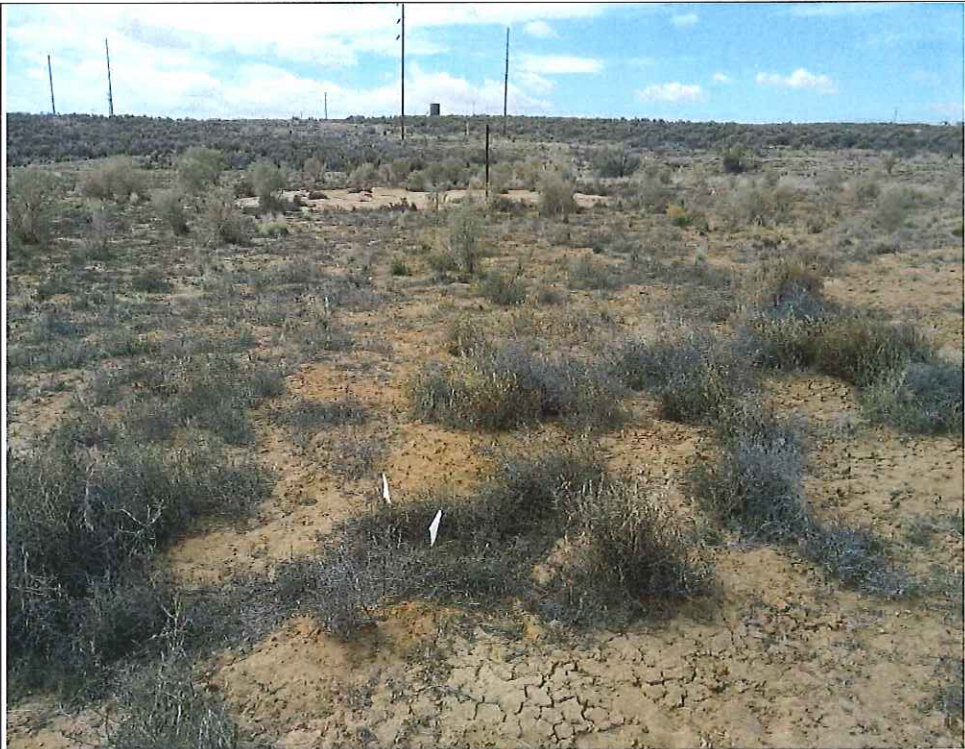
Photo #2

Client: ConocoPhillips	
Project Name: Angel Peak B 30  San Juan County, NM	
Date Photo Taken: April 25, 2016	
BGT GPS and Location: 36.66758, -107.95216	
NW¼ NE¼, Section 13, T28N, R11W	
Taken by: Delilah Dougi, AES	
Subject: BGT sampling, April 2016	
Description: Facing S, sample location.
