Pit, Closed-Loop System, Below-Grade Tank, or
Proposed Alternative Method Permit or Closure Plan Application

BELOW-GRADE TANK CLOSURE PLAN

Gallegos Canyon Unit # 363 – Tank ID: B

API #: 3004526882

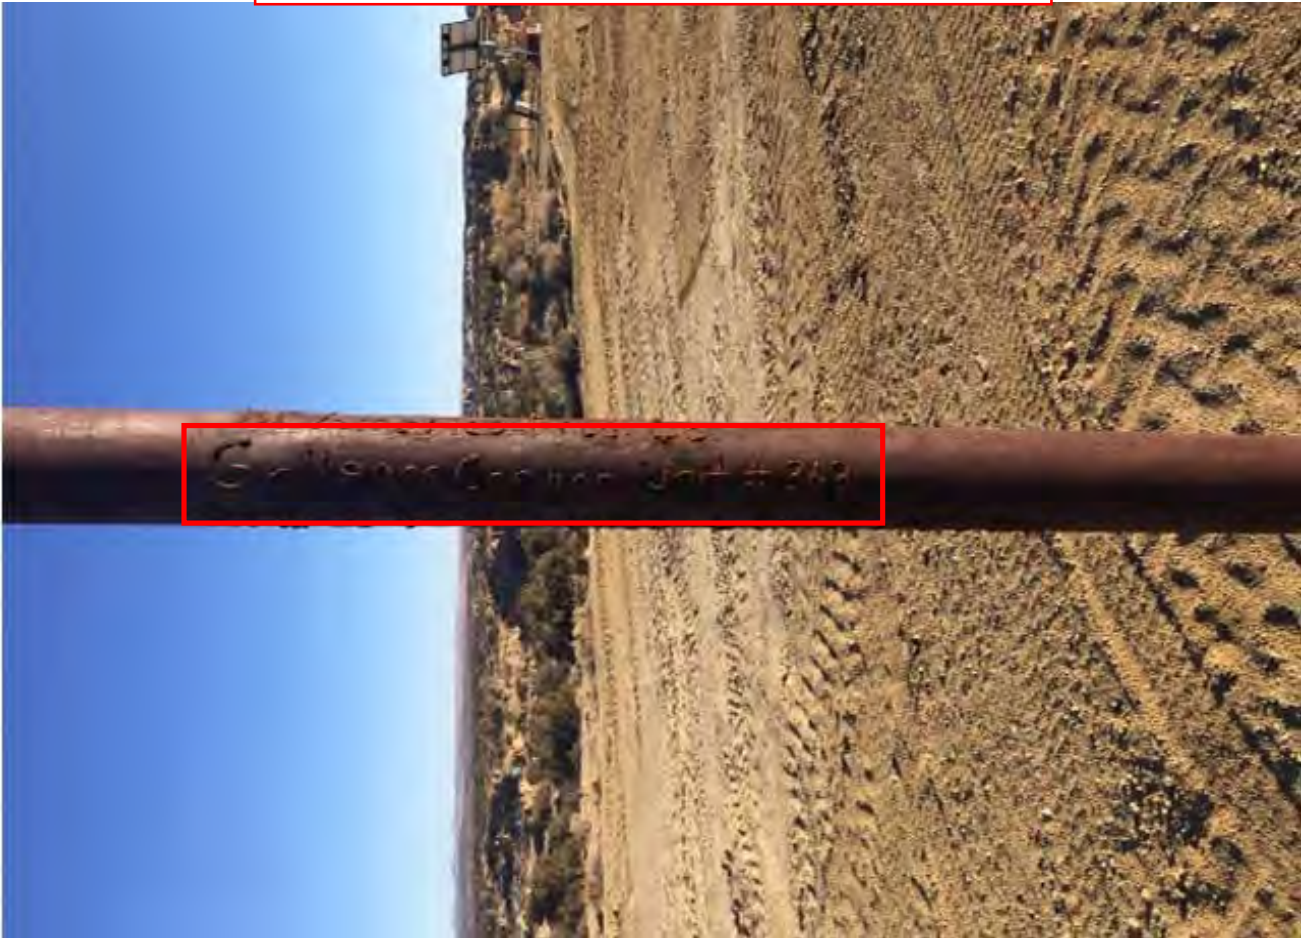
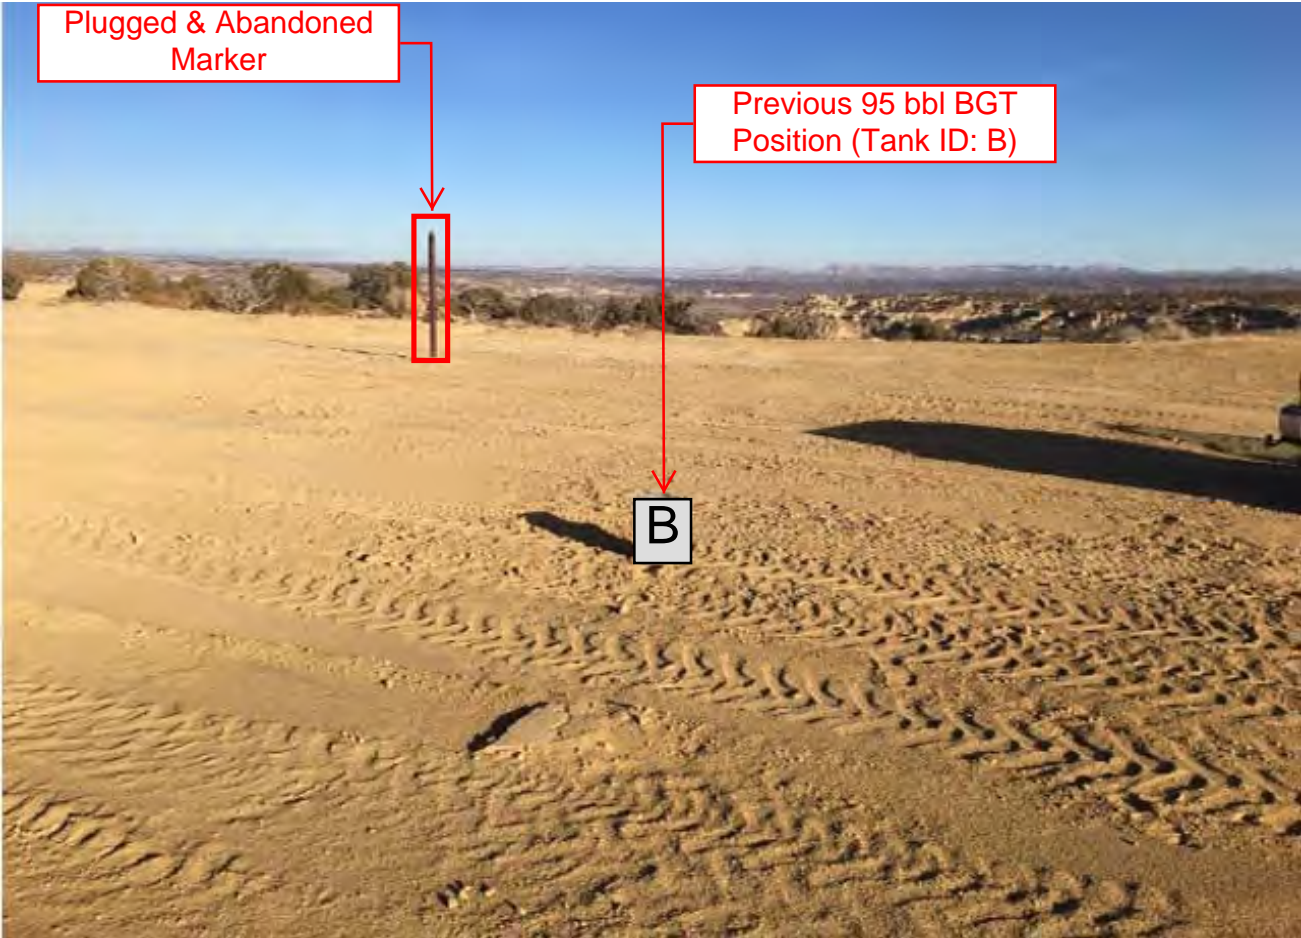
GALLEGOS CANYON UNIT 363

The BGT area has been backfilled with clean, earthen material and is within the active well pad. Reclamation will be completed within the allowable timeframe and will meet the specified requirements of 19.15.17.13 NMAC.
