BELOW-GRADE TANK CLOSURE PLAN

Fields Gas Com A 001 – Tank ID: B

API #: 3004527881

Unit Letter K, Section 28, T32N, R11W

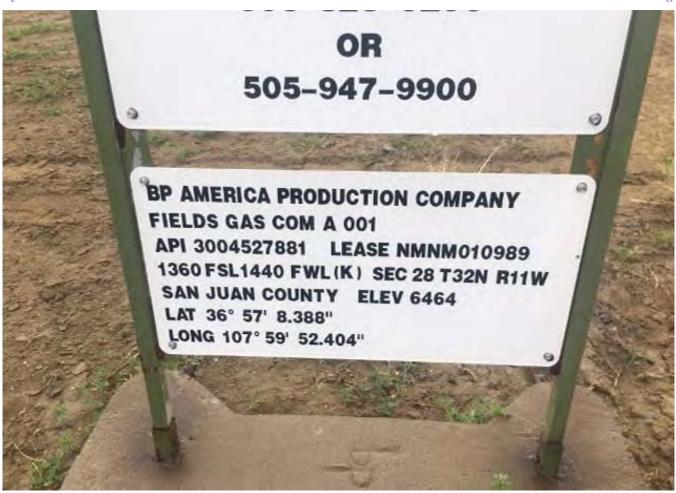
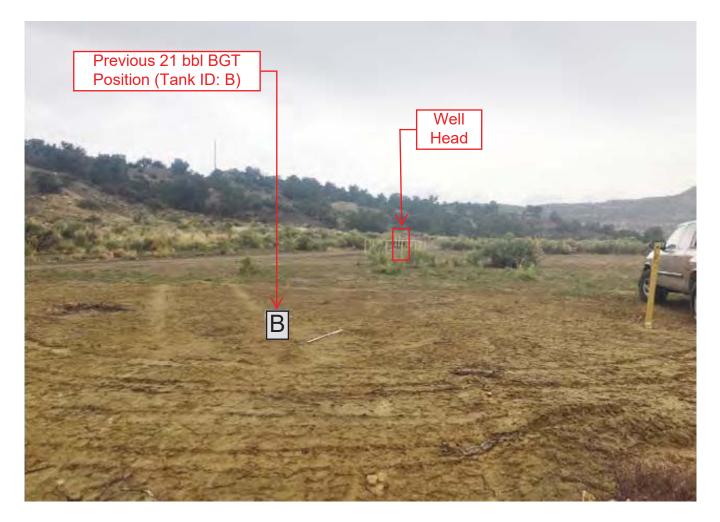
<u>Closure report on C-144 form is included & contains a photo of the current reclamation requirements completed.</u>

BGT area has been backfilled with clean, earthen material. Reclamation will be completed within the allowable timeframe and will meet the specified requirements of 19.15.17.13 NMAC.
