Pit, Closed-Loop	System, Below-Gr	ade Tank, or		
_	Prop	oosed Alternative M	lethod Permit or Cl	osure Plan App	<u>olication</u>	
7445	Type of action:	Permit of a pit, closed	d-loop system, below-grad	le tank, or proposed a	alternative method	
5 ⁴⁷			ed-loop system, below-gra			
		Modification to an ex	cisting permit			
		Closure plan only sub	bmitted for an existing per	mitted or non-permit	ted pit, closed-loop syste	m,
_		•	proposed alternative meth			
		application (Form C-144) p	_			request
		of this request does not relieve the op- elieve the operator of its responsibility	•	•		
1						
		Oil & Gas Company, LP		OGRID#: <u>145</u>	38	
	Box 4289, Farming

Burlington Resources Oil Gas Company, LP San Juan Basin Closure Report

Lease Name: SAN JUAN 28-5 UNIT 2C

API No.: 30-039-30608

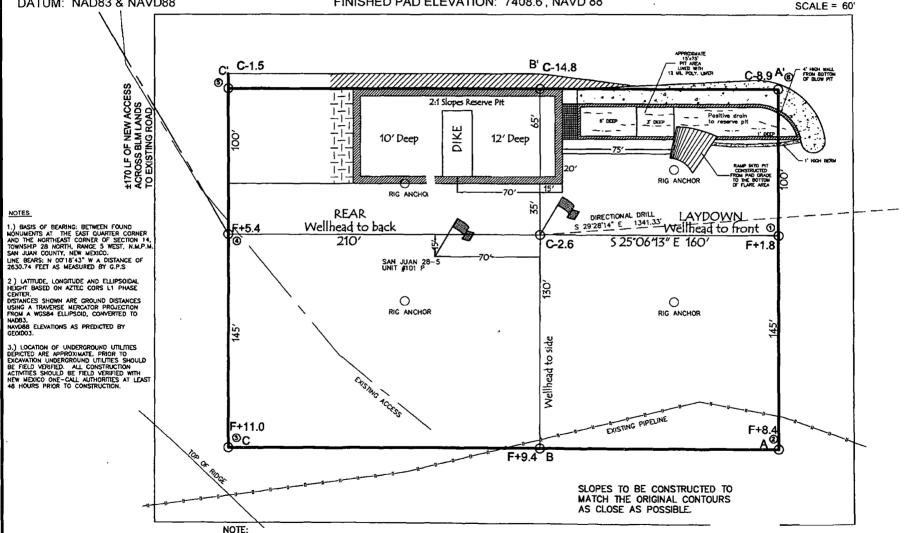
WELL FLAG LATITUDE: 36.66209°N LONGITUDE: 107.32053°W CENTER OF PIT LATITUDE: 36.66237° N LONGITUDE: 107.32046° W ELEVATION: 7396.6' DATUM: NAD83 & NAVD88

330' x 400' = 3.03 ACRES OF DISTURBANCE

RESERVE PIT DIKE: TO BE 8' ABOVE DEEP SIDE (OVERFLOW - 3' WIDE AND 1' ABOVE SHALLOW SIDE).
RUSSELL SURVEYING, INC. IS NOT LIABLE FOR UNDERGROUND UTILITIES OR PIPELINES.
CONTRACTOR SHOULD CALL ONE-CALL FOR LOCATION OF ANY MARKED OR UNMARKED, BURIED PIPELINES OR
CABLES ON WELL PAD. IN CONSTRUCTION ZONE AND/OR ACCESS ROAD AT LEAST TWO (2) WORKING DAYS PRIOR
TO CONSTRUCTION.
