XTO Energy Inc. San Juan Basin Below Grade Tank Closure Report

Lease Name: EH Pipkin #9 API No.: 30-045-06957

Description: Unit N, Section 35, Township 28N, Range 11W, San Juan County

XTO Energy, Inc. EH Pipkin #9 Section 35 (N), Township 28N, Range 11W Closure Date 4/12/2013

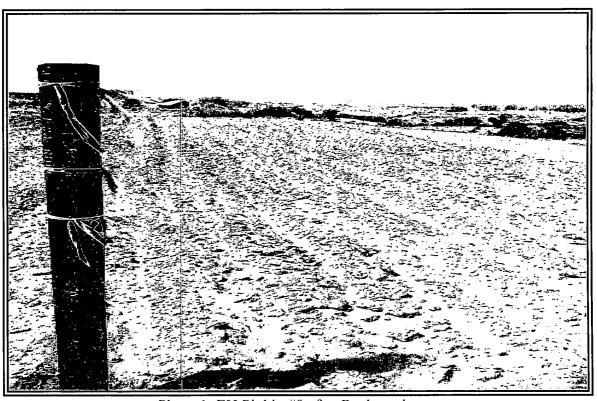
Photo 1: EH Pipkin #9 after Reclamation.

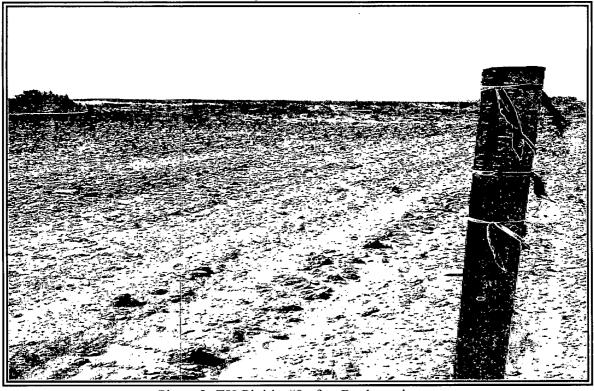
Photo 2: EH Pipkin #9 after Reclamation.

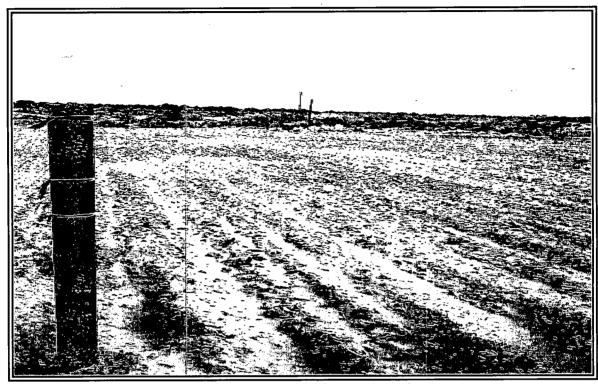
Photo 3: EH Pipkin #9 after Reclamation.

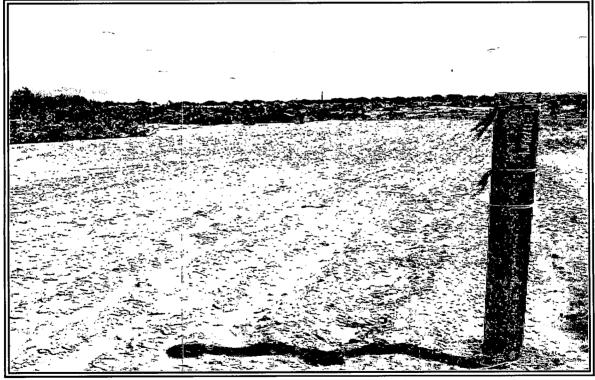
Photo 4: EH Pipkin #9 after Reclamation.
