Burlington Resources Oil Gas Company, LP San Juan Basin Closure Report

Lease Name: SAN JUAN 28-6 UNIT 117N

API No.: 30-039-30726

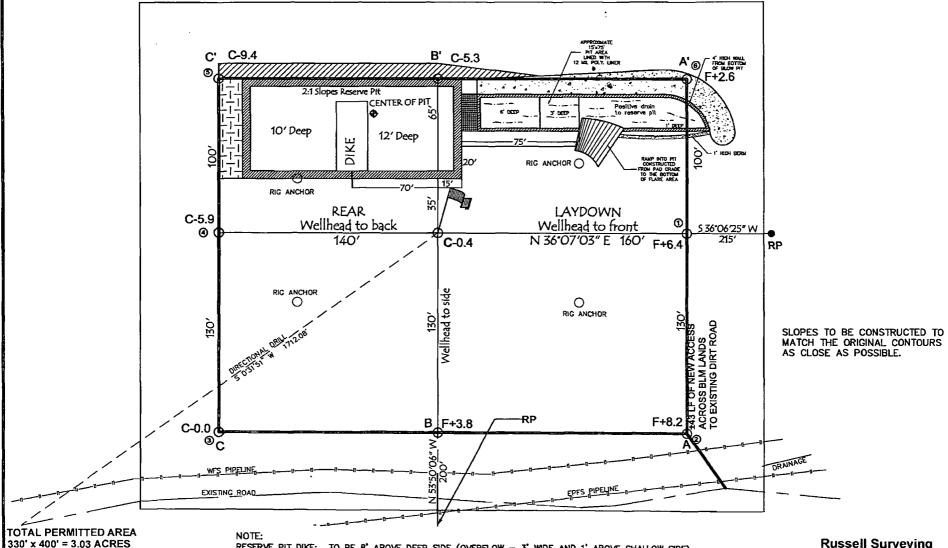
RESERVE PIT DIKE: TO BE 8' ABOVE DEEP SIDE (OVERFLOW - 3' WIDE AND 1' ABOVE SHALLOW SIDE). RUSSELL SURVEYING, INC. IS NOT LIABLE FOR UNDERGROUND UTILITIES OR PIPELINES.
CONTRACTOR SHOULD CALL ONE-CALL FOR LOCATION OF ANY MARKED OR UNMARKED, BURIED PIPELINES OR CABLES ON WELL PAD, IN CONSTRUCTION ZONE AND/OR ACCESS ROAD AT LEAST TWO (2) WORKING DAYS PRIOR TO CONSTRUCTION.

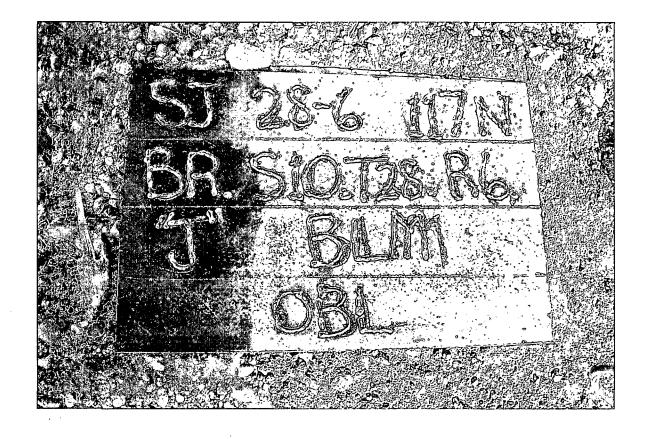
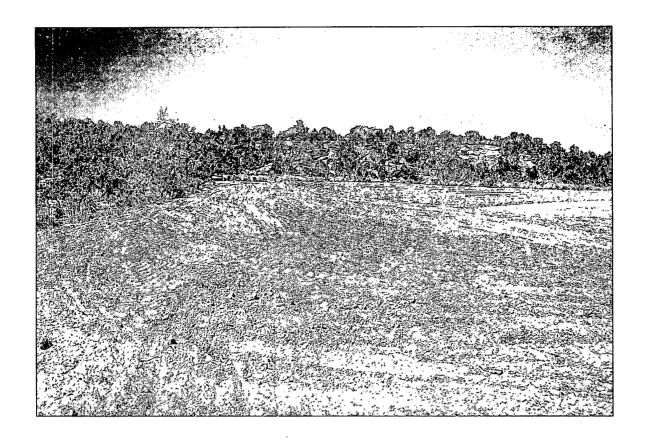
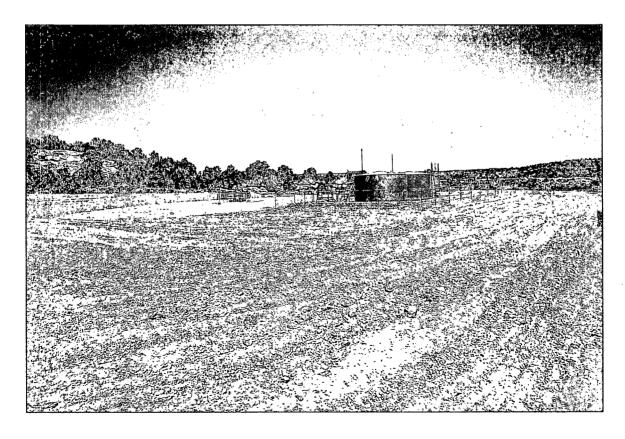
SAN JUAN 28-6 UNIT #117N
LATITUDE 36° 40 MIN 25.57200 SEC N (NAD83)
LONGITUDE 107° 27 MIN 07.34400 SEC W (NAD 83)
UNIT J SEC 10 T28N RO6W
BH: SW1/4SE1/4 SEC. 10 T28N RO6W
1909' FSL 1920' FEL / API#30-039-30726
LEASE# SF-080505-A ELEV.6411'
RIO ARRIBA COUNTY, NEW MEXICO
EMERGENCY CONTACT: 1-505-324-5170

Provision 15 was accomplished by installing a steel marker in the temporary pit, no less than four inches in diameter, cemented in a hole three feet deep in the center of the onsite burial. The marker is flush with the ground to allow access of the active well pad and for safety concerns. The top of the marker contains a welded steel 12" square plate that indicates the onsite burial of the temporary pit. The plate contains the following: Operator Name, Lease Name, Well Name and number, Unit Number, Section, Township, Range and an indicator that the marker is an onsite burial location.

The plate will be easily removable and a four foot tall riser will be threaded into the top of the collar marker and welded around the base with the following operator's information at the time of all wells on the pad are abandoned. The riser will be labeled: BR, BLM, SAN JUAN 28-6 UNIT 117N, UL-J, Sec. 10, T 28N, R 6W, API # 30-039-30726
