Pit, Below-Grade Tank, or  
Proposed Alternative Method Permit or Closure Plan Application

BELOW-GRADE TANK CLOSURE PLAN

Riddle C LS 2A Tank B (95 bbl)

API No. 3004522451

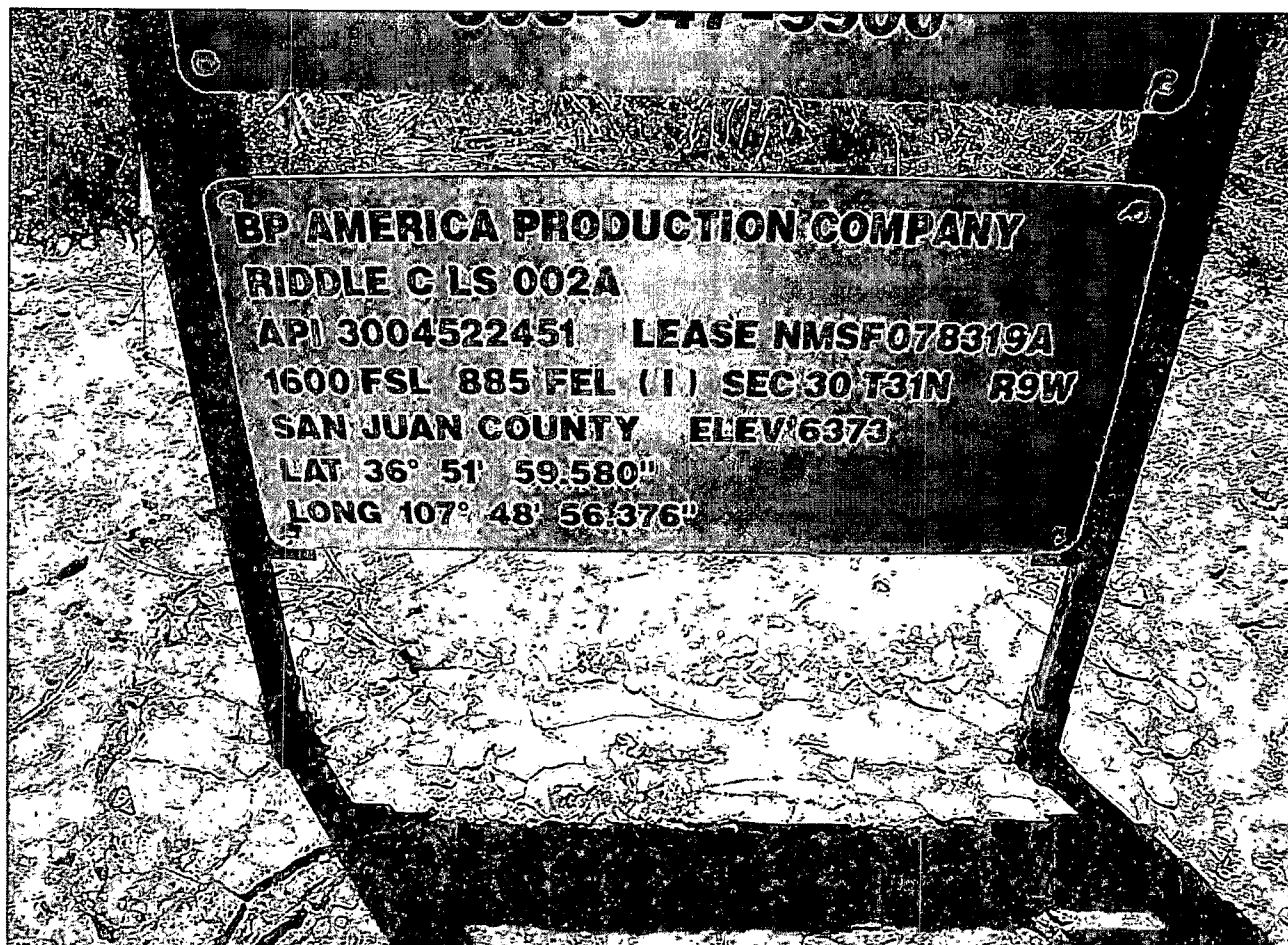
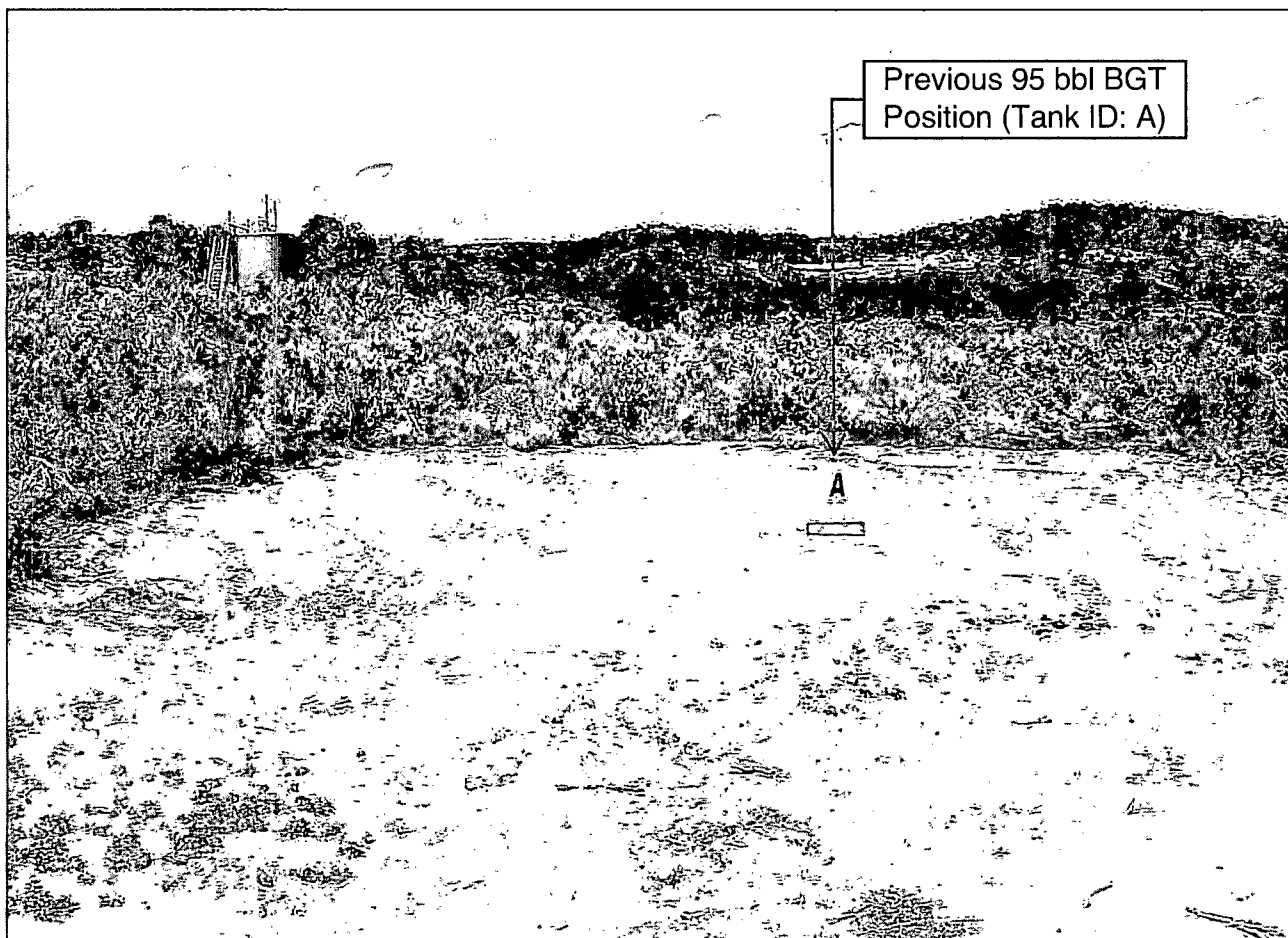
- ☐ Proof of Closure Notice (surface owner and division)
- ☐ Proof of Deed Notice (required for on-site closure for private land only)
- ☐ Plot Plan (for on-site closures and temporary pits)
- ☒ Confirmation Sampling Analytical Results (if applicable)
- ☐ Waste Material Sampling Analytical Results (required for on-site closure)
- ☒ Disposal Facility Name and Permit Number
- ☒ Soil Backfilling and Cover Installation
- ☐ Re-vegetation Application Rates and Seeding Technique
- ☒ Site Reclamation (Photo Documentation)

**The area under the BGT was backfilled with clean soil and is still within the active well area.**

**The area over the BGT is still within the active well area. This area will be reclaimed when the well is plugged and abandoned as part of final reclamation.**
