Pit, Below-Grade Tank, or
Proposed Alternative Method Permit or Closure Plan Application

1.
Operator: BP America Production Company _____ OGRID #: 778 _____ **OIL CONS. DIV DIST. 3**
Address: 200 Energy Court, Farmington, NM 87401 _____
Facility or well name: Gallegos Canyon Unit 93 _____ **JUN 12 2014**
API Number: 3004507699 _____ OCD Permit Number: _____
U/L or Qtr/Qtr E _____ Section 36 _____ Township 29N _____ Range 12W _____ County: San Juan _____
Center of Proposed Design: Latitude 36.68537 _____ Longitude -108.0568 _____ NAD: ☐ 1927 ☒ 1983
Surface Owner: ☐ Federal ☐ State ☒ Private ☐ Tribal Trust or Indian Allotment

BELOW-GRADE TANK CLOSURE PLAN

Gallegos Canyon Unit 93
API No. 3004507699
Unit Letter E, Section 36, T29N, R12W

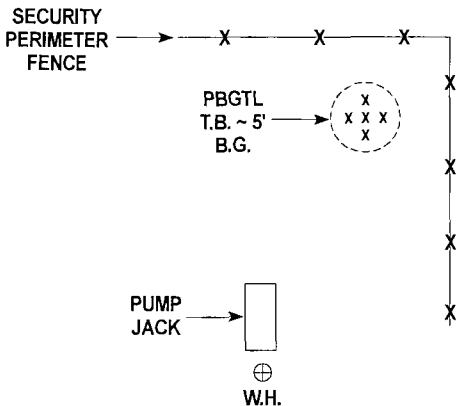
SITE OBSERVATIONS: LOST INTEGRITY OF EQUIPMENT: YES NO EXPLANATION - _____ APPARENT EVIDENCE OF A RELEASE OBSERVED AND/OR OCCURRED: YES NO EXPLANATION: _____ EQUIPMENT SET OVER RECLAIMED AREA: YES NO EXPLANATION - _____ OTHER: _____		
SOIL IMPACT DIMENSION ESTIMATION: NA ft. X NA ft. X NA ft. EXCAVATION ESTIMATION (Cubic Yards): NA DEPTH TO GROUNDWATER: <50' NEAREST WATER SOURCE: >1,000' NEAREST SURFACE WATER: <1,000' NMOCOD TPH CLOSURE STD: 100 ppm		
SITE SKETCH BGT Located: off on site PLOT PLAN circle: attached

<p style="text-align: center;">X - S.P.D.</p>		OVM CALIB. READ. = 101.0 ppm RF=1.00 OVM CALIB. GAS = 100 ppm TIME: 7:22 am/pm DATE: 04/04/14
NOTES: BGT = BELOW-GRADE TANK; E.D. = EXCAVATION DEPRESSION; B.G. = BELOW GRADE; B = BELOW; T.H. = TEST HOLE; ~ = APPROX.; W.H. = WELL HEAD; T.B. = TANK BOTTOM; PBGTL = PREVIOUS BELOW-GRADE TANK LOCATION; SPD = SAMPLE POINT DESIGNATION; R.W. = RETAINING WALL; NA - NOT APPLICABLE OR NOT AVAILABLE; SW - SINGLE WALL; DW - DOUBLE WALL; SB - SINGLE BOTTOM; DB - DOUBLE BOTTOM.		MISCELL. NOTES WO: N15188382 PO #: _____ PK: ZEVB01BGT2 PJ #: Z2-006Q0 Permit date(s): 06/14/10 OCD Appr. date(s): 01/22/13 Tank ID: A OVM = Organic Vapor Meter ppm = parts per million BGT Sidewalls Visible: Y / (N) BGT Sidewalls Visible: Y / N BGT Sidewalls Visible: Y / N Magnetic declination: 10° E

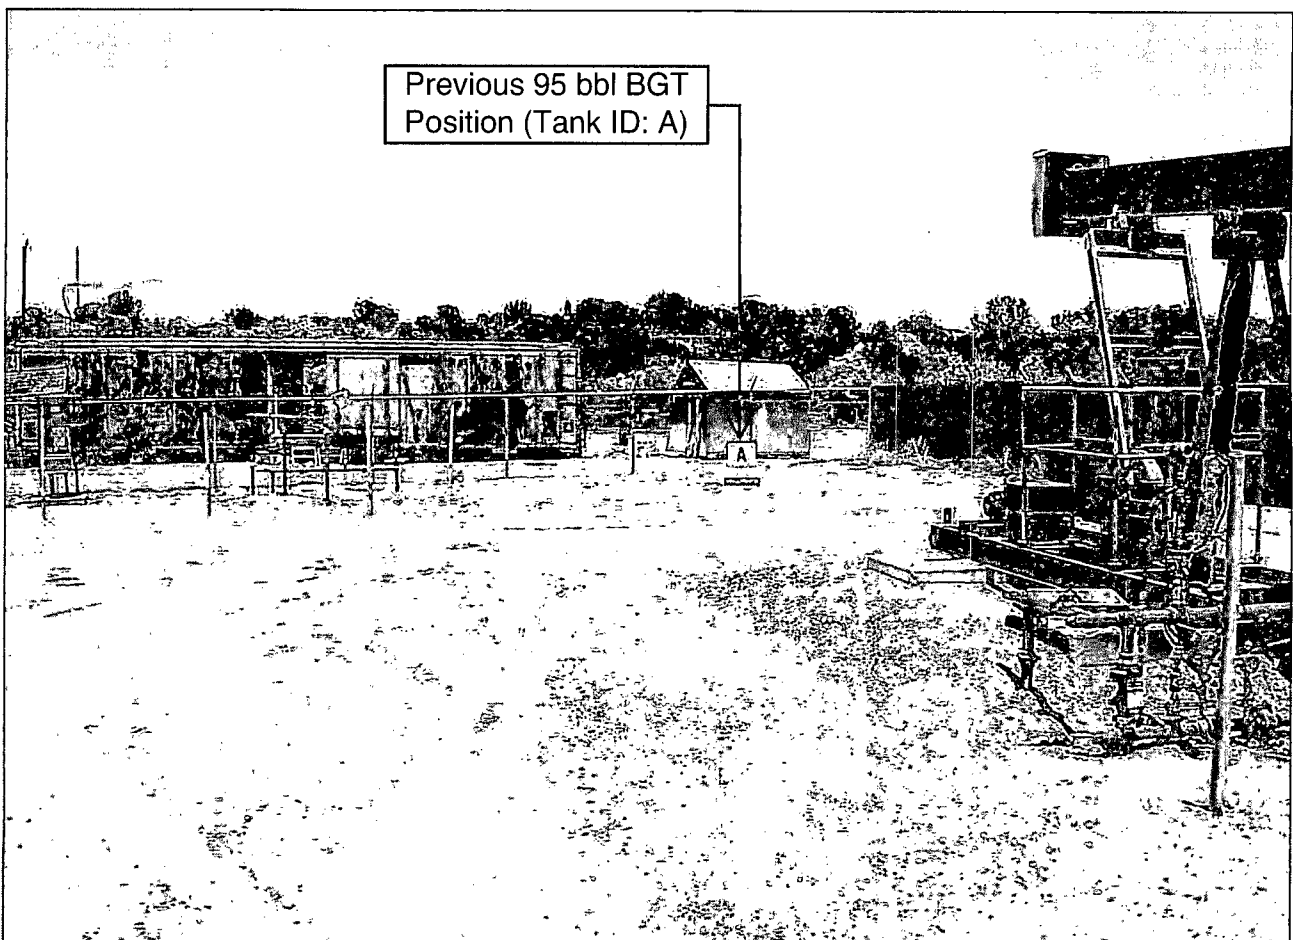
BP AMERICA PRODUCTION COMPANY
GALLEGOS CANYON UNIT 093
API 3004507699 LEASE NMNM78391C
1750 FNL 890 FWL (E) SEC 36 T29N R12W
San Juan County ELEV 5375
LAT 36° 41' 6.792"
LONG 108° 3' 24.336"

Previous 95 bbl BGT
Position (Tank ID: A)
