Pit, Below-Grade Tank, or
Proposed Alternative Method Permit or Closure Plan Application

BELOW-GRADE TANK CLOSURE PLAN

Gallegos Canyon Unit 399

API No. 3004529036

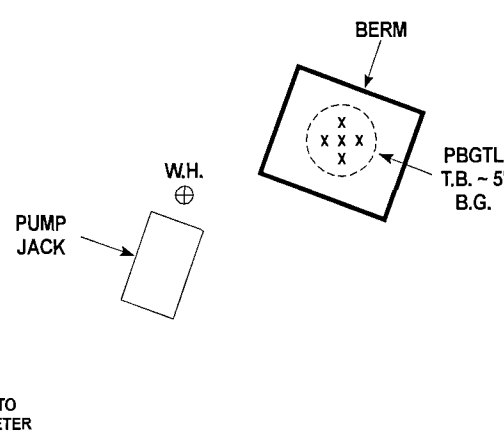
SOIL DESCRIPTION:	SOIL TYPE: <u>SAND</u> SILTY SAND / SILT / SILTY CLAY / CLAY / GRAVEL / OTHER
SOIL COLOR: DARK YELLOWISH ORANGE	PLASTICITY (CLAYS): NON PLASTIC / SLIGHTLY PLASTIC / COHESIVE / MEDIUM PLASTIC / HIGHLY PLASTIC
COHESION (ALL OTHERS): <u>NON COHESIVE</u> SLIGHTLY COHESIVE / COHESIVE / HIGHLY COHESIVE	DENSITY (COHESIVE CLAYS & SILTS): SOFT / FIRM / STIFF / VERY STIFF / HARD
CONSISTENCY (NON COHESIVE SOILS): <u>LOOSE</u> / FIRM / DENSE / VERY DENSE	HC ODOR DETECTED: YES <u>NO</u> EXPLANATION -
MOISTURE: DRY / <u>SLIGHTLY MOIST</u> / MOIST / WET / SATURATED / SUPER SATURATED	ANY AREAS DISPLAYING WETNESS: YES <u>NO</u> EXPLANATION -
SAMPLE TYPE: GRAB <u>COMPOSITE</u> # OF PTS. 5	
DISCOLORATION/STAINING OBSERVED: YES <u>NO</u> EXPLANATION -

SITE OBSERVATIONS:	LOST INTEGRITY OF EQUIPMENT: YES <u>NO</u> EXPLANATION -
APPARENT EVIDENCE OF A RELEASE OBSERVED AND/OR OCCURRED: YES <u>NO</u> EXPLANATION:	
EQUIPMENT SET OVER RECLAIMED AREA: <u>YES</u> NO EXPLANATION - LP AGT TO BE SET ATOP BGT POSITION.	
OTHER:

SITE SKETCH	BGT Located : off <u>on</u> site	PLOT PLAN circle: <u>attached</u>	OVM CALIB. READ. = 101.0 ppm OVM CALIB. GAS = 100 ppm TIME: 7:22 <u>am</u> DATE: 04/04/14
-------------	----------------------------------	-----------------------------------	---
