Pit, Below-Grade Tank, or
Proposed Alternative Method Permit or Closure Plan Application

BELOW-GRADE TANK CLOSURE PLAN

Riddle C 6, Tank A (95 bbl)

API No. 3004526787

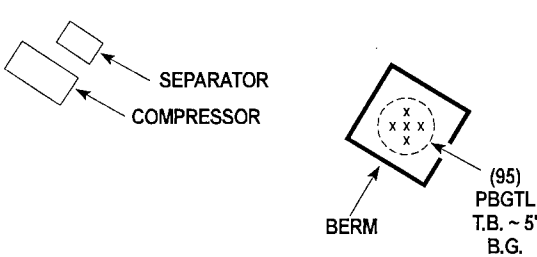
SITE OBSERVATIONS: LOST INTEGRITY OF EQUIPMENT: YES <input type="checkbox"/> NO <input checked="" type="checkbox"/> EXPLANATION - APPARENT EVIDENCE OF A RELEASE OBSERVED AND/OR OCCURRED: YES <input type="checkbox"/> NO <input checked="" type="checkbox"/> EXPLANATION - EQUIPMENT SET OVER RECLAIMED AREA: YES NO EXPLANATION - T-BLOCK LIFT TO BE SET ATOP 21 BGT POSITION. OTHER:		
SOIL IMPACT DIMENSION ESTIMATION: NA ft. X NA ft. X NA ft. EXCAVATION ESTIMATION (Cubic Yards): NA DEPTH TO GROUNDWATER: >100' NEAREST WATER SOURCE: >1,000' NEAREST SURFACE WATER: <200' NMOCD TPH CLOSURE STD: 100 ppm		
SITE SKETCH BGT Located: off <input checked="" type="checkbox"/> on site PLOT PLAN circle: attached <div style="text-align: center;">

<p>SEPARATOR COMPRESSOR BERM (95) PBGTL T.B. ~ 5' B.G.</p></div> <p style="text-align: center;">W.H. ⊕</p> <p style="text-align: right;">X - S.P.D.</p>		
NOTES: BGT = BELOW-GRADE TANK; E.D. = EXCAVATION DEPRESSION; B.G. = BELOW GRADE; B = BELOW; T.H. = TEST HOLE; ~ = APPROX.; W.H. = WELL HEAD; T.B. = TANK BOTTOM; PBGTL = PREVIOUS BELOW-GRADE TANK LOCATION; SPD = SAMPLE POINT DESIGNATION; R.W. = RETAINING WALL; NA = NOT APPLICABLE OR NOT AVAILABLE; SW - SINGLE WALL; DW - DOUBLE WALL; SB - SINGLE BOTTOM; DB - DOUBLE BOTTOM.		MISCELL. NOTES WO: N15420303 PO #: PK: ZEVB01BGT2 PJ #: Z2-006Q0 Permit date(s): 06/14/10 OCD Appr. date(s): 02/21/14 Tank ID: OVM = Organic Vapor Meter ppm = parts per million A BGT Sidewalls Visible: Y <input checked="" type="checkbox"/> N B BGT Sidewalls Visible: Y <input checked="" type="checkbox"/> N BGT Sidewalls Visible: Y / N Magnetic declination: 10° E
