Pit, Below-Grade Tank, or
Proposed Alternative Method Permit or Closure Plan Application

BP AMERICA PRODUCTION COMPANY
SAN JUAN BASIN, NORTHWEST NEW MEXICO

BELOW-GRADE TANK CLOSURE PLAN

Gallegos Canyon Unit 218

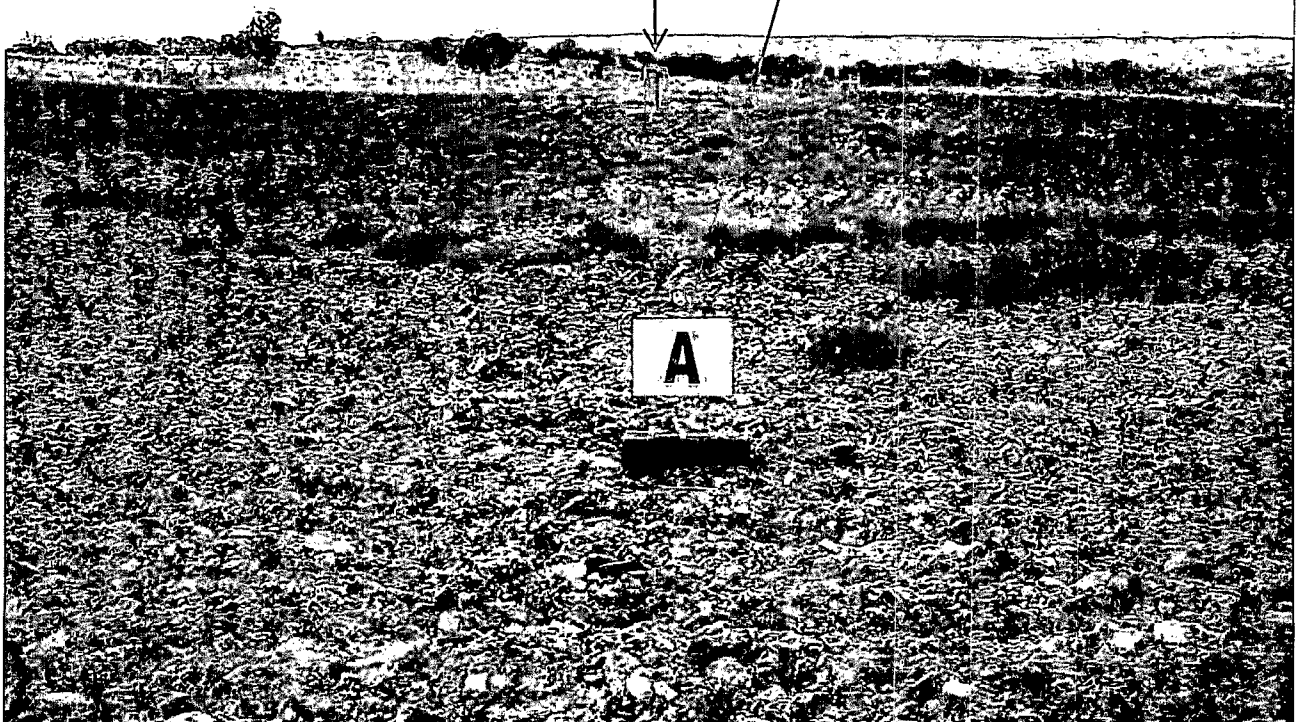
Previous 95 bbl BGT
Position (Tank ID: A)

The BGT was transported to a storage area for sale and re-use.

All equipment associated with the BGT has been removed.
