#### **Release Notification and Corrective Action**

#### BELOW-GRADE TANK CLOSURE PLAN

Well Name – Jicarilla Apache 102-13E API # 30-039-22499 Location UL- I, Sec 10, T-26N, R-4W Lat: N 36.4978 Lat W -107.23345 Note: This below grade tank was closed under the old Pit Rule.

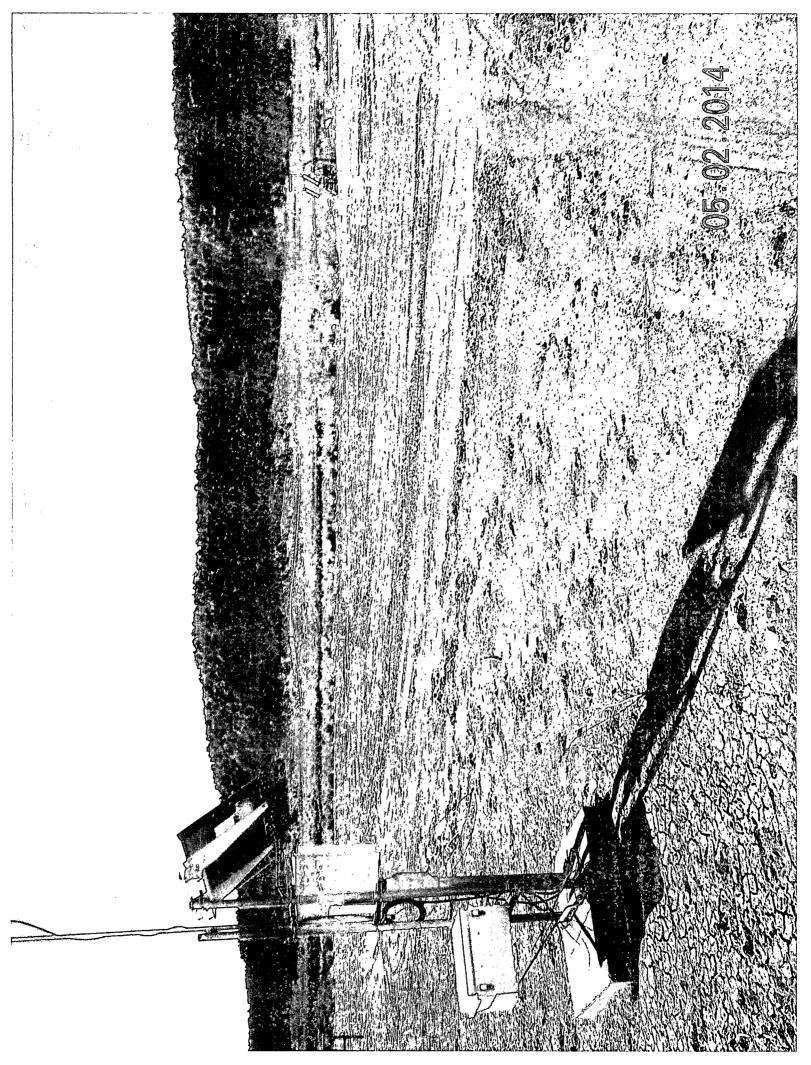
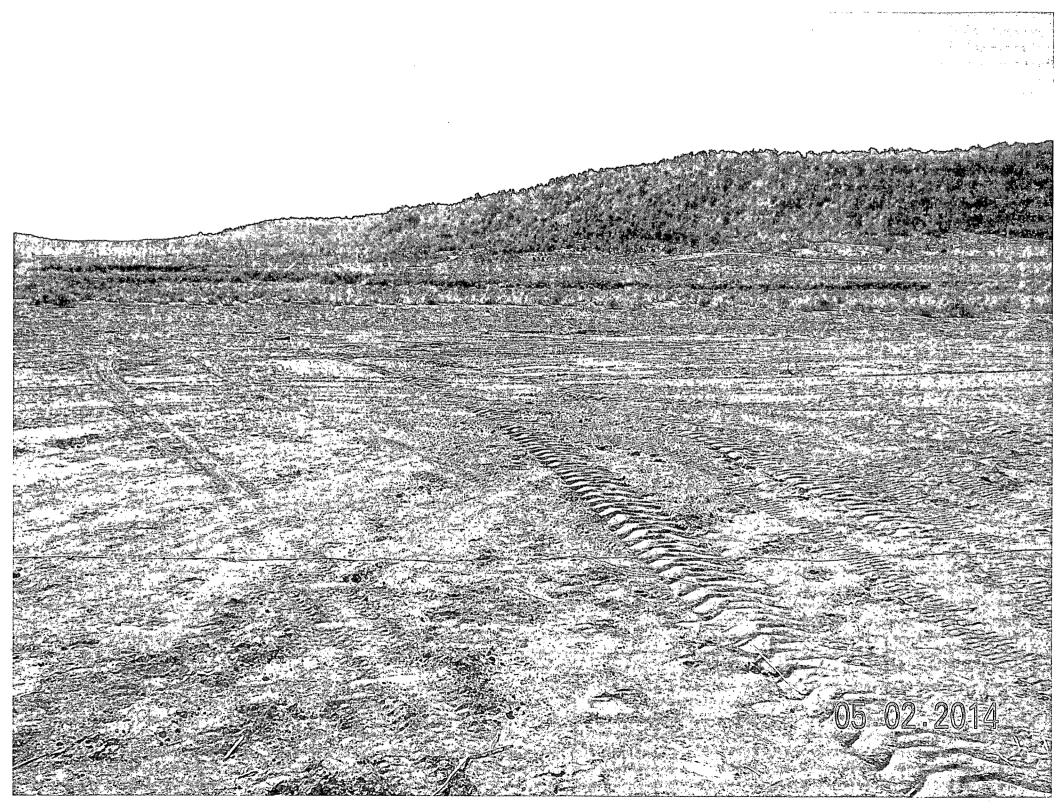
# The excavation was back filled by Lindrith Backhoe Service, on April 24 2014 utilizing soil from a nearby pond. The location was contoured to match the existing terrain. See attached photographs

EV has seeded the excavated area with Jicarilla Southern Seed mix, on June 16, 2014. See attached photographs.
