12305 Proposed Alternative Method Permit or Closure Plan Application

BP AMERICA PRODUCTION COMPANY  
SAN JUAN BASIN, NORTHWEST NEW MEXICO

BELOW-GRADE TANK CLOSURE PLAN

Heath Gas Com C 1

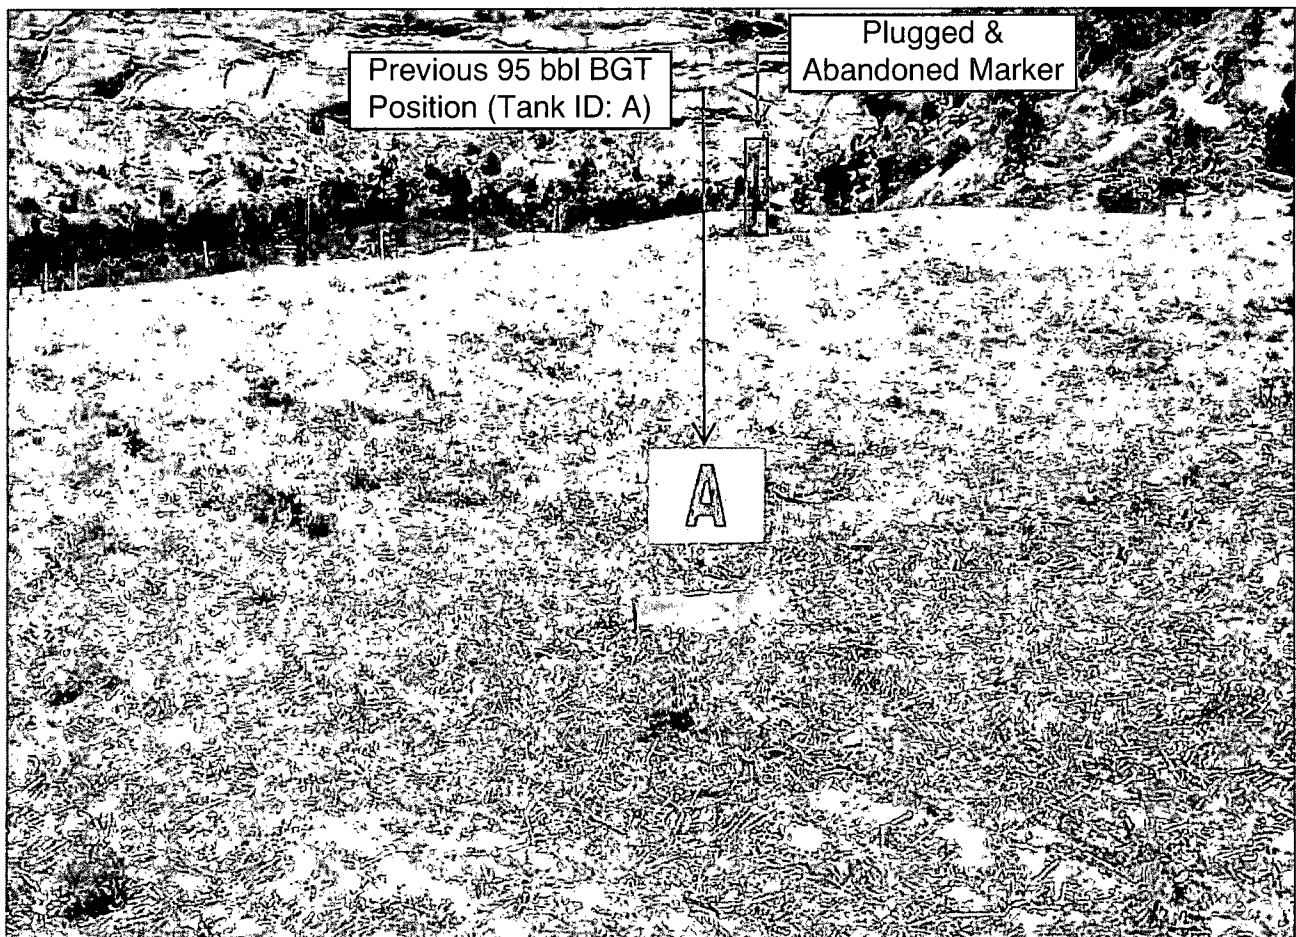
# Heath GC C # 1

**The area under the BGT was backfilled with clean soil and has been reclaimed since the well was plugged and abandoned.**
10. BP shall reclaim the BGT location and all areas associated with the BGT including associated access roads to a safe and stable condition that blends with the surrounding undisturbed area. BP shall substantially restore the impacted surface area to the condition that existed prior to oil and gas operations by placement of the soil cover as provided in Subsection H of 19.15.17.13 NMAC, re-contour the location and associated areas to a contour that approximates the original contour and blends with the surrounding topography and re-vegetate according to Subsection I of 19.15.17.13 NMAC.
