BP AMERICA PRODUCTION COMPANY  
SAN JUAN BASIN, NORTHWEST NEW MEXICO

BELOW-GRADE TANK CLOSURE PLAN

Roelofs B 2

API No. 3004508371

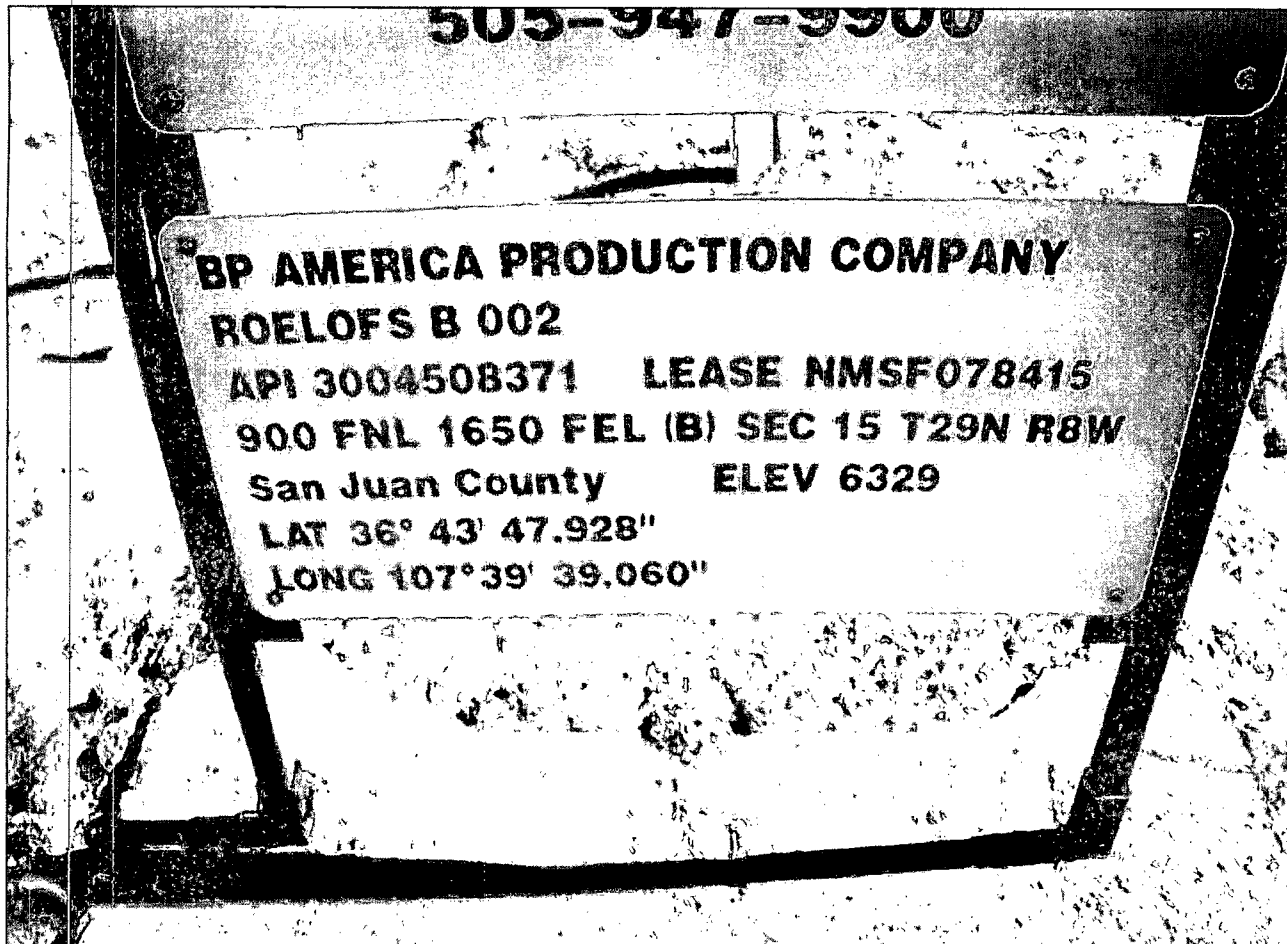
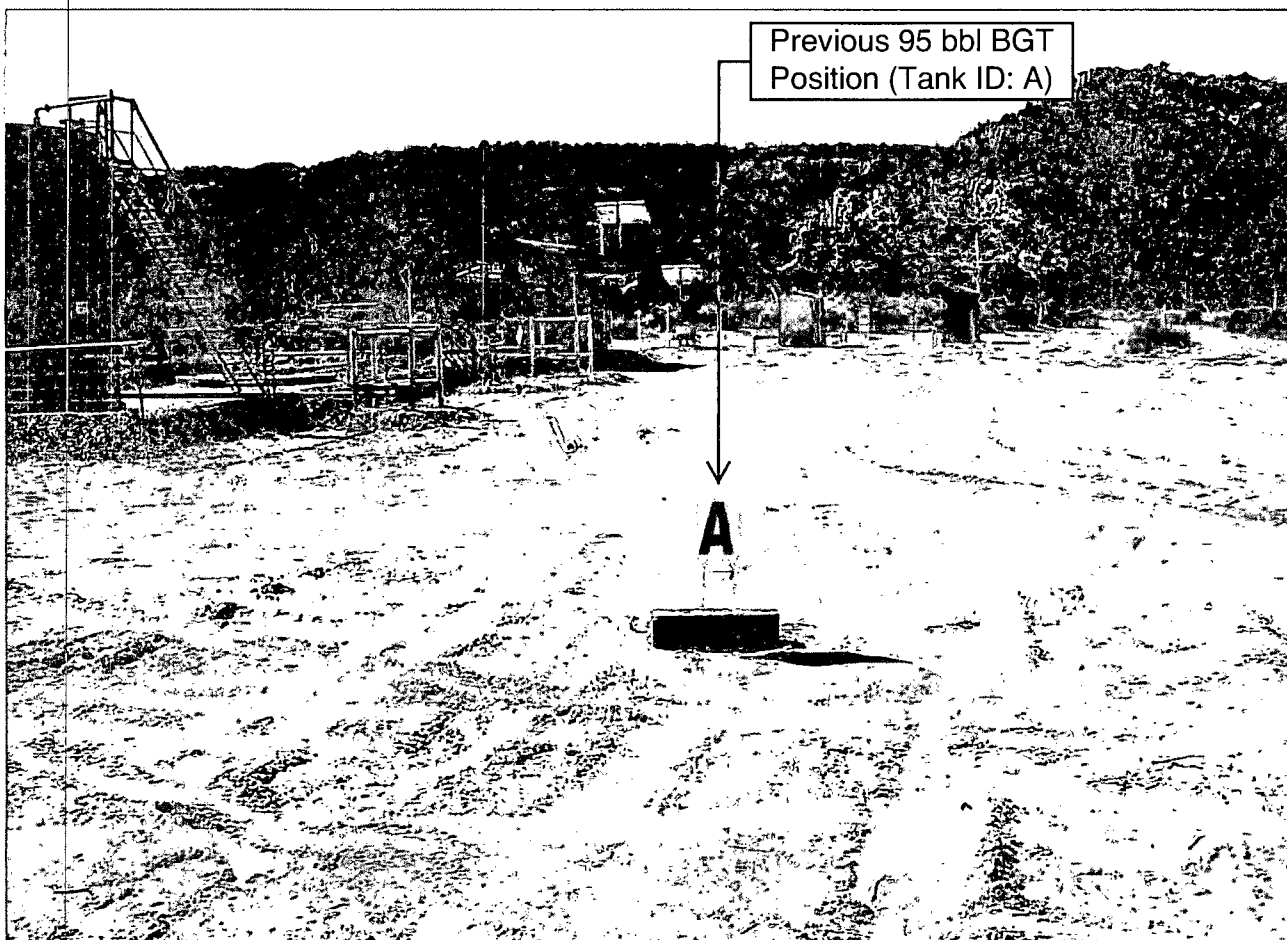
- ☐ Proof of Closure Notice (surface owner and division)
- ☐ Proof of Deed Notice (required for on-site closure for private land only)
- ☐ Plot Plan (for on-site closures and temporary pits)
- ☒ Confirmation Sampling Analytical Results (if applicable)
- ☐ Waste Material Sampling Analytical Results (required for on-site closure)
- ☒ Disposal Facility Name and Permit Number
- ☒ Soil Backfilling and Cover Installation
- ☐ Re-vegetation Application Rates and Seeding Technique
- ☒ Site Reclamation (Photo Documentation)

**The area under the BGT was backfilled with clean soil and is still within the active well area.**
10. BP shall reclaim the BGT location and all areas associated with the BGT including associated access roads to a safe and stable condition that blends with the surrounding undisturbed area. BP shall substantially restore the impacted surface area to the condition that existed prior to oil and gas operations by placement of the soil cover as provided in Subsection H of 19.15.17.13 NMAC, re-contour the location and associated areas to a contour that approximates the original contour and blends with the surrounding topography and re-vegetate according to Subsection I of 19.15.17.13 NMAC.
