BP AMERICA PRODUCTION COMPANY
SAN JUAN BASIN, NORTHWEST NEW MEXICO

BELOW-GRADE TANK CLOSURE PLAN

Jaquez Gas Com A 1, BGT Tank A (95 bbl)

API No. 3004508755

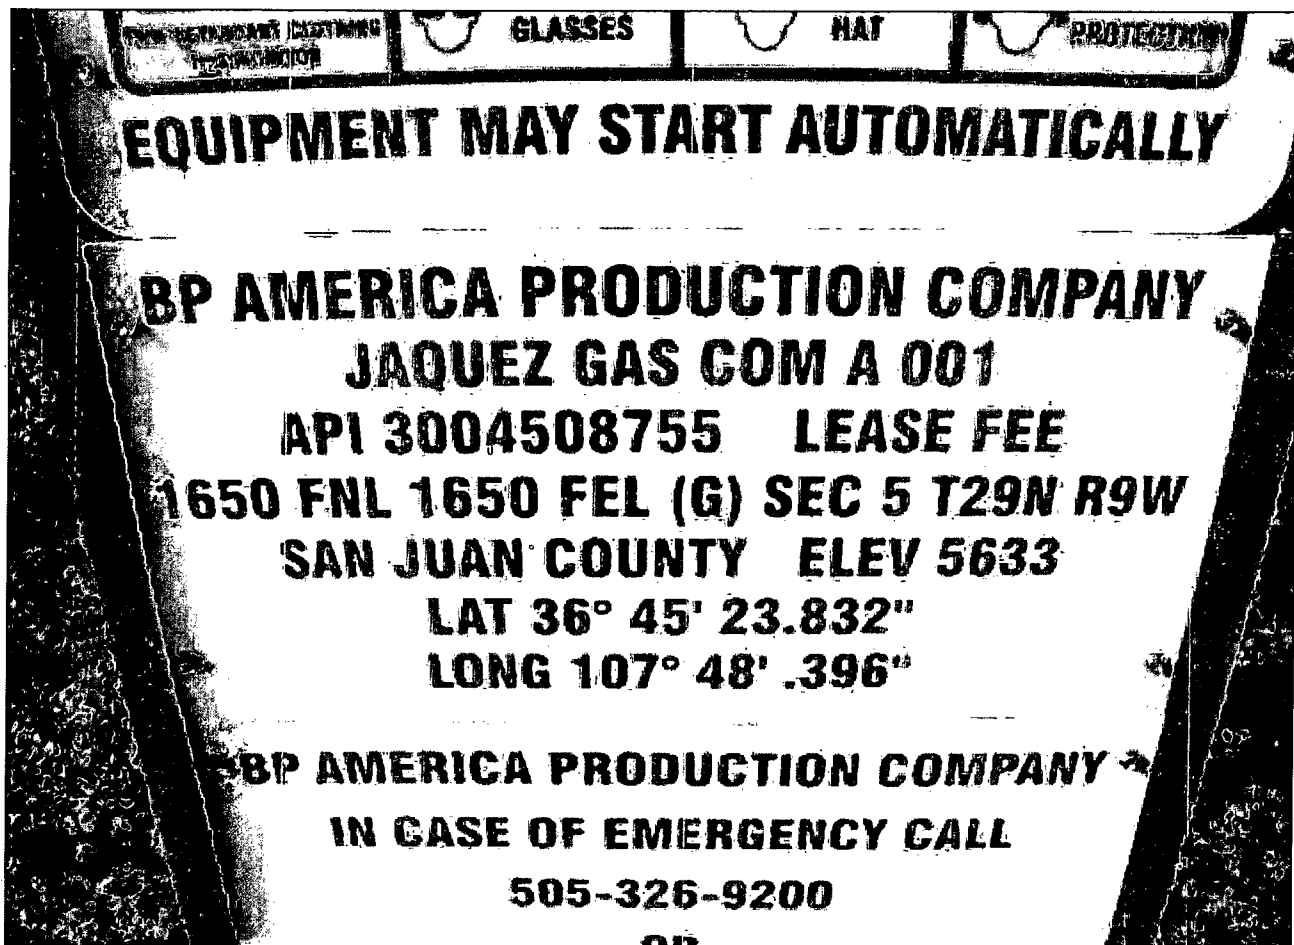
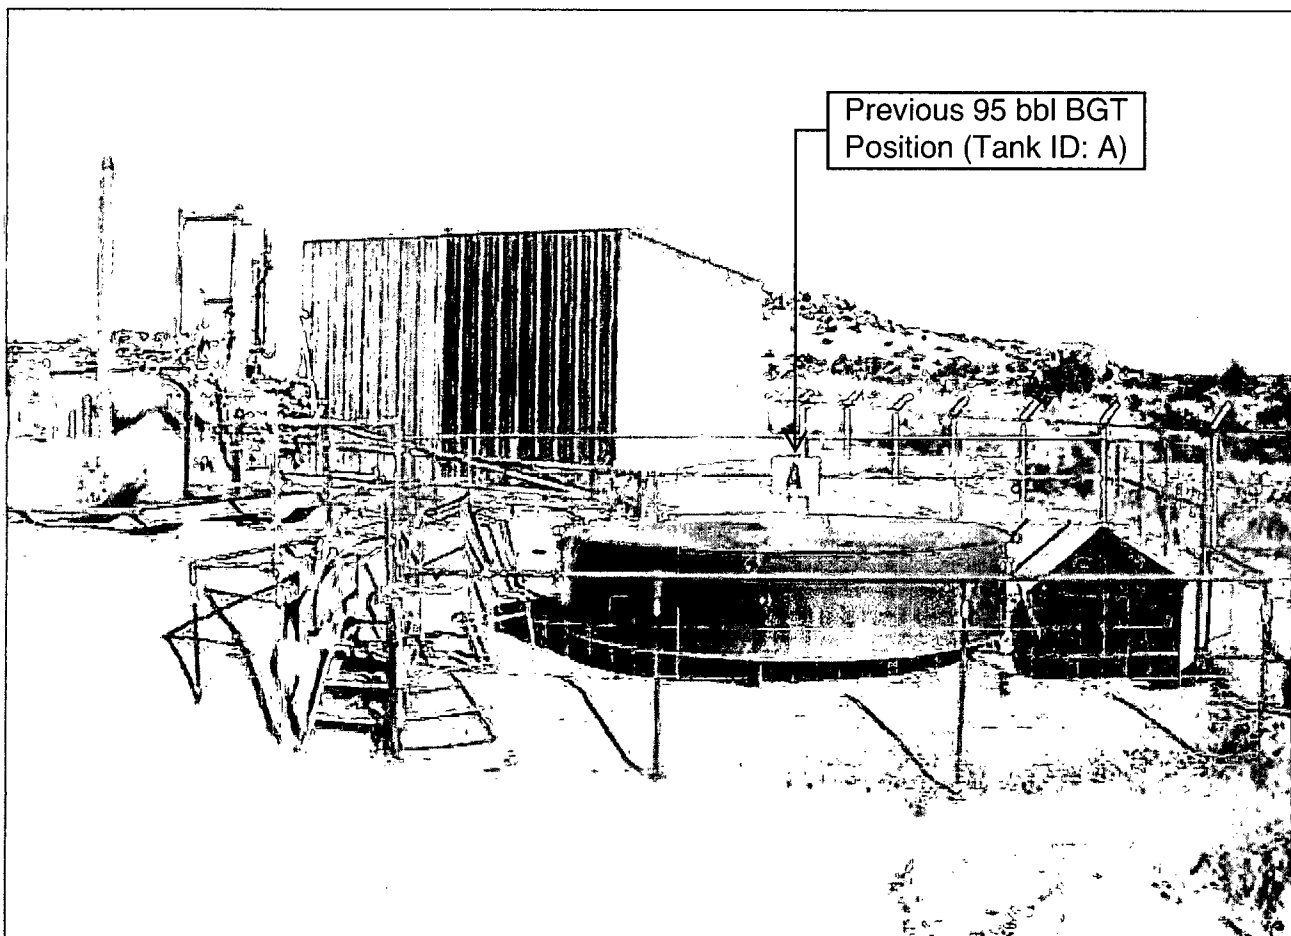
- ☒ Proof of Closure Notice (surface owner and division)
☐ Proof of Deed Notice (required for on-site closure for private land only)
☐ Plot Plan (for on-site closures and temporary pits)
☒ Confirmation Sampling Analytical Results (if applicable)
☐ Waste Material Sampling Analytical Results (required for on-site closure)
☒ Disposal Facility Name and Permit Number
☒ Soil Backfilling and Cover Installation
☐ Re-vegetation Application Rates and Seeding Technique
☒ Site Reclamation (Photo Documentation)

10. BP shall reclaim the BGT location and all areas associated with the BGT including associated access roads to a safe and stable condition that blends with the surrounding undisturbed area. BP shall substantially restore the impacted surface area to the condition that existed prior to oil and gas operations by placement of the soil cover as provided in Subsection H of 19.15.17.13 NMAC, re-contour the location and associated areas to a contour that approximates the original contour and blends with the surrounding topography and re-vegetate according to Subsection I of 19.15.17.13 NMAC.
The area over the BGT is covered by the LPT and is still within the active well area. This area will be reclaimed when the well is plugged and abandoned as part of final reclamation.
