BP AMERICA PRODUCTION COMPANY
SAN JUAN BASIN, NORTHWEST NEW MEXICO

BELOW-GRADE TANK CLOSURE PLAN

Riddle A 3, BGT Tank B (95 bbl)

API No. 3004511791

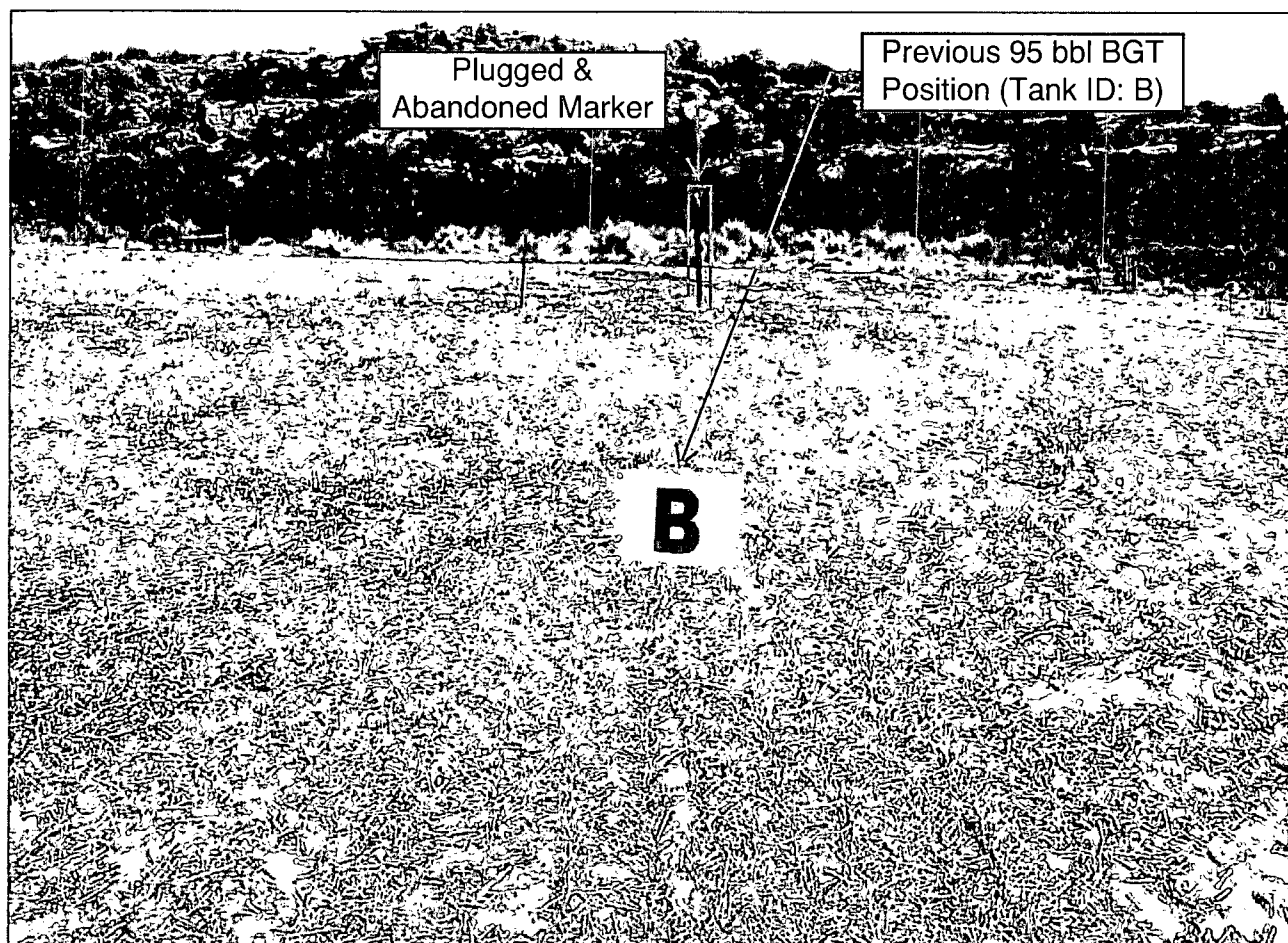
RIDDLE A # 3

10. BP shall reclaim the BGT location and all areas associated with the BGT including associated access roads to a safe and stable condition that blends with the surrounding undisturbed area. BP shall substantially restore the impacted surface area to the condition that existed prior to oil and gas operations by placement of the soil cover as provided in Subsection H of 19.15.17.13 NMAC, re-contour the location and associated areas to a contour that approximates the original contour and blends with the surrounding topography and re-vegetate according to Subsection I of 19.15.17.13 NMAC.
The area over the BGT has been reclaimed since the well was plugged and abandoned.
