BP AMERICA PRODUCTION COMPANY
SAN JUAN BASIN, NORTHWEST NEW MEXICO

BELOW-GRADE TANK CLOSURE PLAN

Vandewart 1

API No. 3004523823

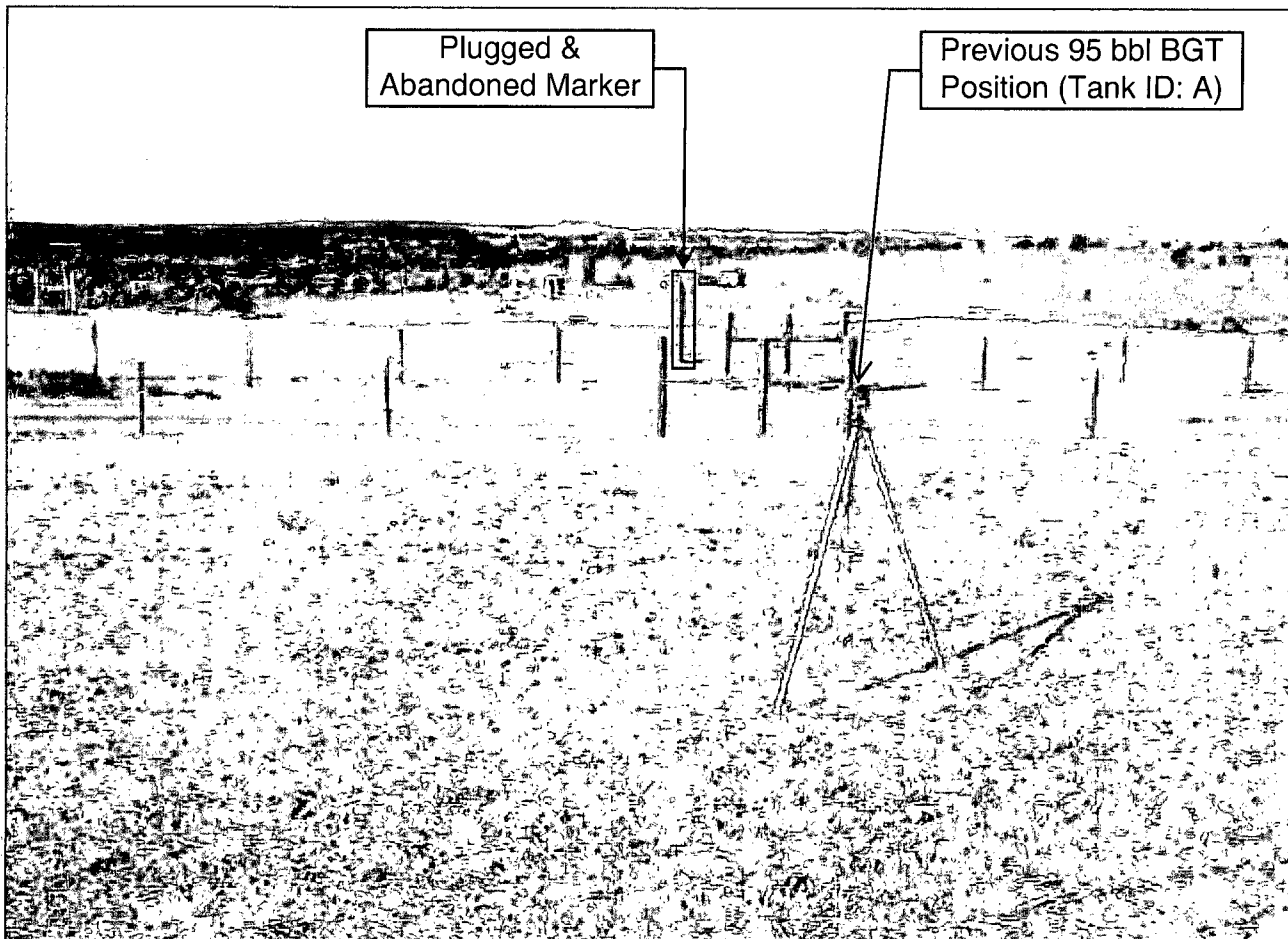
VANDEWART # 001

Plugged &
Abandoned Marker

Previous 95 bbl BGT
Position (Tank ID: A)

10. BP shall reclaim the BGT location and all areas associated with the BGT including associated access roads to a safe and stable condition that blends with the surrounding undisturbed area. BP shall substantially restore the impacted surface area to the condition that existed prior to oil and gas operations by placement of the soil cover as provided in Subsection H of 19.15.17.13 NMAC, re-contour the location and associated areas to a contour that approximates the original contour and blends with the surrounding topography and re-vegetate according to Subsection I of 19.15.17.13 NMAC.
The area over the BGT has been reclaimed since the well was plugged and abandoned.
