BP AMERICA PRODUCTION COMPANY
SAN JUAN BASIN, NORTHWEST NEW MEXICO

BELOW-GRADE TANK CLOSURE PLAN

Florance J 48A, Tank B (18 bbl)

API No. 3004522146

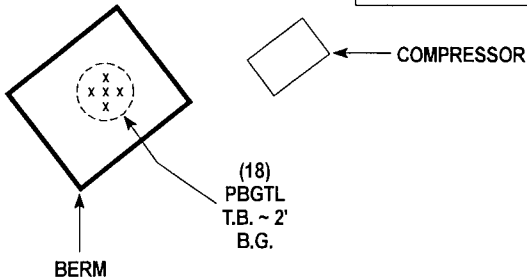
SITE OBSERVATIONS: LOST INTEGRITY OF EQUIPMENT: YES / NO EXPLANATION - 18 BGT ONLY APPARENT EVIDENCE OF A RELEASE OBSERVED AND/OR OCCURRED: YES / NO EXPLANATION: 18 BGT ONLY EQUIPMENT SET OVER RECLAIMED AREA: YES / NO EXPLANATION - OTHER: BEDROCK SANDSTONE OUTCROP @ GROUND SURFACE THROUGHOUT NORTHERN HALF OF WELL PAD. 18 BGT INSTALLED BY CARVING INTO BEDROCK. IMPACTED SOIL VERY MINIMAL. WILL LEAVE IN PLACE. SOIL IMPACT DIMENSION ESTIMATION: 5 ft. X 5 ft. X 0.5 ft. EXCAVATION ESTIMATION (Cubic Yards): <1 DEPTH TO GROUNDWATER: >100' NEAREST WATER SOURCE: >1,000' NEAREST SURFACE WATER: >1,000' NMOC DTPH CLOSURE STD: 5,000 ppm		
SITE SKETCH BGT Located: off on site PLOT PLAN circle: attached

W.H. ⊕		
X - S.P.D. NOTES: BGT = BELOW-GRADE TANK; E.D. = EXCAVATION DEPRESSION; B.G. = BELOW GRADE; B = BELOW; T.H. = TEST HOLE; ~ = APPROX.; W.H. = WELL HEAD; T.B. = TANK BOTTOM; PBGTL = PREVIOUS BELOW-GRADE TANK LOCATION; SPD = SAMPLE POINT DESIGNATION; R.W. = RETAINING WALL; NA = NOT APPLICABLE OR NOT AVAILABLE; SW - SINGLE WALL; DW - DOUBLE WALL; SB - SINGLE BOTTOM; DB - DOUBLE BOTTOM.		MISCELL. NOTES WO: N15182573 PO #: 4300261710 PK: PJ #: Permit date(s): 06/14/10 OCD Appr. date(s): 05/14/14 Tank ID: B OVM = Organic Vapor Meter ppm = parts per million B BGT Sidewalls Visible: (Y) / N C BGT Sidewalls Visible: (Y) / N BGT Sidewalls Visible: Y / N Magnetic declination: 10° E
