12724 Proposed Alternative Method Permit or Closure Plan Application

## BELOW-GRADE TANK CLOSURE PLAN

Archuleta Gas Com A 1

API No. 3004508670

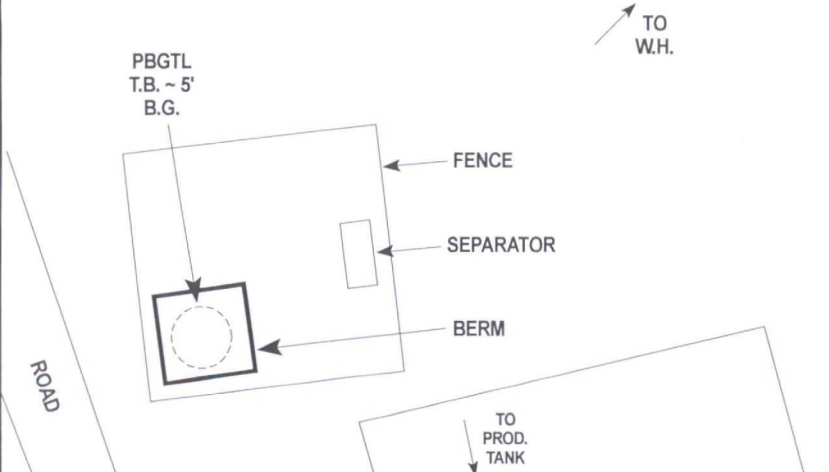
<b>SAMPLING DATA:</b> CHAIN OF CUSTODY RECORD(S) # OR LAB USED: <b>HALL</b> 1) SAMPLE ID: <b>95 BGT 5-pt. @ 4'</b> SAMPLE DATE: <b>01/13/14</b> SAMPLE TIME: <b>1140</b> LAB ANALYSIS: <b>418.1/8015B/8021B/300.0 (CI)</b> OVM READING (ppm): <b>0.0</b> 2) SAMPLE ID: SAMPLE DATE: SAMPLE TIME: LAB ANALYSIS: 3) SAMPLE ID: SAMPLE DATE: SAMPLE TIME: LAB ANALYSIS: 4) SAMPLE ID: SAMPLE DATE: SAMPLE TIME: LAB ANALYSIS:		
<b>SOIL DESCRIPTION:</b> SOIL TYPE: SAND / SILTY SAND <u>SILT / SILTY CLAY</u> / CLAY / GRAVEL / OTHER SOIL COLOR: <b>GRAY</b> COHESION (ALL OTHERS): NON COHESIVE / SLIGHTLY COHESIVE <u>COHESIVE</u> / HIGHLY COHESIVE CONSISTENCY (NON COHESIVE SOILS): LOOSE <u>FIRM</u> / DENSE / VERY DENSE MOISTURE: DRY / SLIGHTLY MOIST / MOIST <u>WET / SATURATED</u> / SUPER SATURATED SAMPLE TYPE: GRAB <u>COMPOSITE</u> # OF PTS. <b>4</b> DISCOLORATION/STAINING OBSERVED: YES <u>NO</u> EXPLANATION - <b>GRAY</b> PLASTICITY (CLAYS): NON PLASTIC / SLIGHTLY PLASTIC / COHESIVE / MEDIUM PLASTIC / HIGHLY PLASTIC DENSITY (COHESIVE CLAYS & SILTS): SOFT / FIRM / STIFF / VERY STIFF / HARD HC ODOR DETECTED: <u>YES</u> / NO EXPLANATION - <b>MINOR</b> ANY AREAS DISPLAYING WETNESS: YES <u>NO</u> EXPLANATION -

<b>SITE OBSERVATIONS:</b> LOST INTEGRITY OF EQUIPMENT: YES <u>NO</u> EXPLANATION - APPARENT EVIDENCE OF A RELEASE OBSERVED AND/OR OCCURRED <u>YES</u> / NO EXPLANATION: <b>OVM &amp; COLOR</b> EQUIPMENT SET OVER RECLAIMED AREA: YES <u>NO</u> EXPLANATION - OTHER:		
SOIL IMPACT DIMENSION ESTIMATION: <b>NA</b> ft. X <b>NA</b> ft. X <b>NA</b> ft. EXCAVATION ESTIMATION (Cubic Yards): <b>NA</b> DEPTH TO GROUNDWATER: <b>&lt;50</b> NEAREST WATER SOURCE: <b>&gt;1,000'</b> NEAREST SURFACE WATER: <b>&lt;1,000'</b> NMOCD TPH CLOSURE STD: <b>100</b> ppm		
<b>SITE SKETCH</b> BGT Located : off <u>on</u> site PLOT PLAN circle: <u>attached</u>

NOTES: BGT = BELOW-GRADE TANK; E.D. = EXCAVATION DEPRESSION; B.G. = BELOW GRADE; B = BELOW; T.H. = TEST HOLE; ~ = APPROX.; W.H. = WELL HEAD; T.B. = TANK BOTTOM; PBGTL = PREVIOUS BELOW-GRADE TANK LOCATION; SPD = SAMPLE POINT DESIGNATION; R.W. = RETAINING WALL; NA - NOT APPLICABLE OR NOT AVAILABLE; SW - SINGLE WALL; DW - DOUBLE WALL; SB - SINGLE BOTTOM; DB - DOUBLE BOTTOM. NOTES: <b>GOOGLE EARTH IMAGERY DATE: 11/17/13.</b> ONSITE: <b>01/13/14</b>
