1. Operator:Enervest Operating LLC OGRID #:
Address:2700 Farmington Ave , Building K, Suite #1 Farmington, NM 87042
Facility or well name:Jicarilla Apache 102 #016
API Number:30-039-20190 OCD Permit Number:
U/L or Qtr/QtrO Section10 Township26N Range4W County:Rio Arriba
Center of Proposed Design: Latitude36. 496676 Longitude107.234973 NAD: \[\begin{array}{c} 1927 \ \textbf{X} \ 1983 \end{array}
Surface Owner: Federal State Private X Tribal Trust or Indian Allotment
Pit: Subsection F, G or J of 19.15.17.11 NMAC Temporary: Drilling Workover Permanent Emergency Cavitation P&A Multi-Well Fluid Management Low Chloride Drilling Fluid yes no Lined Unlined Liner type: Thickness mil LLDPE HDPE PVC Other String-Reinforced Liner Seams: Welded Factory Other Volume: bbl Dimensions: L x W x D 3. X Below-grade tank: Subsection I of 19.15.17.11 NMAC Volume: 95 bbl Type of fluid: Produced Water Tank Construction material: Steel Secondary containment with leak detection Visible sidewalls, liner, 6-inch lift and automatic overflow shut-off

BELOW-GRADE TANK CLOSURE PLAN

Well Name – Jicarilla Apache 102 #016 API # 30-039-20190 Location UL- O, Sec 10, T-26N, R-4W Lat: N 36.496676 Lat W -107.234973

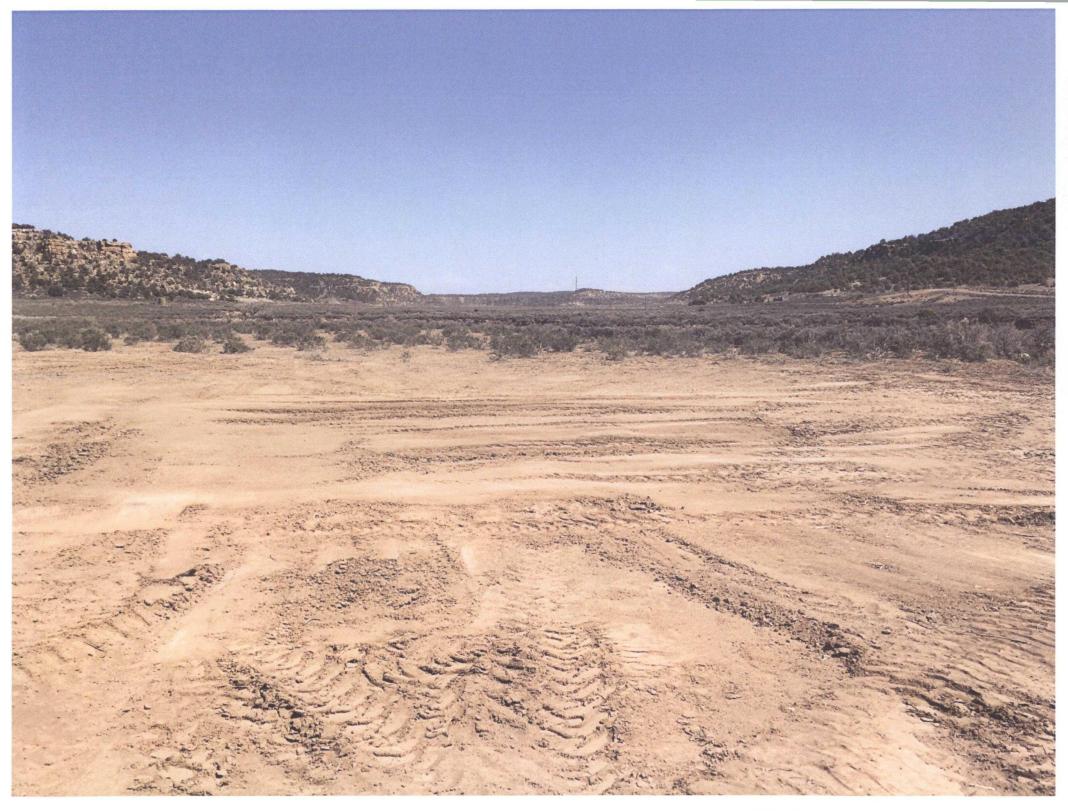
JIC APACHE 102 016-MV
API# 3003920190
FEDERAL LEASE# JIC102
SW/4 SE/4 (0) SEC.10-T26N-R4W
RIO Arriba County
ENERVEST OPERATING, LLC
LAT 36.4966 LONG 107.2350

The excavation was back filled by Tomahawk Oilfield Services on 4/8/2015 utilizing soil that was already on location. The location was contoured to match the existing terrain. See attached photographs

EV reseeded the excavated area with Jicarilla Southern Seed Mix. See attached photos.
