EnerVest Operating, LLC (EV)

BELOW-GRADE TANK CLOSURE PLAN

Well Name – Williams #001B Below Grade Tank API # 30-045-31587 Location UL- G, Sec 24 T-31N, R-13W Lat: N 36.888617 Lat W -107. 153827

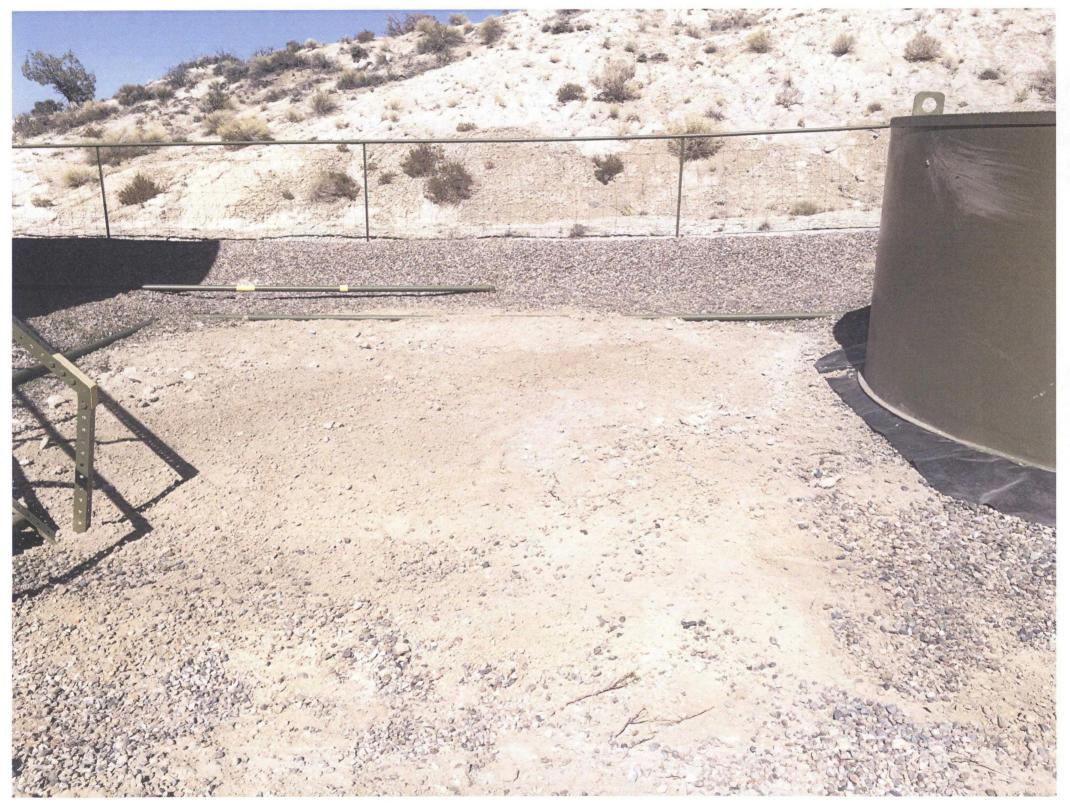
Williams No. 1B 1390' FNL & 2135' FEL SEC 24 T 31N R 13W SAN JUAN C.O. N.M. LATITUDE: 36° 35' 19" longitude: 108° 09' 11" Phone SS5-325-0318

The excavation was back filed by Sierra Oil Field Services on April 6, 2015, utilizing soil that was already on location. The location was contoured to match the existing terrain. See attached photographs.
