BP AMERICA PRODUCTION COMPANY
SAN JUAN BASIN, NORTHWEST NEW MEXICO

BELOW-GRADE TANK CLOSURE PLAN

Gallegos Canyon Unit 193, BGT Tank B (21 bbl)

API No. 3004511570

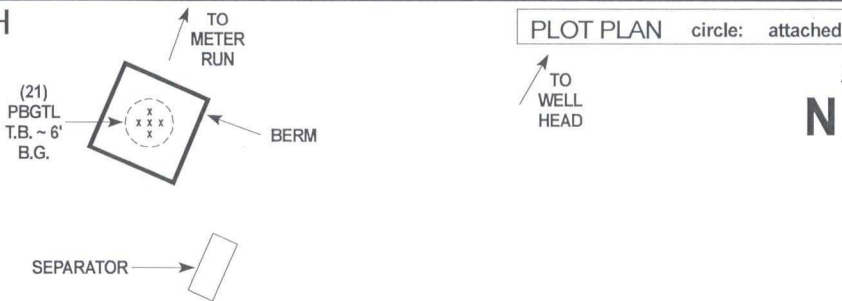
SITE SKETCH

| CONSISTENCY (NON COHESIVE SOILS): LOOSE <input checked="" type="checkbox"/> FIRM / DENSE <input type="checkbox"/> VERY DENSE | HC ODOR DETECTED: <input checked="" type="checkbox"/> YES / NO EXPLANATION - FROM DISCOLORED SOILS ONLY. |
| MOISTURE: <input checked="" type="checkbox"/> DRY / <input type="checkbox"/> SLIGHTLY MOIST / MOIST / WET / SATURATED / SUPER SATURATED | DISCOLORATION/STAINING OBSERVED: <input checked="" type="checkbox"/> YES / NO EXPLANATION - DUSKY BROWN TO LIGHT GRAY @ 21 BGT ONLY. |

ADDITIONAL COMMENTS: ~~NO APPARENT EVIDENCE OF A RELEASE OBSERVED FROM 95 BGT.~~ **IMPACTED SOILS BELOW 21 BGT NOT FROM LOST INTEGRITY. IMPACTED SOILS APPEARS TO BE FROM SEPARATE/DIFFERENT SOURCE. COMPETENT BEDROCK EXPOSED AT 6 FT. BELOW GRADE.**

SOIL IMPACT DIMENSION ESTIMATION: **?** ft. X **?** ft. X **?** ft. EXCAVATION ESTIMATION (Cubic Yards): **?**
 DEPTH TO GROUNDWATER: **>100'** NEAREST WATER SOURCE: **>1,000'** NEAREST SURFACE WATER: **<1,000'** NMOCD TPH CLOSURE STD: **1,000** ppm
