12929 Pit, Below-Grade Tank, or
Proposed Alternative Method Permit or Closure Plan Application

BELOW-GRADE TANK CLOSURE PLAN

Gallegos Canyon Unit 193, BGT Tank A (95 bbl)

API No. 3004511570

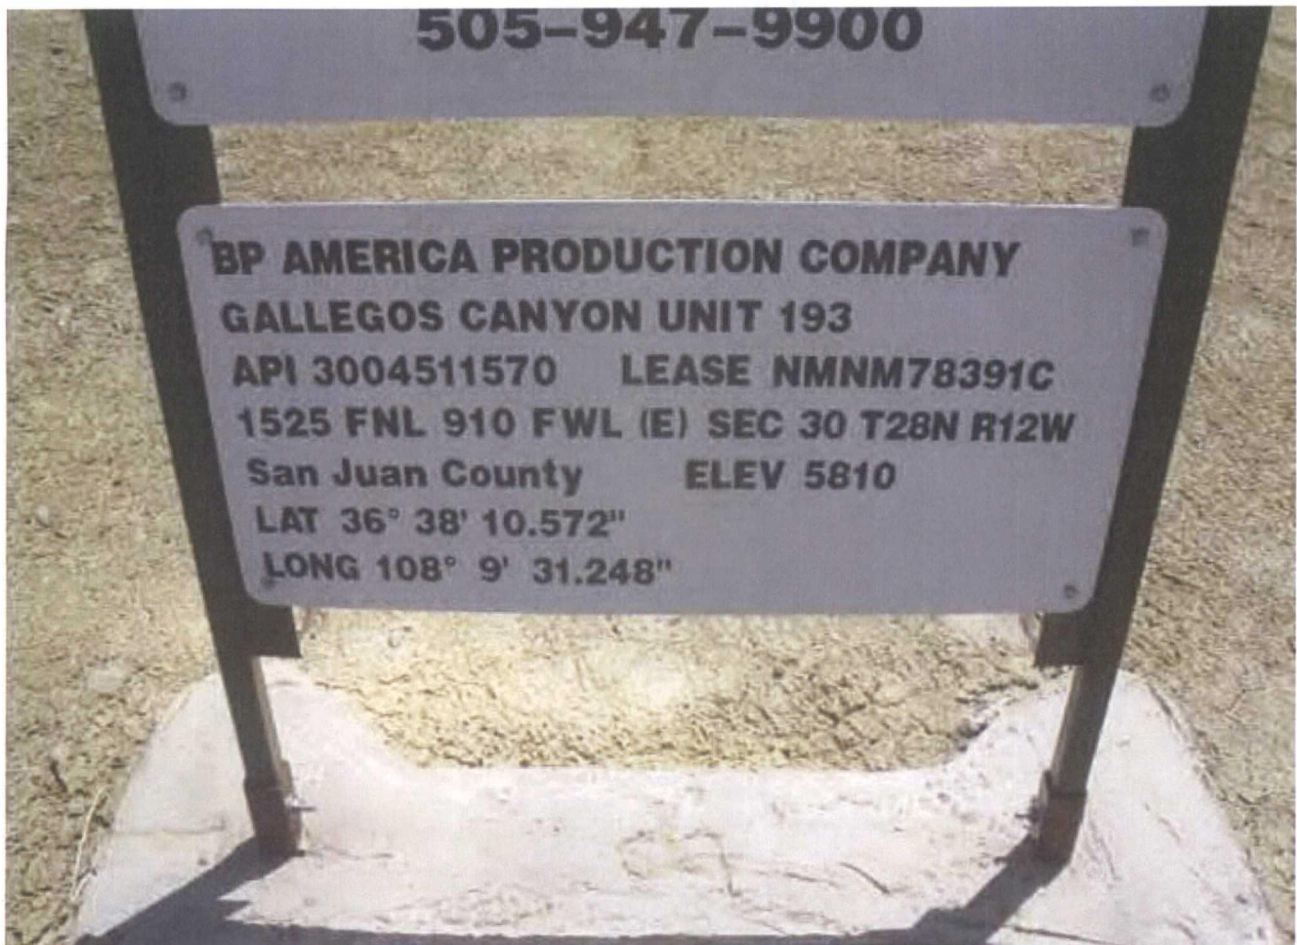
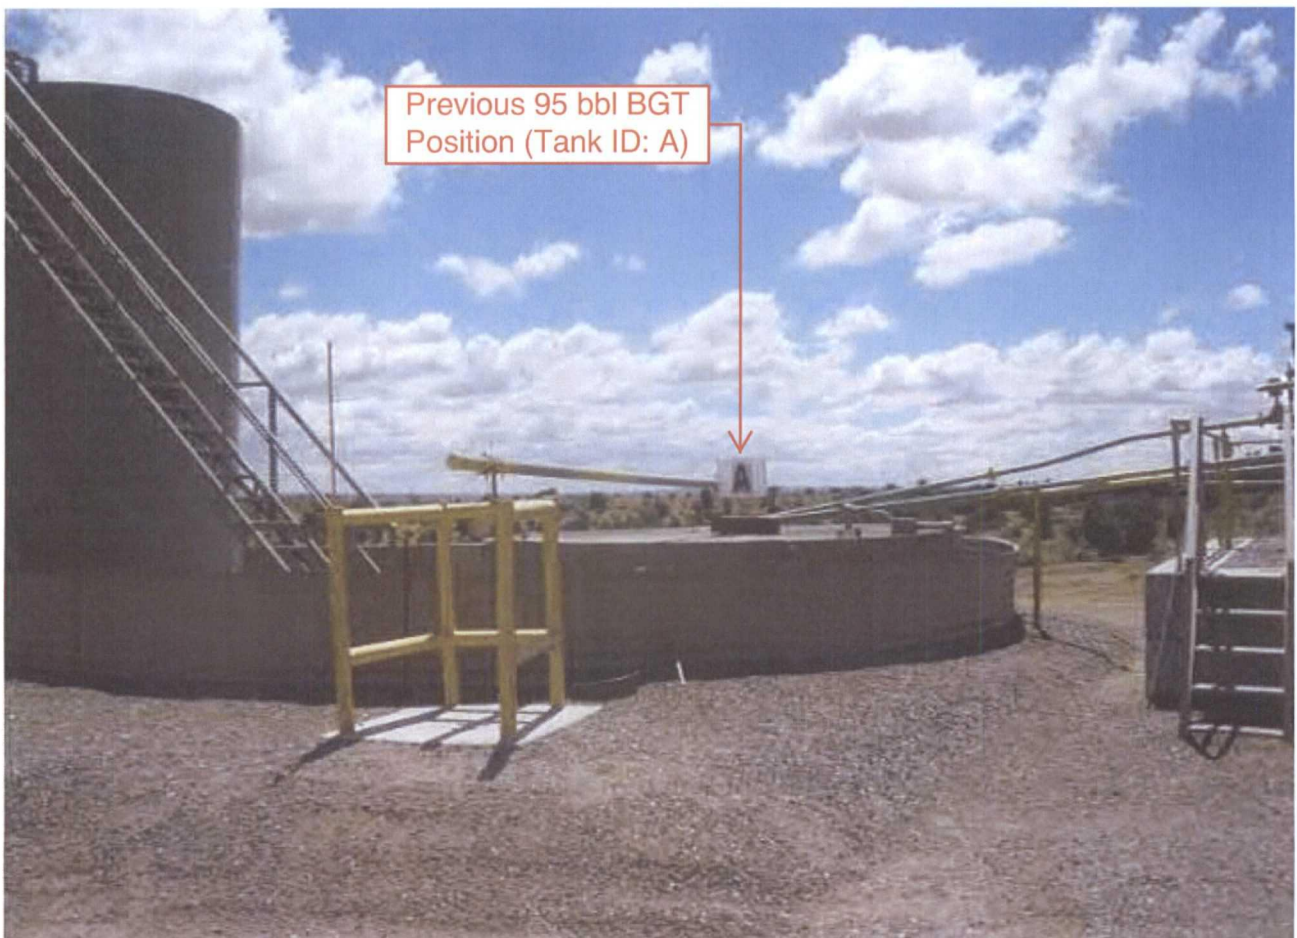
- ☒ Proof of Closure Notice (surface owner and division)
- ☐ Proof of Deed Notice (required for on-site closure for private land only)
- ☐ Plot Plan (for on-site closures and temporary pits)
- ☒ Confirmation Sampling Analytical Results (if applicable)
- ☐ Waste Material Sampling Analytical Results (required for on-site closure)
- ☒ Disposal Facility Name and Permit Number
- ☒ Soil Backfilling and Cover Installation
- ☐ Re-vegetation Application Rates and Seeding Technique
- ☒ Site Reclamation (Photo Documentation)

10. BP shall reclaim the BGT location and all areas associated with the BGT including associated access roads to a safe and stable condition that blends with the surrounding undisturbed area. BP shall substantially restore the impacted surface area to the condition that existed prior to oil and gas operations by placement of the soil cover as provided in Subsection H of 19.15.17.13 NMAC, re-contour the location and associated areas to a contour that approximates the original contour and blends with the surrounding topography and re-vegetate according to Subsection I of 19.15.17.13 NMAC.
