Pit, Below-Grade Tank, or
Proposed Alternative Method Permit or Closure Plan Application

**ConocoPhillips Company
San Juan Basin
Below Grade Tank Closure Report**

Lease Name: SAN JUAN 29-5 UNIT 55

API No.: 30-039-20458

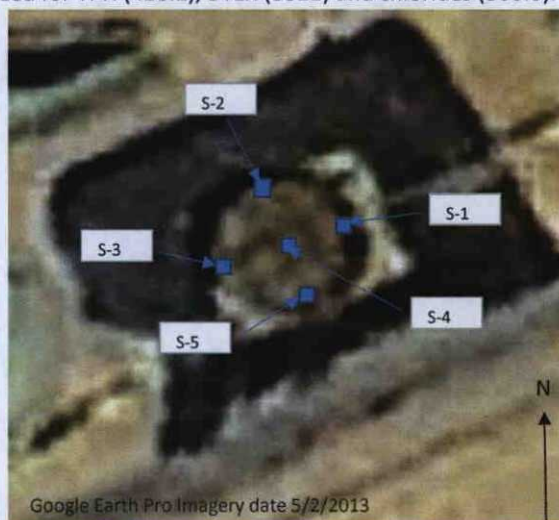
Observations: No staining or indication of a release.

SC-1 is a 5-point composite of S-1 through S-5, collected 0.5 ft below tank liner.
