13969 Proposed Alternative Method Permit or Closure Plan Application

BELOW-GRADE TANK CLOSURE PLAN

Gallegos Canyon Unit 412

API No. 3004528759

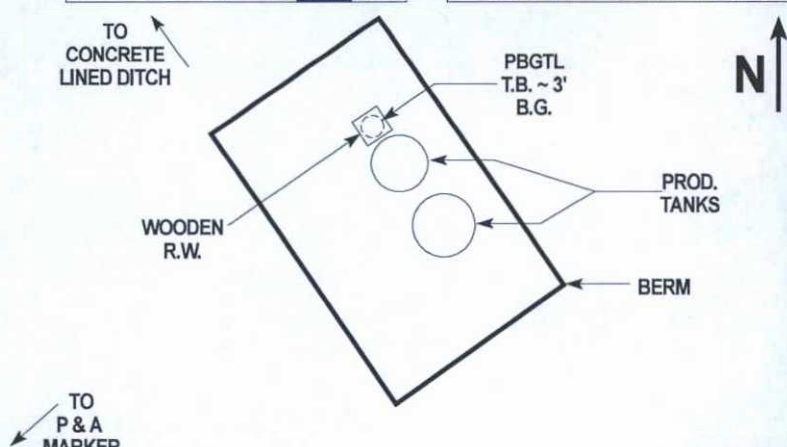
NOTES: BGT = BELOW-GRADE TANK; E.D. = EXCAVATION DEPRESSION; B.G. = BELOW GRADE; B = BELOW; T.H. = TEST HOLE; ~ = APPROX.; W.H. = WELL HEAD; T.B. = TANK BOTTOM; PBGT = PREVIOUS BELOW-GRADE TANK LOCATION; SPD = SAMPLE POINT DESIGNATION; R.W. = RETAINING WALL; NA - NOT APPLICABLE OR NOT AVAILABLE; SW - SINGLE WALL; DW - DOUBLE WALL; SB - SINGLE BOTTOM; DB - DOUBLE BOTTOM.		MISCELL. NOTES WO: REF #: P - 207 VID: VBES0COM PJ #: Permit date(s): 06/14/10 OCD Appr. date(s): 09/13/10 Tank ID: A OVM = Organic Vapor Meter ppm = parts per million BGT Sidewalls Visible: Y / N BGT Sidewalls Visible: Y / N BGT Sidewalls Visible: Y / N Magnetic declination: 10° E

NOTES: GOOGLE EARTH IMAGERY DATE: 03/15/2015. ONSITE: 11/25/15
