14201 Proposed Alternative Method Permit or Closure Plan Application

BELOW-GRADE TANK CLOSURE PLAN

Gallegos Canyon Unit 031

API No. 3004507026

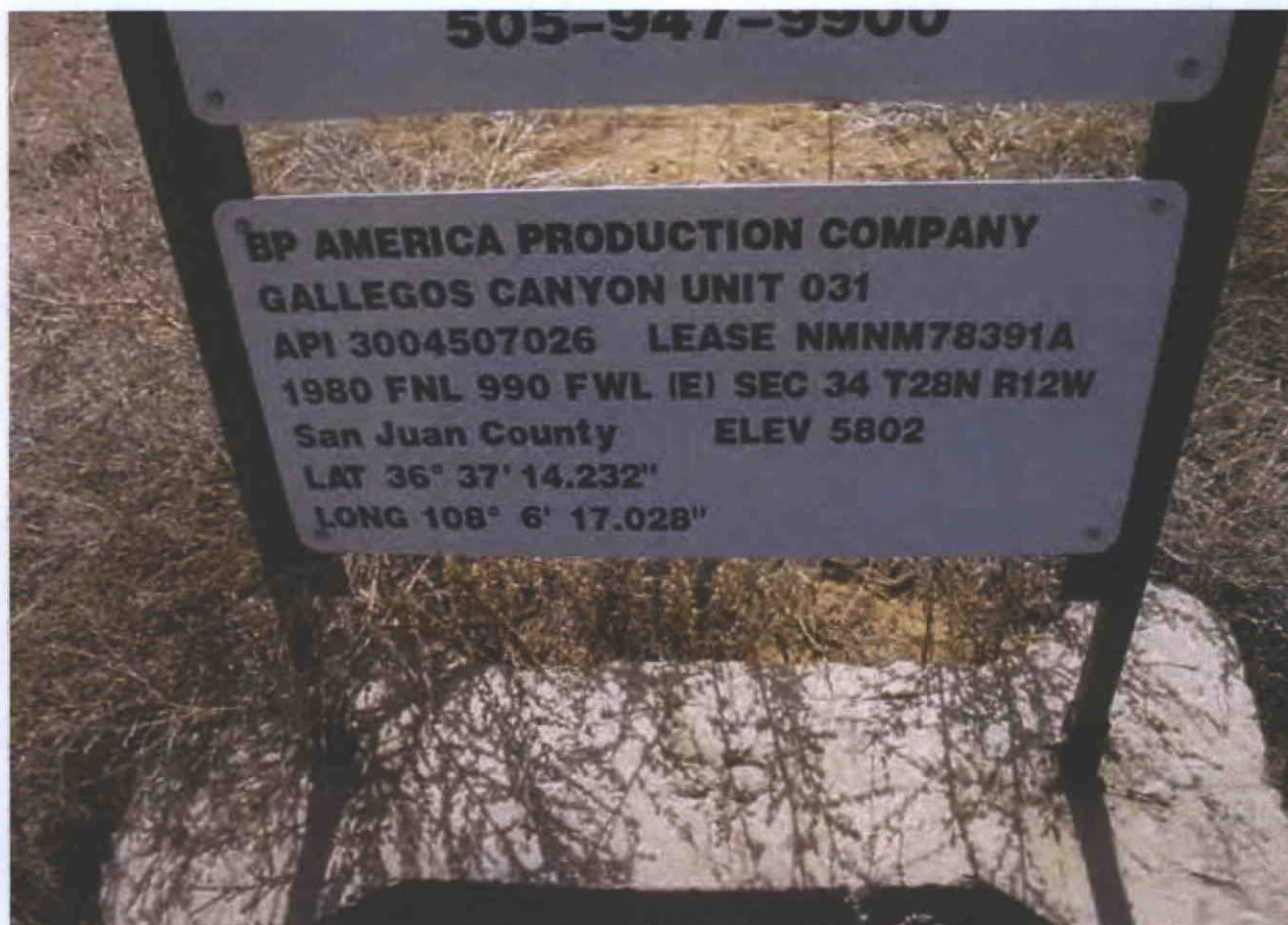
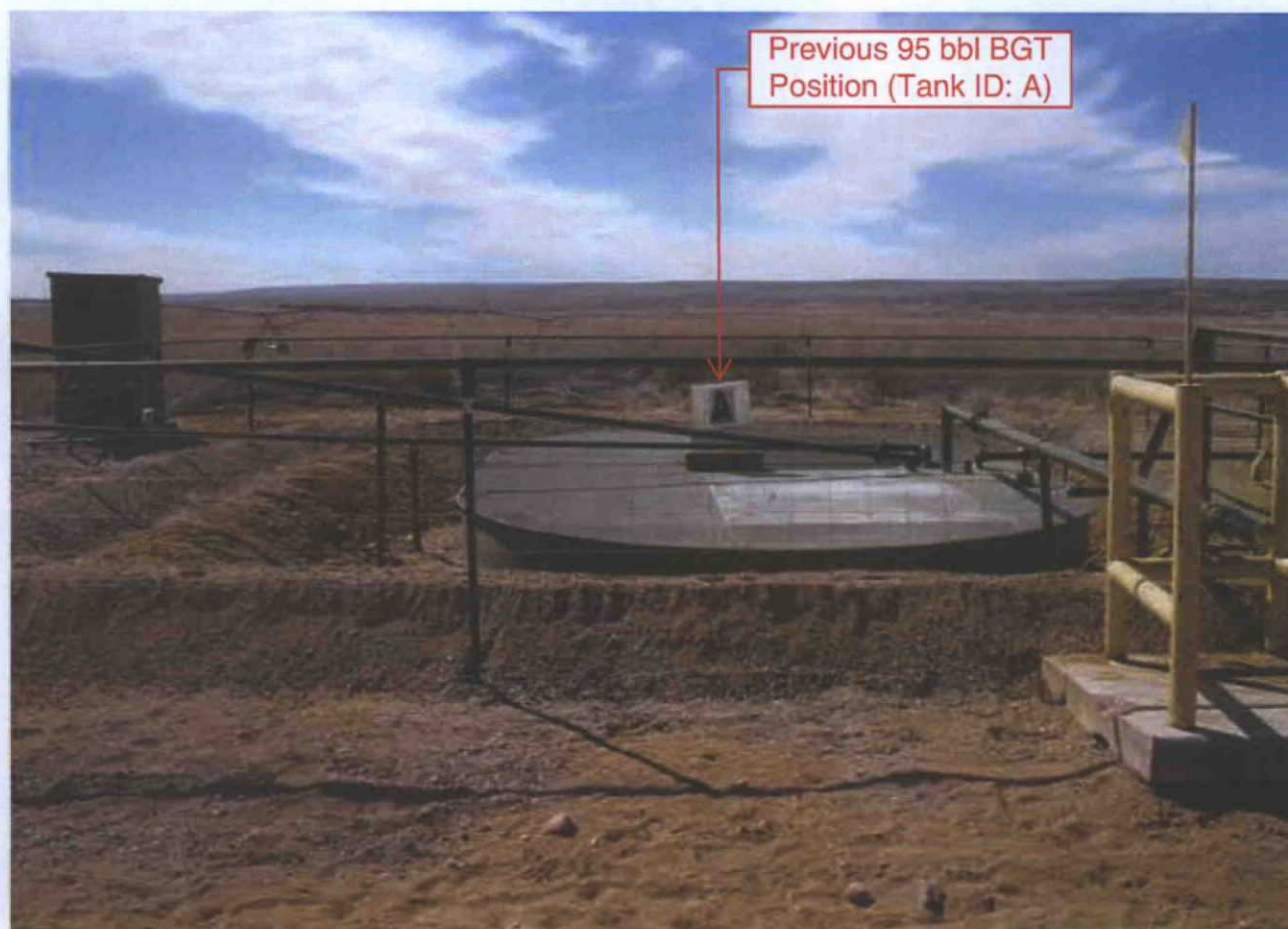
Sampling results determine no significant release has occurred. Area was backfilled with clean, earthen material.

The area has been backfilled and will be reclaimed when the well has been plugged and abandoned.
