BP AMERICA PRODUCTION COMPANY  
SAN JUAN BASIN, NORTHWEST NEW MEXICO

BELOW-GRADE TANK CLOSURE PLAN

Gallegos Canyon Unit 502

API No. 3004528119

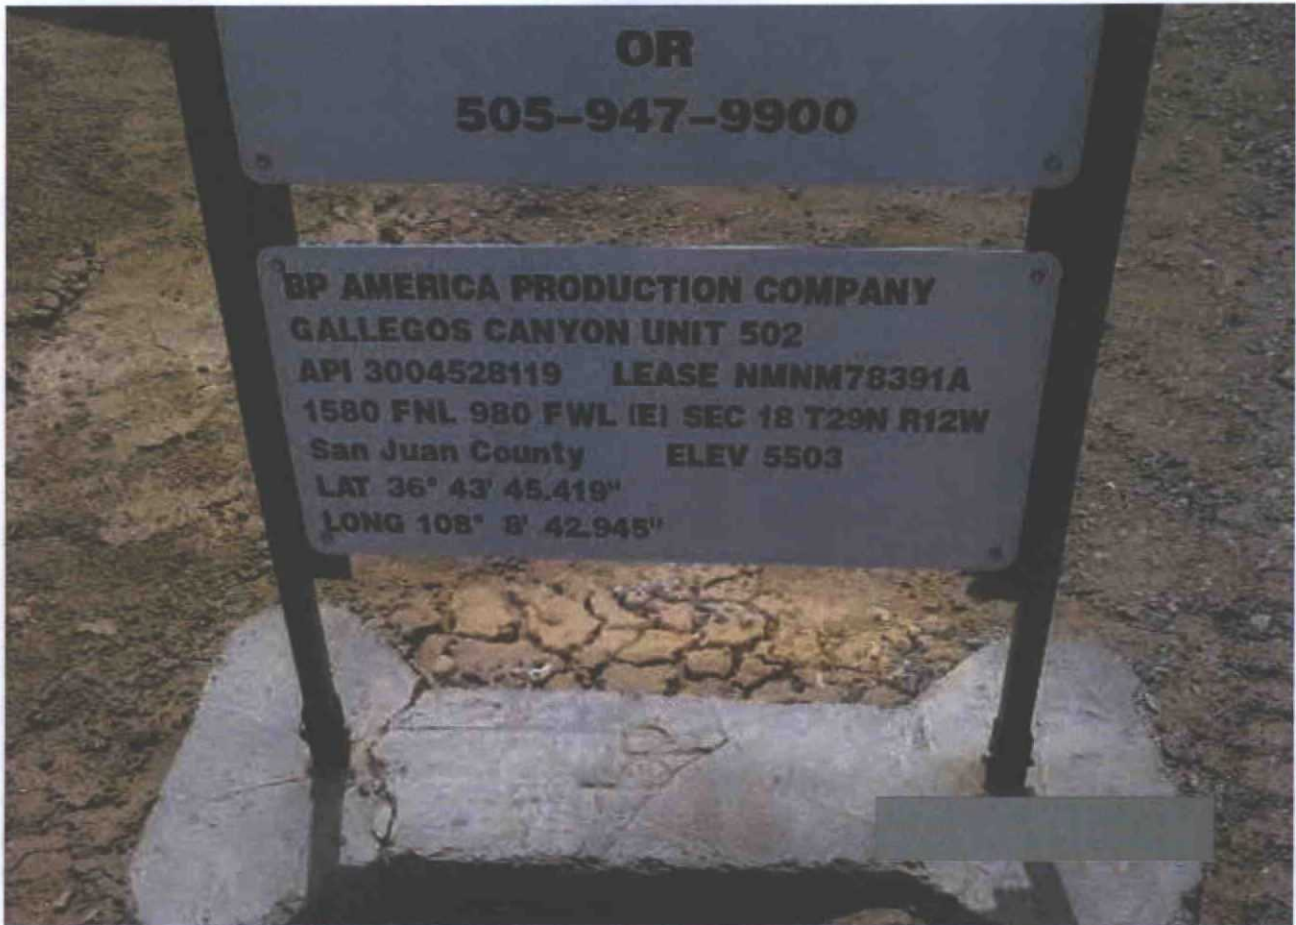
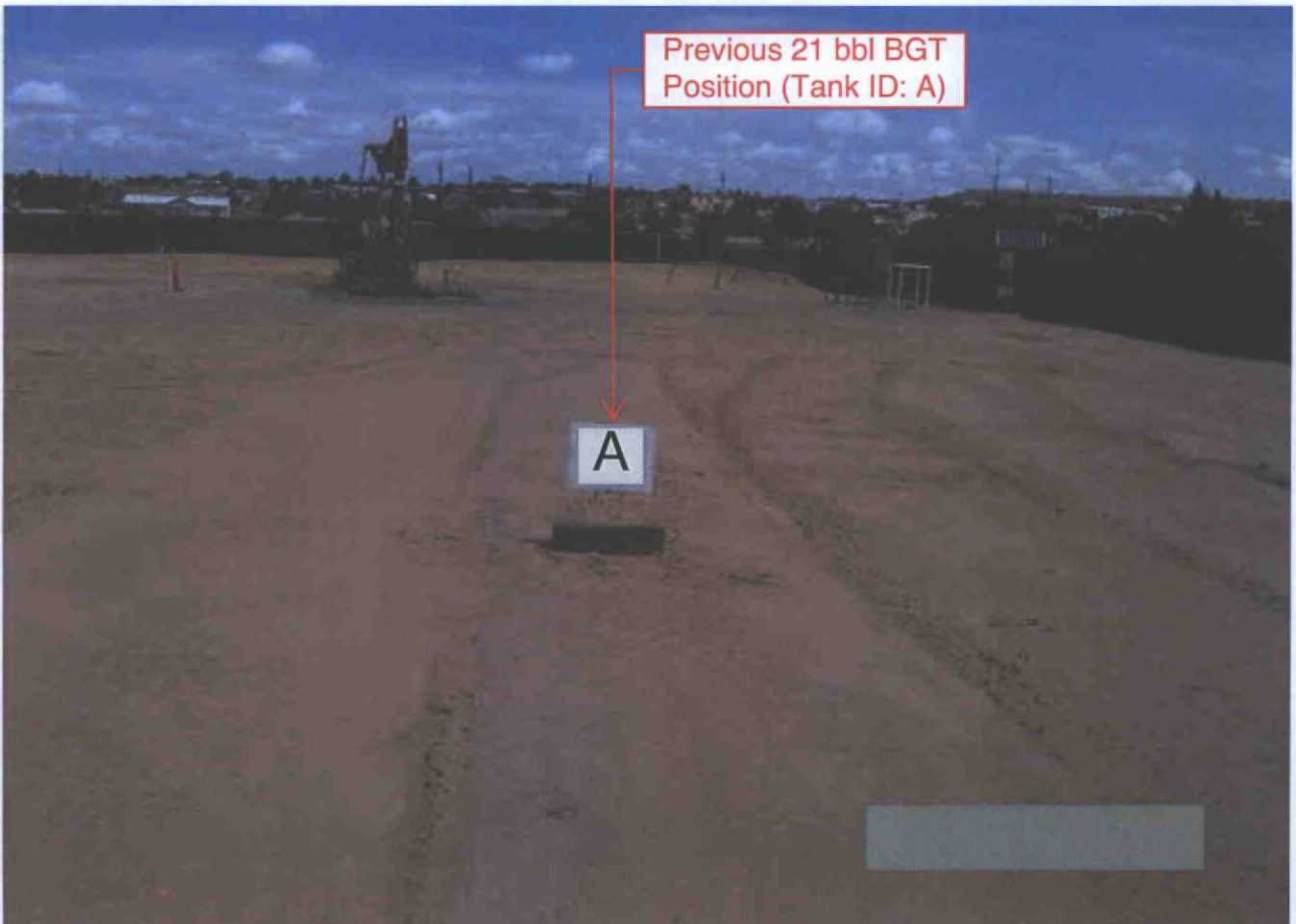
**Closure report on C-144 form is included including photos of reclamation completion.**

**The area has been backfilled and will be reclaimed once the well has been plugged and abandoned.**
11. The soil cover for closures where the BGT has been removed or remediated to the NMOCD's satisfaction shall consist of the background thickness of topsoil or one foot of suitable material to establish vegetation at the site, whichever is greater. The soil cover will be constructed to the site's existing grade and all practicable efforts will be made to prevent ponding of water and erosion of the cover material.
