14641 Pit, Below-Grade Tank, or
Proposed Alternative Method Permit or Closure Plan Application

BELOW-GRADE TANK CLOSURE PLAN

Gallegos Canyon Unit 598
API No. 3004531600
Unit Letter M, Section 22, T29N, R12W

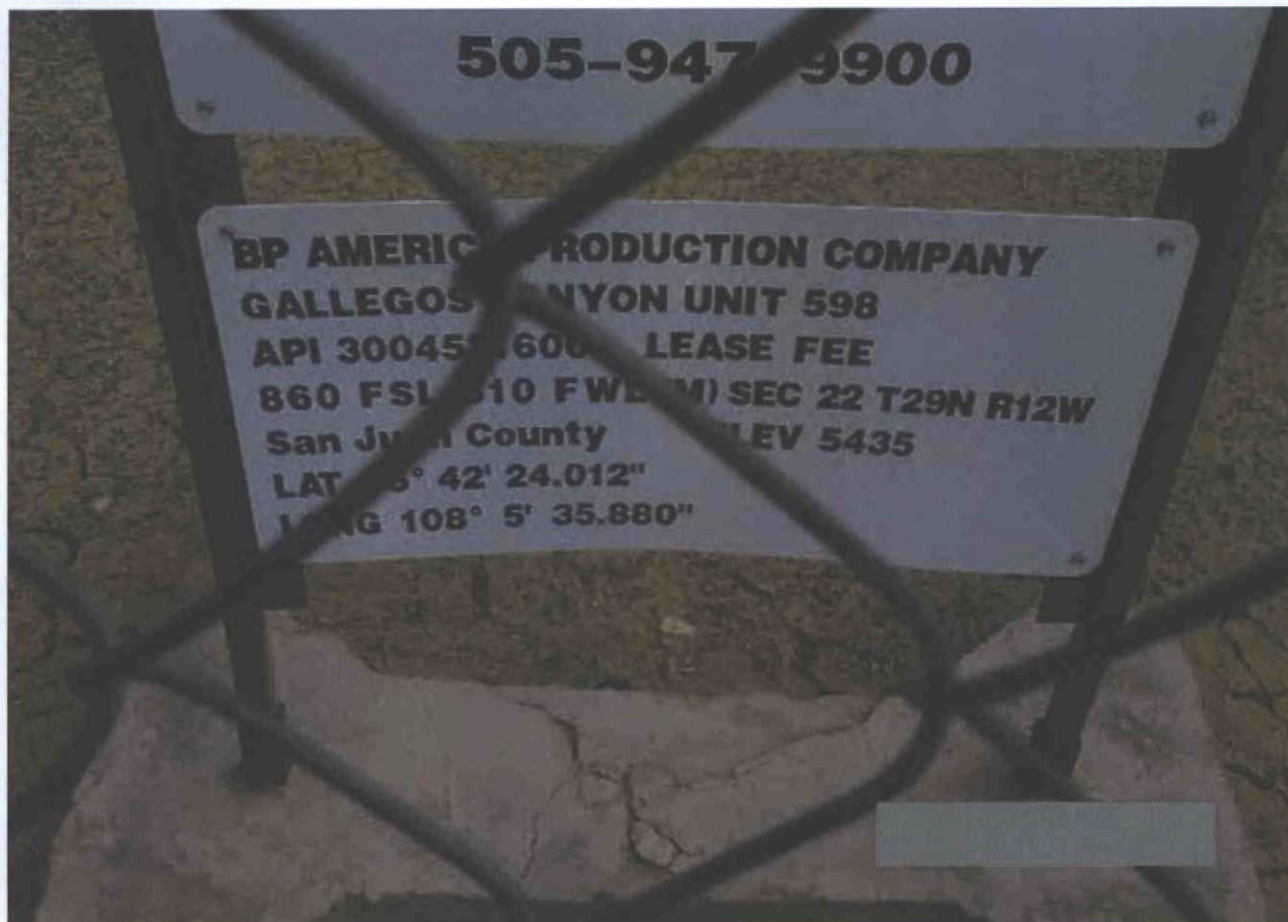
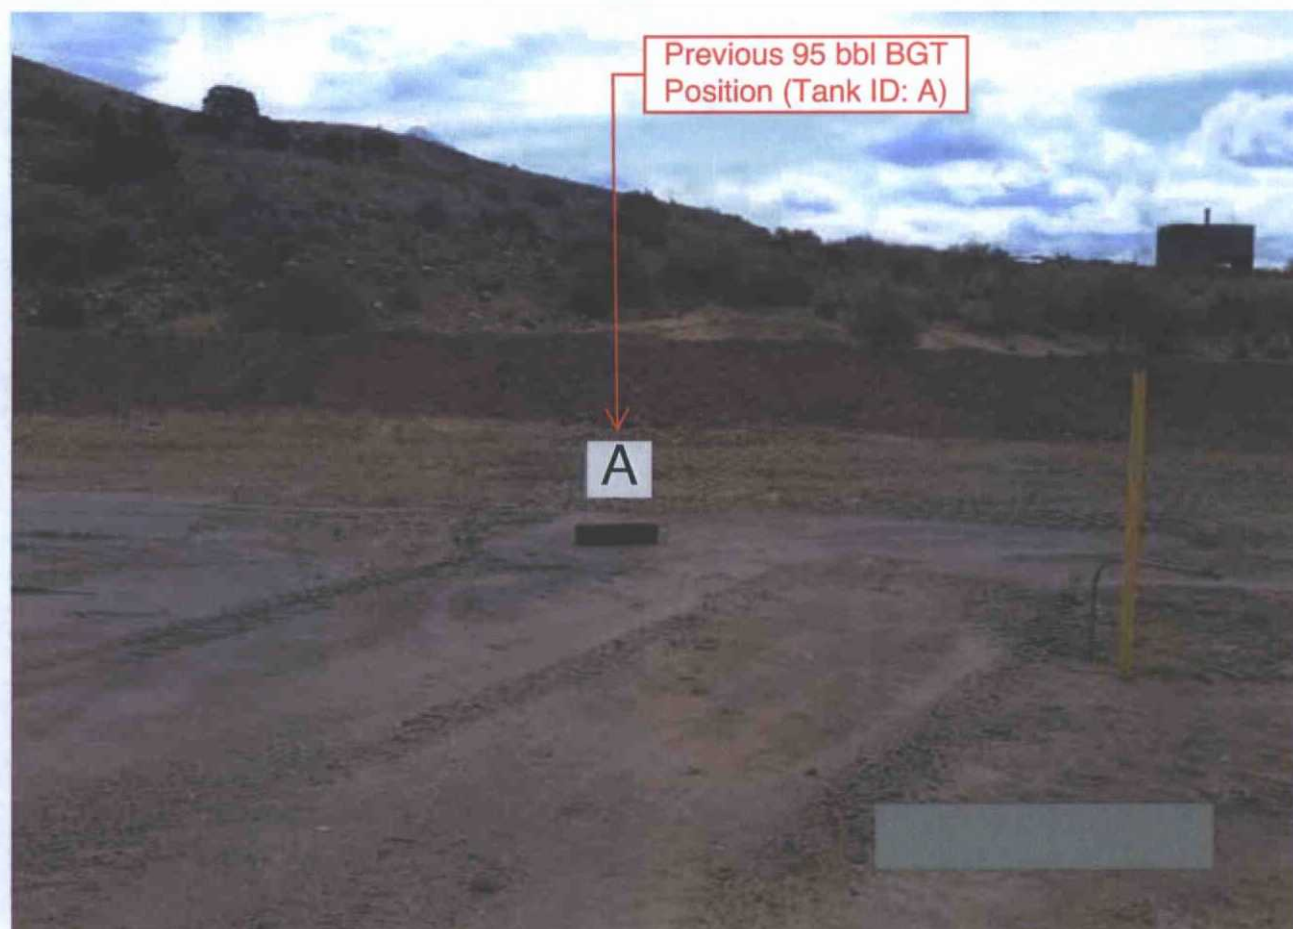
Closure report on C-144 form is included including photos of reclamation completion.

10. BP shall reclaim the BGT location and all areas associated with the BGT including associated access roads to a safe and stable condition that blends with the surrounding undisturbed area. BP shall substantially restore the impacted surface area to the condition that existed prior to oil and gas operations by placement of the soil cover as provided in Subsection H of 19.15.17.13 NMAC, re-contour the location and associated areas to a contour that approximates the original contour and blends with the surrounding topography and re-vegetate according to Subsection I of 19.15.17.13 NMAC.
The area has been backfilled and will be reclaimed once the well has been plugged and abandoned.
