Pit, Closed-Loop System, Below-Grade Tank, or
Proposed Alternative Method Permit or Closure Plan Application

BELOW-GRADE TANK CLOSURE PLAN

Mudge Com B # 2E – Tank ID: A

API #: 3004525381

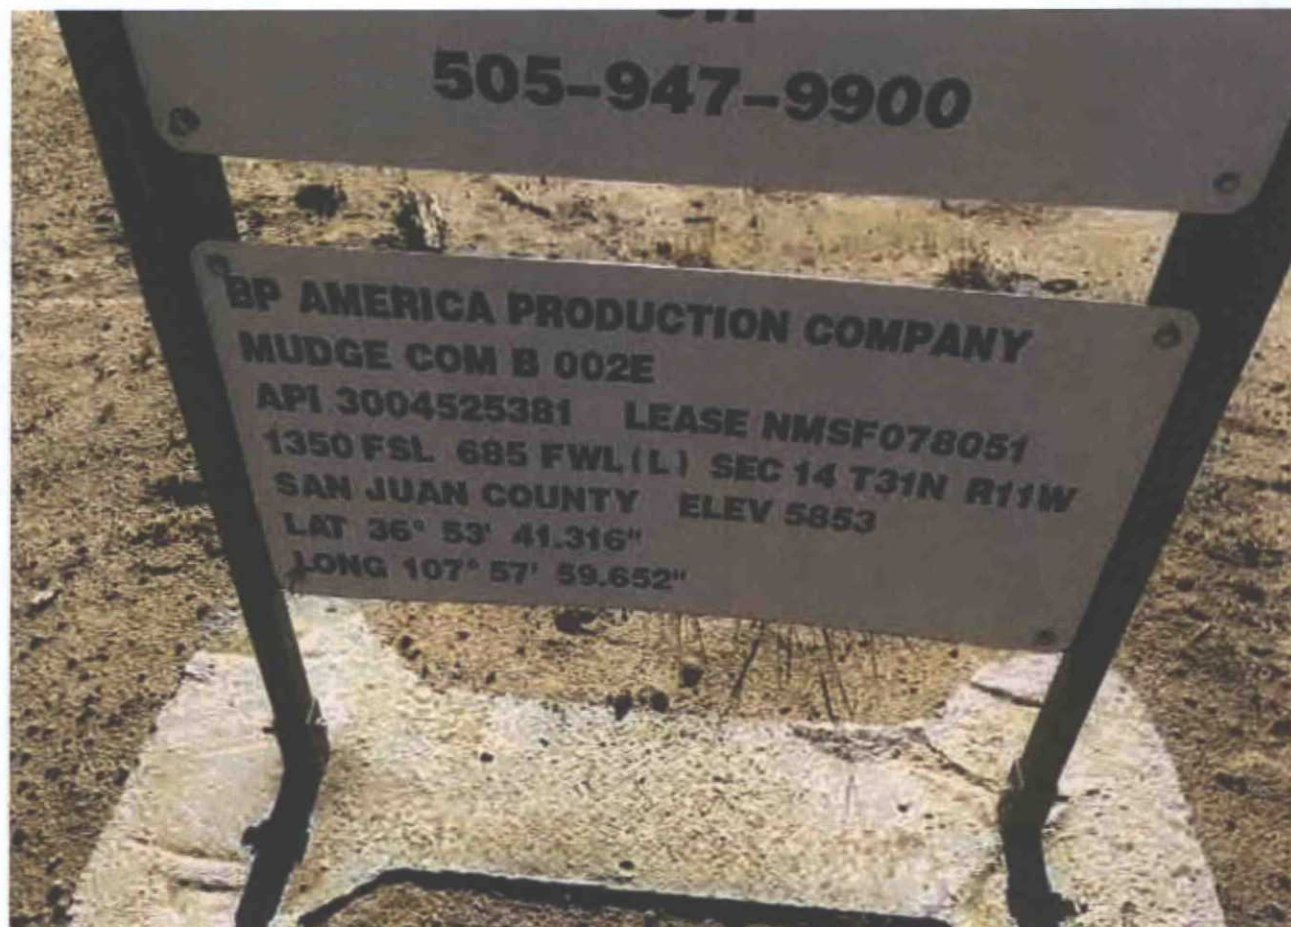
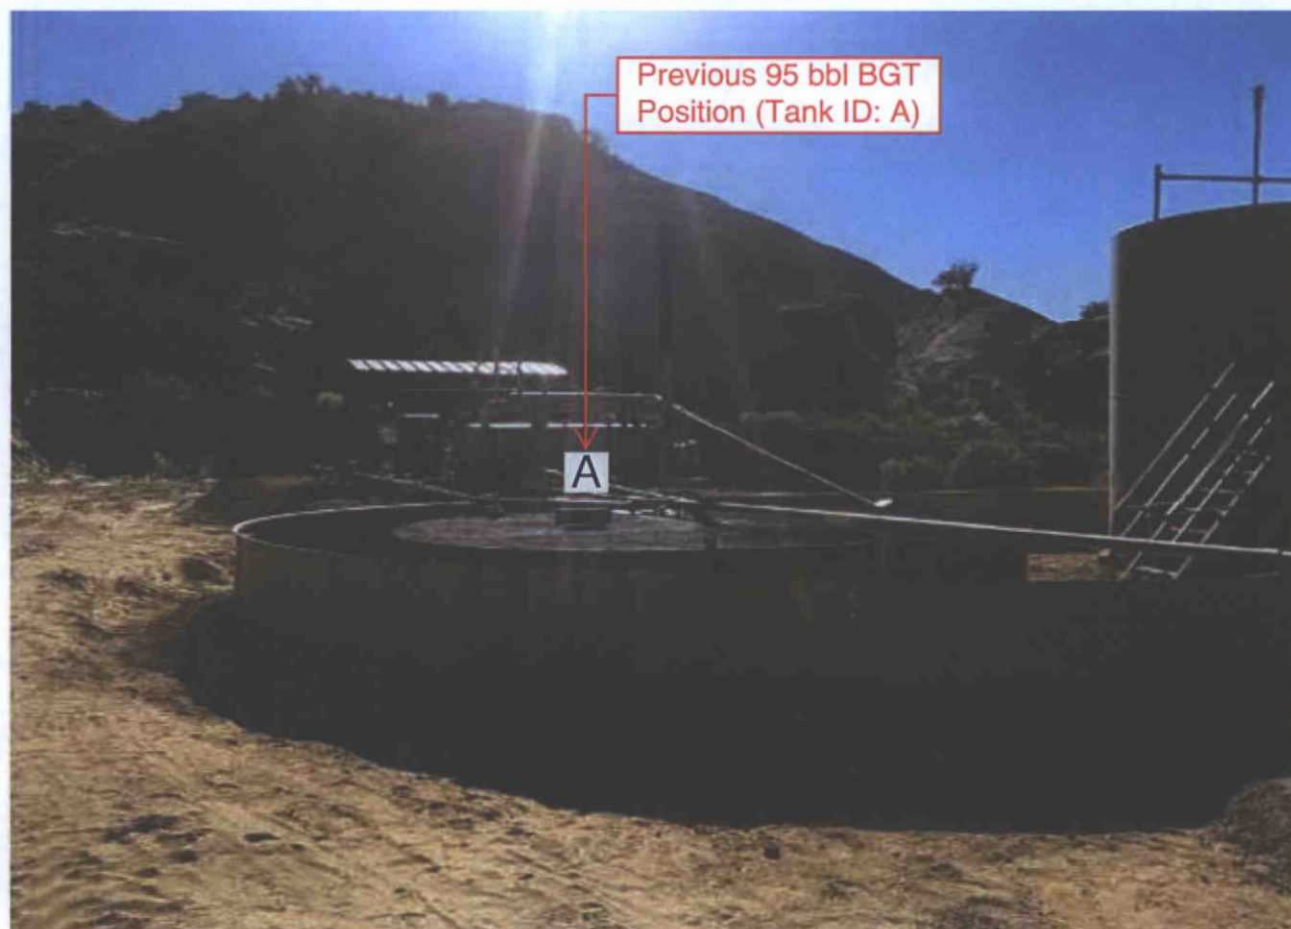
- e. site reclamation, photo documentation.**Closure report on C-144 form is included & contains a photo of the reclamation completion.**
16. BP shall certify that all information in the report and attachments is accurate, truthful, and compliant with all applicable closure requirements and conditions specified in the approved closure plan.
Certification section of C-144 has been completed.

10. BP shall reclaim the BGT location and all areas associated with the BGT including associated access roads to a safe and stable condition that blends with the surrounding undisturbed area. BP shall substantially restore the impacted surface area to the condition that existed prior to oil and gas operations by placement of the soil cover as provided in Subsection H of 19.15.17.13 NMAC, re-contour the location and associated areas to a contour that approximates the original contour and blends with the surrounding topography and re-vegetate according to Subsection I of 19.15.17.13 NMAC.
