Pit, Closed-Loop System, Below-Grade Tank, or
Proposed Alternative Method Permit or Closure Plan Application

BELOW-GRADE TANK CLOSURE PLAN

Hughes A # 4 – Tank ID: B

API #: 3004523517

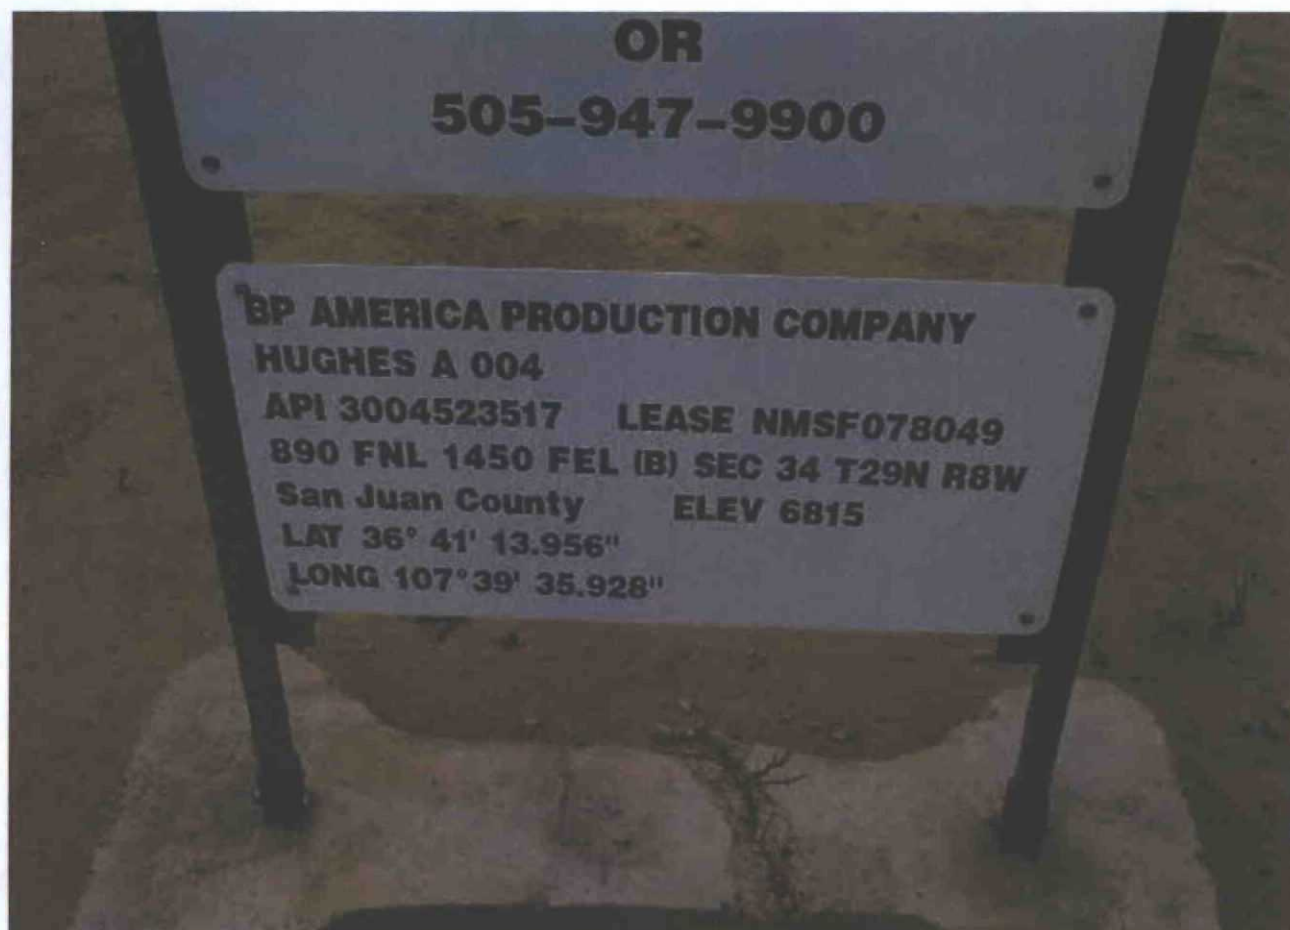
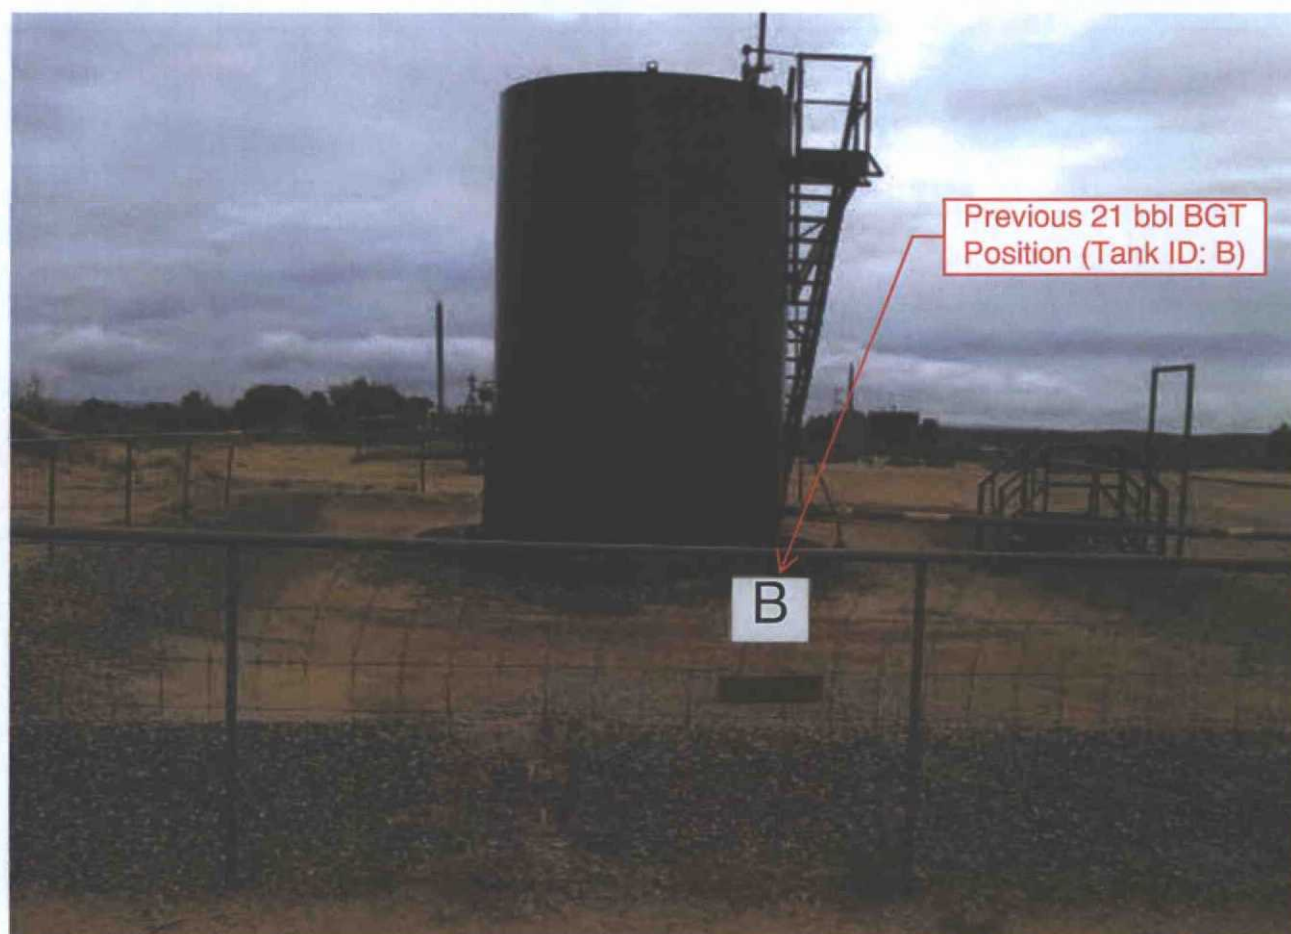
- e. site reclamation, photo documentation.**Closure report on C-144 form is included & contains a photo of the reclamation completion.**
16. BP shall certify that all information in the report and attachments is accurate, truthful, and compliant with all applicable closure requirements and conditions specified in the approved closure plan.
Certification section of C-144 has been completed.

10. BP shall reclaim the BGT location and all areas associated with the BGT including associated access roads to a safe and stable condition that blends with the surrounding undisturbed area. BP shall substantially restore the impacted surface area to the condition that existed prior to oil and gas operations by placement of the soil cover as provided in Subsection H of 19.15.17.13 NMAC, re-contour the location and associated areas to a contour that approximates the original contour and blends with the surrounding topography and re-vegetate according to Subsection I of 19.15.17.13 NMAC.
