Pit, Below-Grade Tank, or
Proposed Alternative Method Permit or Closure Plan Application

BP AMERICA PRODUCTION COMPANY
SAN JUAN BASIN, NORTHWEST NEW MEXICO

BELOW-GRADE TANK CLOSURE PLAN

Lawson 001A

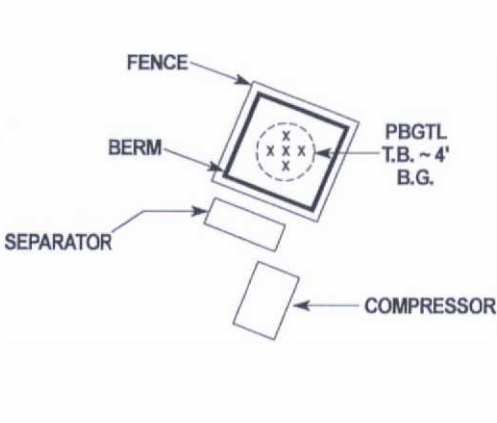
SITE OBSERVATIONS: LOST INTEGRITY OF EQUIPMENT: YES / <u>NO</u> EXPLANATION - _____ APPARENT EVIDENCE OF A RELEASE OBSERVED AND/OR OCCURRED: <u>YES</u> / NO EXPLANATION: DISCOLORATION & HC ODOR. APPEARS HISTORICAL. EQUIPMENT SET OVER RECLAIMED AREA: <u>YES</u> / NO EXPLANATION - 105 BBL SHALLOW LOW PROFILE ABOVE-GRADE TANK TO BE SET ATOP BGT POSITION. OTHER: SANDSTONE ENCOUNTERED APPROX. 4 FT. BELOW GRADE BENEATH BGT.		
SOIL IMPACT DIMENSION ESTIMATION: NA ft. X NA ft. X NA ft. EXCAVATION ESTIMATION (Cubic Yards): NA DEPTH TO GROUNDWATER: >100' NEAREST WATER SOURCE: >1,000' NEAREST SURFACE WATER: >1,000' NMOC DTPH CLOSURE STD: 5,000 ppm		
SITE SKETCH: BGT Located: off / <u>on</u> site PLOT PLAN circle: <u>attached</u>

NOTES: BGT = BELOW-GRADE TANK; E.D. = EXCAVATION DEPRESSION; B.G. = BELOW GRADE; B = BELOW; T.H. = TEST HOLE; ~ = APPROX.; W.H. = WELL HEAD; T.B. = TANK BOTTOM; PBGTL = PREVIOUS BELOW-GRADE TANK LOCATION; SPD = SAMPLE POINT DESIGNATION; R.W. = RETAINING WALL; NA - NOT APPLICABLE OR NOT AVAILABLE; SW - SINGLE WALL; DW - DOUBLE WALL; SB - SINGLE BOTTOM; DB - DOUBLE BOTTOM.		MISCELL. NOTES WO: _____ REF #: P - 656 VID: VHIXONEVB2 PJ #: _____ Permit date(s): 06/14/10 OCD Appr. date(s): 02/17/16 Tank ID: A OVM = Organic Vapor Meter ppm = parts per million BGT Sidewalls Visible: <u>Y</u> / N BGT Sidewalls Visible: Y / N BGT Sidewalls Visible: Y / N Magnetic declination: 10° E

NOTES: GOOGLE EARTH IMAGERY DATE: 3/16/2016.		ONSITE: 07/22/16
