Pit, Below-Grade Tank, or  
Proposed Alternative Method Permit or Closure Plan Application

1. **OIL CONS. DIV DIST. 3**  
Operator: BP America Production Company OGRID #: 778  
Address: 200 Energy Court, Farmington, NM 87401 **SEP 30 2016**  
Facility or well name: GALLEGOS CANYON UNIT 040  
API Number: 3004507182 OCD Permit Number: \_\_\_\_\_  
U/L or Qtr/Qtr H Section 29 Township 28N Range 12W County: San Juan  
Center of Proposed Design: Latitude 36.63568 Longitude -108.12794 NAD: ☐ 1927 ☒ 1983  
Surface Owner: ☒ Federal ☐ State ☐ Private ☐ Tribal Trust or Indian Allotment

3. ☒ **Below-grade tank:** Subsection I of 19.15.17.11 NMAC **TANK A**  
Volume: 95 bbl Type of fluid: Produced water  
Tank Construction material: Steel  
☐ Secondary containment with leak detection ☐ Visible sidewalls, liner, 6-inch lift and automatic overflow shut-off  
☐ Visible sidewalls and liner ☐ Visible sidewalls only ☐ Other Double wall/ Double bottom; no visible sidewalls  
Liner type: Thickness \_\_\_\_\_ mil ☐ HDPE ☐ PVC ☐ Other \_\_\_\_\_

BELOW-GRADE TANK CLOSURE PLAN

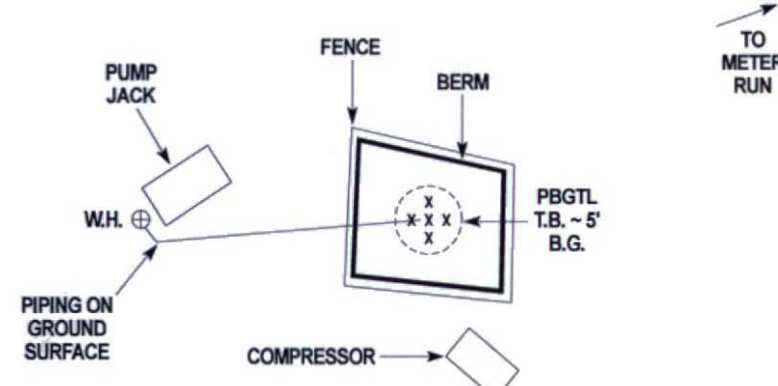
<b>SITE OBSERVATIONS:</b> LOST INTEGRITY OF EQUIPMENT: YES <u>NO</u> EXPLANATION - _____ APPARENT EVIDENCE OF A RELEASE OBSERVED AND/OR OCCURRED: YES <u>NO</u> EXPLANATION: _____ EQUIPMENT SET OVER RECLAIMED AREA: <u>YES</u> <u>NO</u> EXPLANATION - <b>105 BBL SHALLOW LOW PROFILE ABOVE-GRADE TANK TO BE SET ATOP BGT LOCATION.</b> OTHER: _____		
SOIL IMPACT DIMENSION ESTIMATION: <u>NA</u> ft. X <u>NA</u> ft. X <u>NA</u> ft. EXCAVATION ESTIMATION (Cubic Yards): <u>NA</u> DEPTH TO GROUNDWATER: <u>&lt;50'</u> NEAREST WATER SOURCE: <u>&gt;1,000'</u> NEAREST SURFACE WATER: <u>&lt;1,000'</u> NMOCD TPH CLOSURE STD: <b>100</b> ppm		
<b>SITE SKETCH</b> BGT Located: off <u>on</u> site PLOT PLAN circle: <u>attached</u>

NOTES: BGT = BELOW-GRADE TANK; E.D. = EXCAVATION DEPRESSION; B.G. = BELOW GRADE; B = BELOW; T.H. = TEST HOLE; ~ = APPROX.; W.H. = WELL HEAD; T.B. = TANK BOTTOM; PBGT L. = PREVIOUS BELOW-GRADE TANK LOCATION; SPD = SAMPLE POINT DESIGNATION; R.W. = RETAINING WALL; NA - NOT APPLICABLE OR NOT AVAILABLE; SW - SINGLE WALL; DW - DOUBLE WALL; SB - SINGLE BOTTOM; DB - DOUBLE BOTTOM. NOTES: <b>GOOGLE EARTH IMAGERY DATE: 3/15/2015.</b> ONSITE: <b>08/10/16</b>		<b>MISCELL. NOTES</b> WO: _____ REF #: <b>P - 484</b> VID: <b>VHIXONEVB2</b> PJ #: _____ Permit date(s): <b>06/14/10</b> OCD Appr. date(s): <b>08/14/16</b> Tank ID: <b>A</b> OVM = Organic Vapor Meter ppm = parts per million BGT Sidewalls Visible: Y / <u>(N)</u> BGT Sidewalls Visible: Y / N BGT Sidewalls Visible: Y / N Magnetic declination: <b>10° E</b>
