Pit, Below-Grade Tank, or
Proposed Alternative Method Permit or Closure Plan Application

BELOW-GRADE TANK CLOSURE PLAN

Northeast Blanco Unit 304

API No. 3003924163

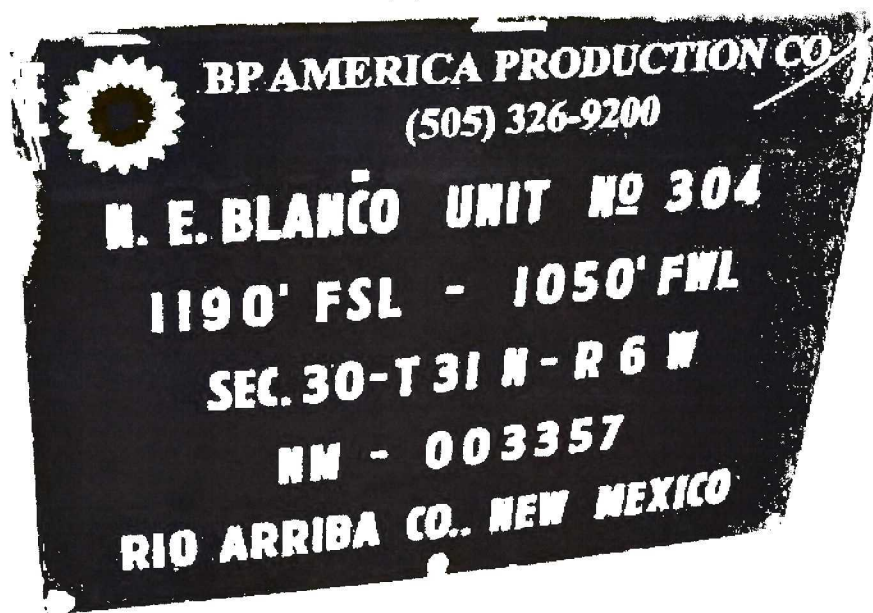
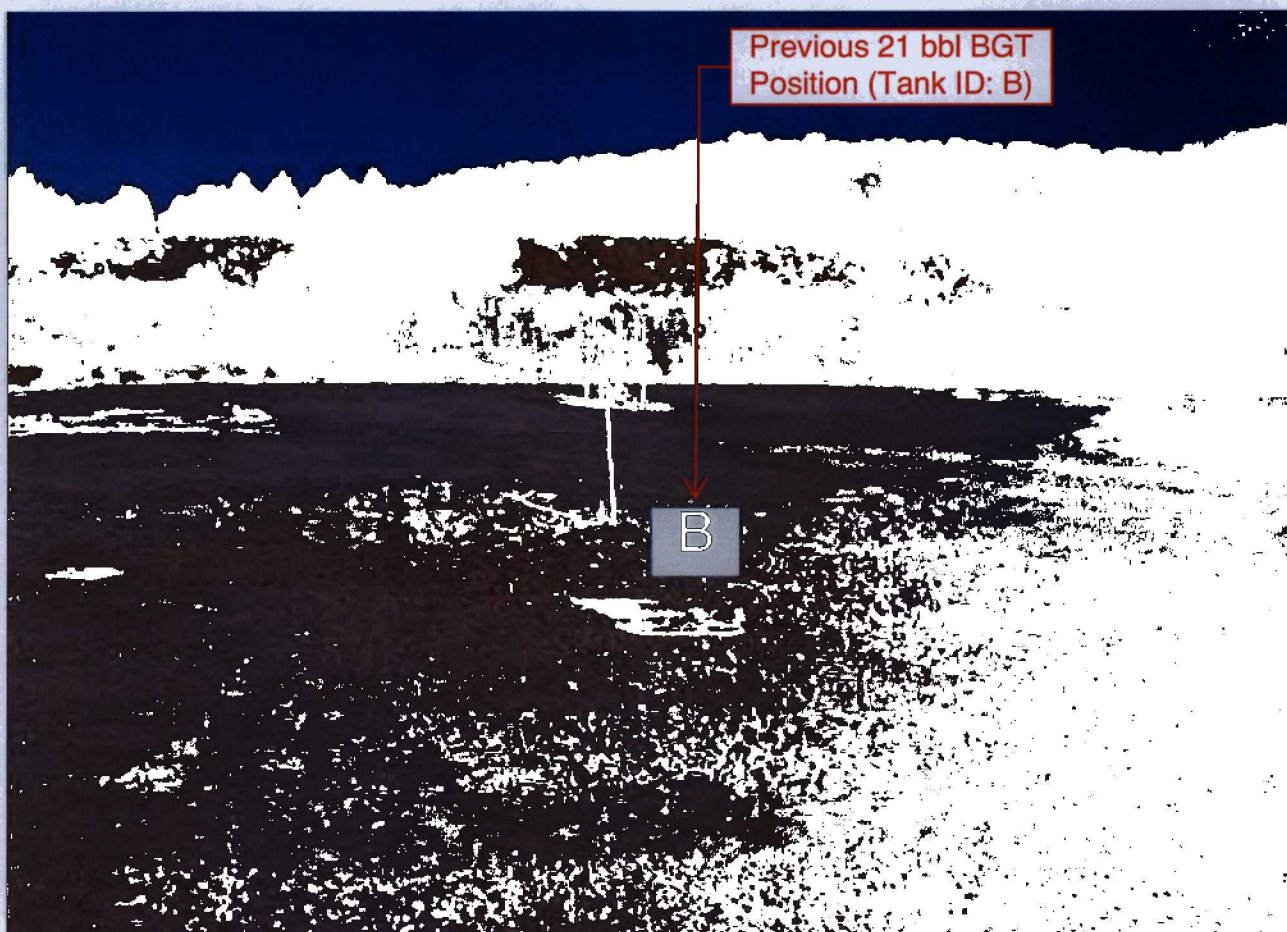
Closure report on C-144 form is included including photos of reclamation completion.
