Pit, Below-Grade Tank, or
Proposed Alternative Method Permit or Closure Plan Application

BP AMERICA PRODUCTION COMPANY
SAN JUAN BASIN, NORTHWEST NEW MEXICO

BELOW-GRADE TANK CLOSURE PLAN

Florance L 019A
API No. 3004521861
Unit Letter P, Section 03, T30N, R09W

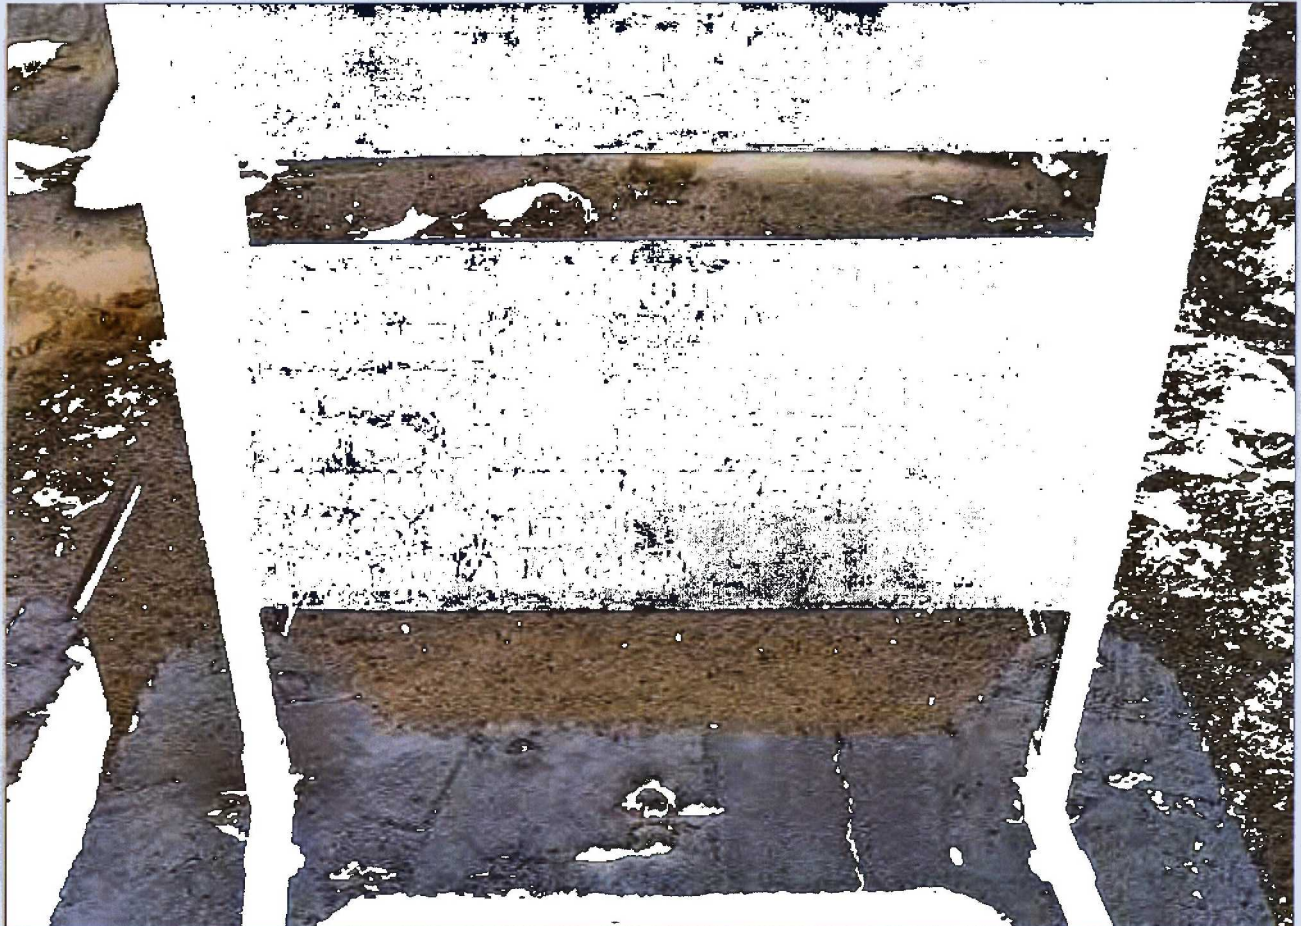
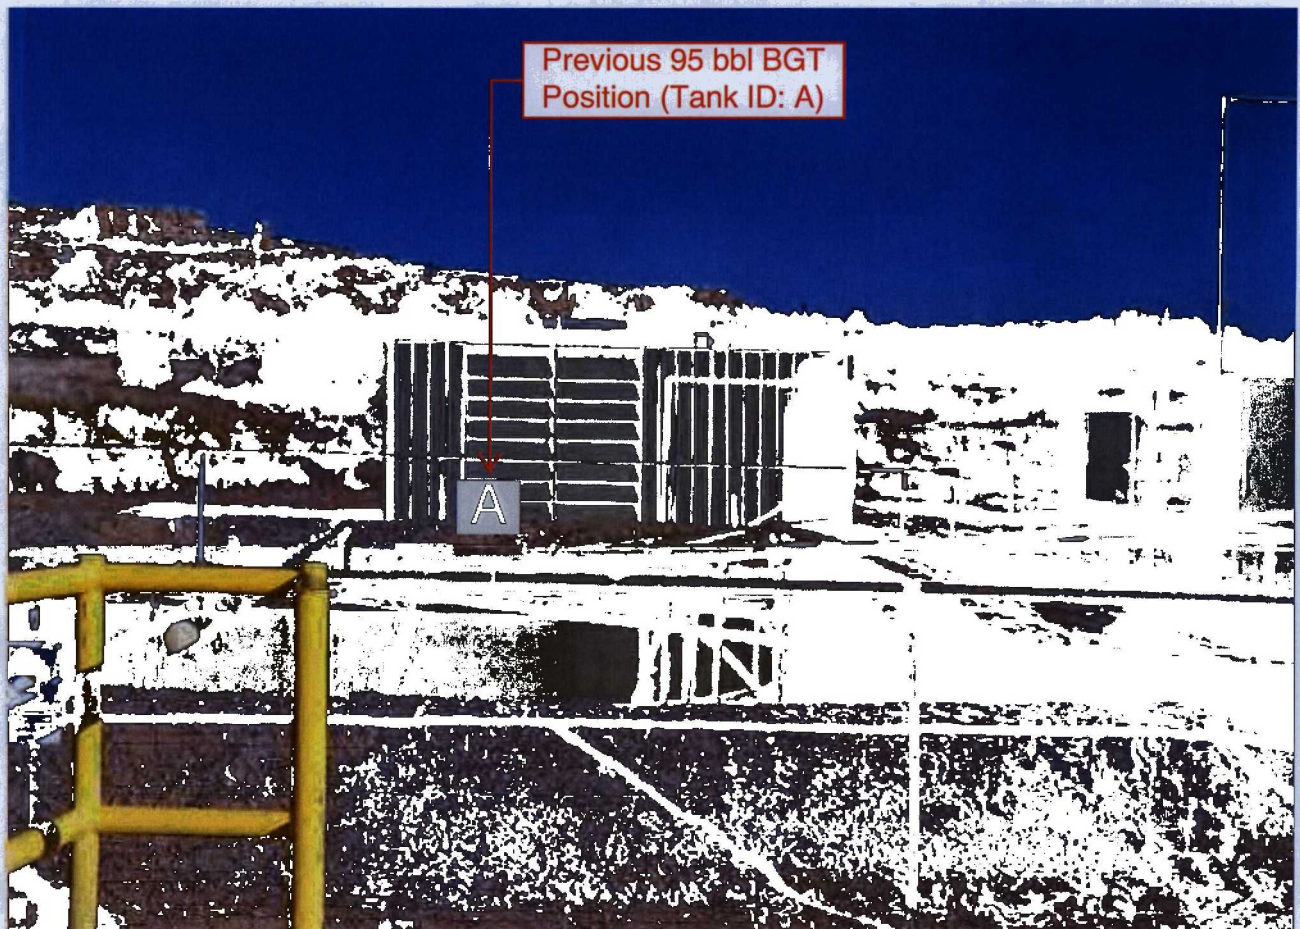
Closure report on C-144 form is included including photos of reclamation completion.

The area has been backfilled and will be reclaimed once the well has been plugged and abandoned.
