Pit, Below-Grade Tank, or  
Proposed Alternative Method Permit or Closure Plan Application

**ConocoPhillips Company  
San Juan Basin  
Below Grade Tank Closure Report**

**Lease Name: Holloway Federal 4  
API No.: 30-045-06704**

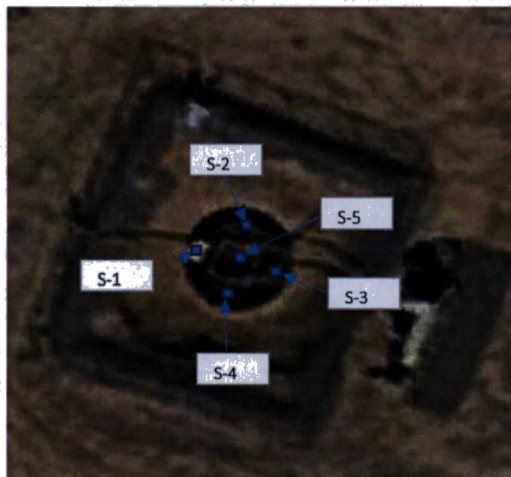
Observations: Possible staining and odor was observed below the tank.

SC-1 is a 5-point composite of S-1 through S-5, collected 0.5 ft below BGT.

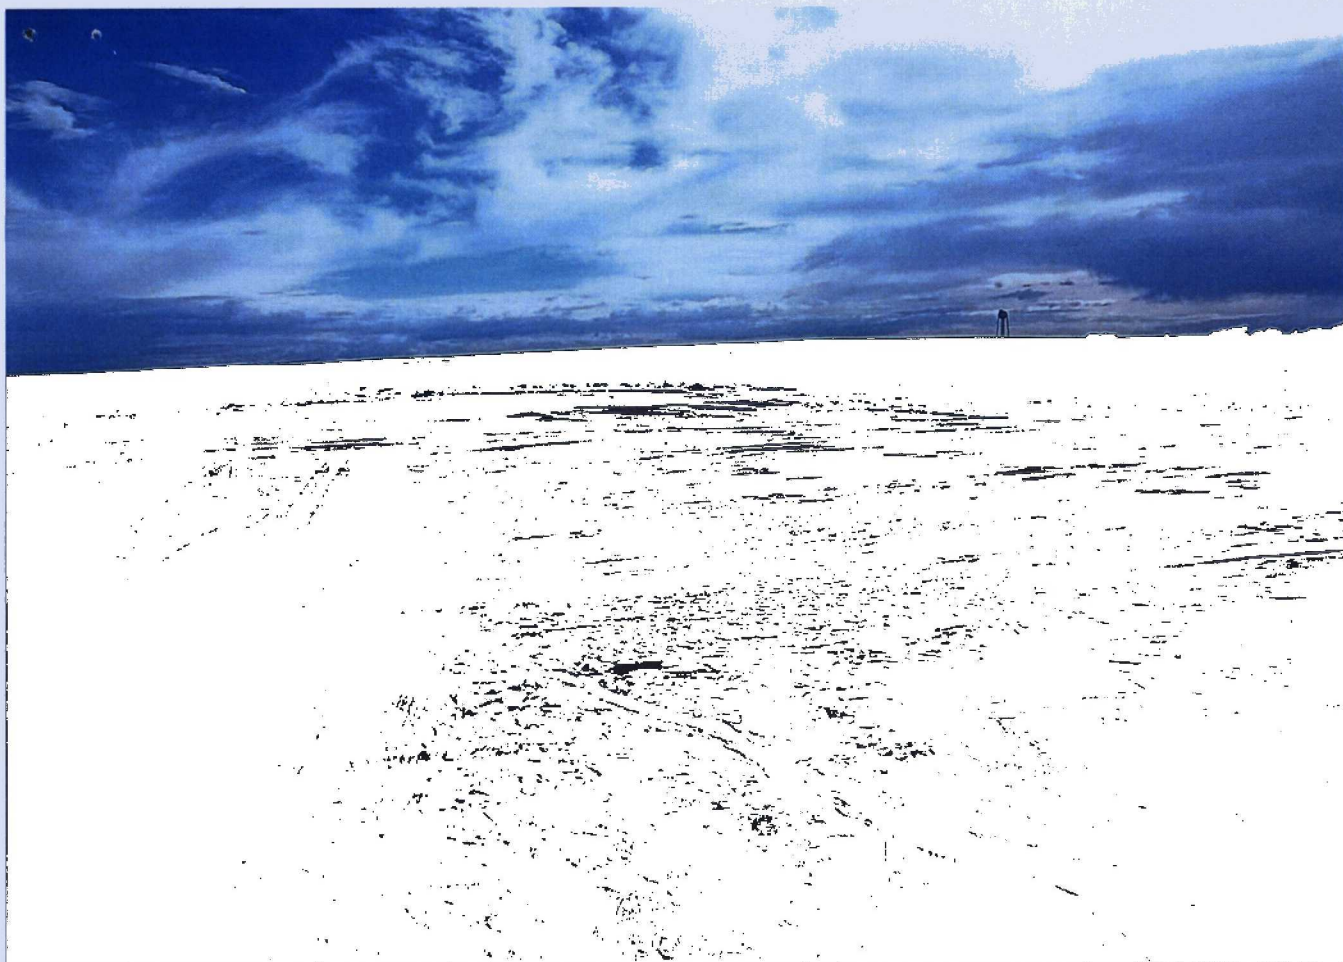
HOLLOWAY FEDERAL 4

On August 17, 2016, following removal of the BGT tank, Rule personnel conducted a visual inspection for surface/subsurface indications of a release. Possible staining and odor was observed below the tank. Rule personnel then collected five soil samples (S-1 through S-5) from 0.5 feet beneath the floor of the BGT excavation. Figure 2 provides the location of the soil samples collected from below the BGT. The field work summary sheet is attached.

Based on field screening and laboratory analytical results, no further work is recommended.
