Pit, Below-Grade Tank, or
Proposed Alternative Method Permit or Closure Plan Application OILCONS. DIV DIST. 3

BP AMERICA PRODUCTION COMPANY
SAN JUAN BASIN, NORTHWEST NEW MEXICO

BELOW-GRADE TANK CLOSURE PLAN

Gallegos Canyon Unit 262E
API No. 3004526159
Unit Letter P, Section 24, T29N, R13W

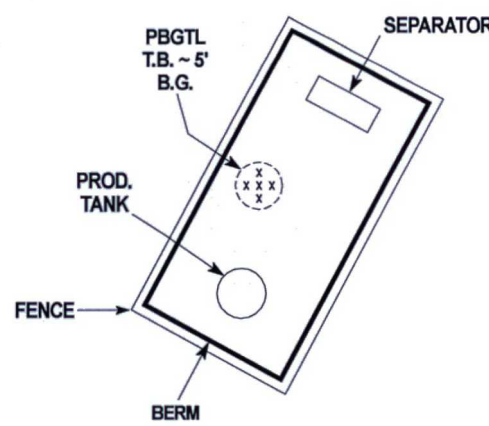
SITE OBSERVATIONS: LOST INTEGRITY OF EQUIPMENT: YES <u>NO</u> EXPLANATION - _____ APPARENT EVIDENCE OF A RELEASE OBSERVED AND/OR OCCURRED: YES <u>NO</u> EXPLANATION: _____ EQUIPMENT SET OVER RECLAIMED AREA: YES <u>NO</u> EXPLANATION - _____ OTHER: GAS WELL RECENTLY PLUGGED & ABANDONED (P&A). NMOCED REP. NOT PRESENT TO WITNESS CONFIRMATION SAMPLING.		
SOIL IMPACT DIMENSION ESTIMATION: <u>NA</u> ft. X <u>NA</u> ft. X <u>NA</u> ft. EXCAVATION ESTIMATION (Cubic Yards): <u>NA</u> DEPTH TO GROUNDWATER: <u><50'</u> NEAREST WATER SOURCE: <u>>1,000'</u> NEAREST SURFACE WATER: <u><200'</u> NMOCED TPH CLOSURE STD: 100 ppm		
SITE SKETCH BGT Located: off <u>on</u> site PLOT PLAN circle: <u>attached</u>

NOTES: BGT = BELOW-GRADE TANK; E.D. = EXCAVATION DEPRESSION; B.G. = BELOW GRADE; B = BELOW; T.H. = TEST HOLE; ~ = APPROX.; W.H. = WELL HEAD; T.B. = TANK BOTTOM; PBGTL = PREVIOUS BELOW-GRADE TANK LOCATION; SPD = SAMPLE POINT DESIGNATION; R.W. = RETAINING WALL; NA = NOT APPLICABLE OR NOT AVAILABLE; SW - SINGLE WALL; DW - DOUBLE WALL; SB - SINGLE BOTTOM; DB - DOUBLE BOTTOM.		MISCELL. NOTES WO: _____ AFE #: X7-006NK-E:REST VID: VBEEBS0PLG PJ #: _____ Permit date(s): 06/14/10 OCD Appr. date(s): 05/02/16 Tank ID: A OVM = Organic Vapor Meter ppm = parts per million BGT Sidewalls Visible: Y / <u>(N)</u> BGT Sidewalls Visible: Y / N BGT Sidewalls Visible: Y / N Magnetic declination: 10° E

NOTES: GOOGLE EARTH IMAGERY DATE: 3/16/2016. ONSITE: 10/21/16

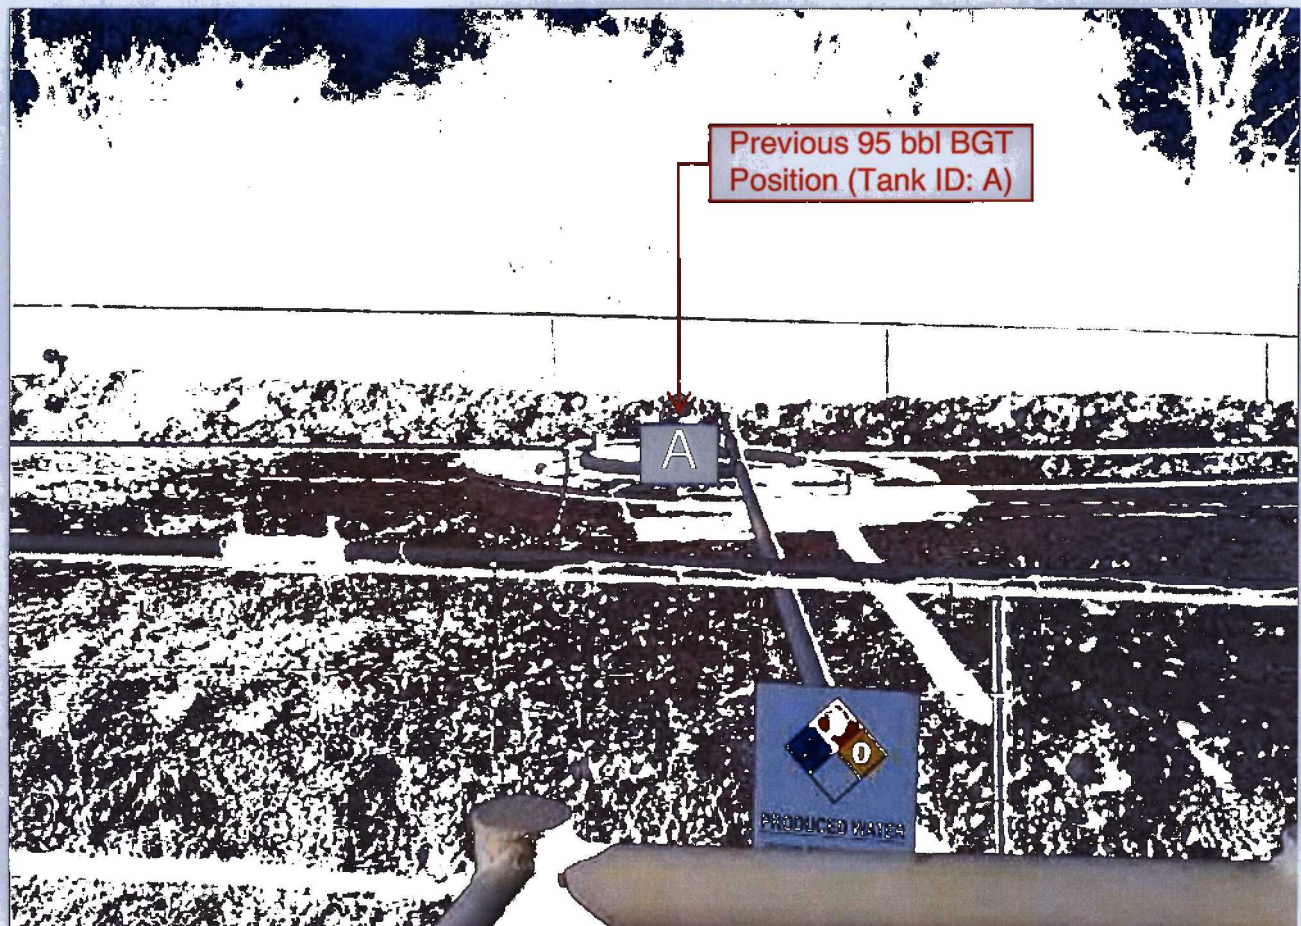
BP AMERICA PRODUCTION COMPANY
GALLEGOS CANYON UNIT 262E
API 3004526159 LEASE NMNM78391C
1040 FSL 1020 FEL (P) SEC 24 T29N R13W
San Juan County ELEV 5296
LAT 36° 42' 28.188"
LONG 108° 9' 7.056"

Closure report on C-144 form is included including photos of reclamation completion.

10. BP shall reclaim the BGT location and all areas associated with the BGT including associated access roads to a safe and stable condition that blends with the surrounding undisturbed area. BP shall substantially restore the impacted surface area to the condition that existed prior to oil and gas operations by placement of the soil cover as provided in Subsection H of 19.15.17.13 NMAC, re-contour the location and associated areas to a contour that approximates the original contour and blends with the surrounding topography and re-vegetate according to Subsection I of 19.15.17.13 NMAC.
