BP AMERICA PRODUCTION COMPANY

SAN JUAN BASIN, NORTHWEST NEW MEXICO

BELOW-GRADE TANK CLOSURE PLAN

<u>Caneple Gas Com # 1A – Tank ID: A</u>
<u>API #: 3004521883</u>
Unit Letter I, Section 18, T31N, R10W

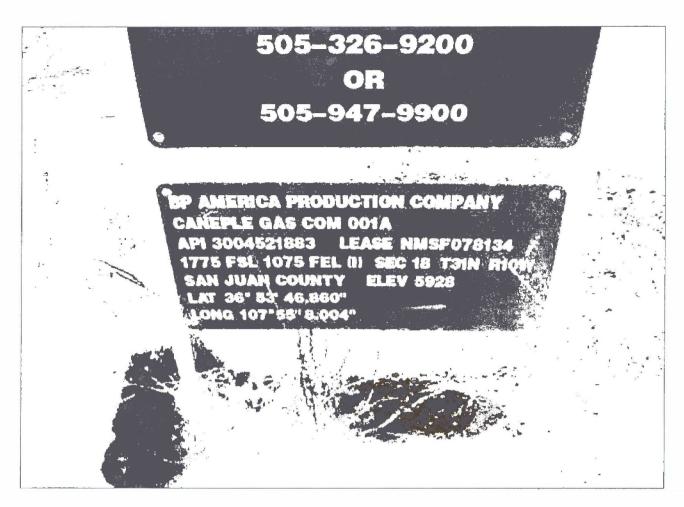
<u>Closure report on C-144 form is included & contains a photo of the reclamation completion.</u>

The BGT area has been backfilled and will be reclaimed once the well has been plugged & abandoned.
