Pit, Closed-Loop System, Below-Grade Tank, or Proposed Alternative Method Permit or Closure Plan Application

SITING AND HYDRO-GEOLOGICAL REPORT FOR RIDDLE 002A

San Juan Basin in Northwest New Mexico Below-Grade Tank Design and Construction Plan

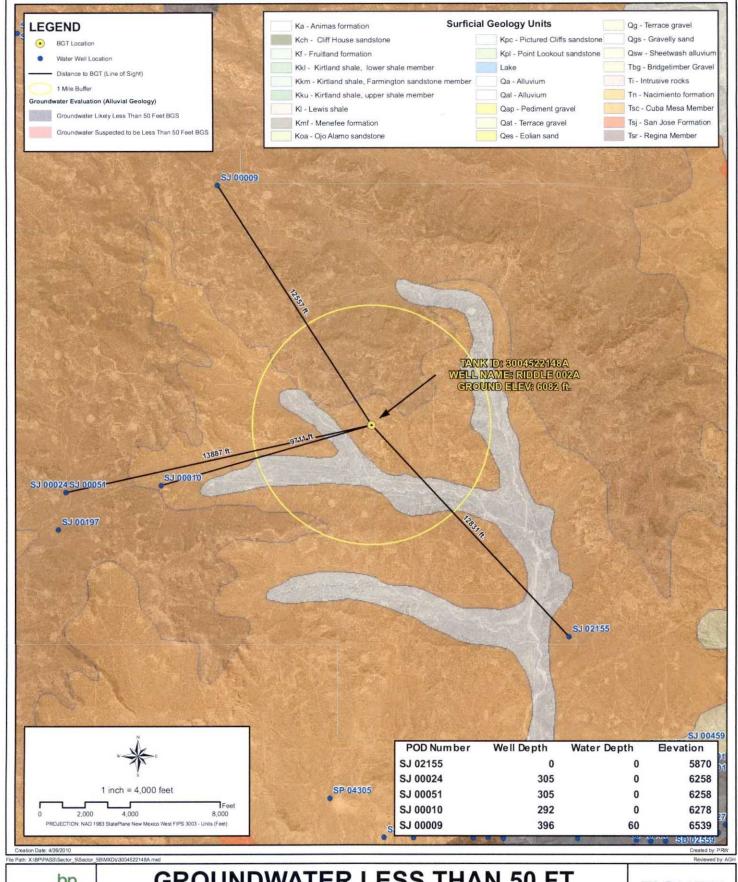
GROUNDWATER LESS THAN 50 FT.

Figure 1: Groundwater Less Than 50 ft.

Results: Spatial Polygons representing "Groundwater likely to be less than 50 ft." and "Groundwater suspected to be less than 50 ft.".

Depth to groundwater at the site is estimated to be greater than 100 feet. This estimation is based on data from Stone and others (1983), and depth to groundwater data obtained from water wells permitted by the New Mexico State Engineer's Office (OSE, Figure 1). Local topography and proximity to adjacent water features is also considered. A topographic map of the site is provided as Figure 2 and demonstrates that the below grade tank (BGT) is not within 300 feet of any continuously flowing watercourse or within 200 feet of any other significant watercourse, lakebed, sinkhole or playa lake as measured from the ordinary high water mark. Figure 3 demonstrates that the BGT is not within 300 feet of a permanent residence, school, hospital, institution or church. Figure 4 demonstrates, based on a search of the OSE database and USGS topographic maps, that there are no freshwater wells or springs within 1000 feet of the BGT. Figure 5 demonstrates that the BGT is not within a municipal boundary or a defined municipal freshwater well field. Figure 6 demonstrates that the BGT is not within 500 feet of a wetland. Figure 7 demonstrates that the BGT is not in an area overlying a subsurface mine. The BGT is not located in an unstable area. Figure 8 demonstrates that the BGT is not within the mapped FEMA 100-year floodplain.

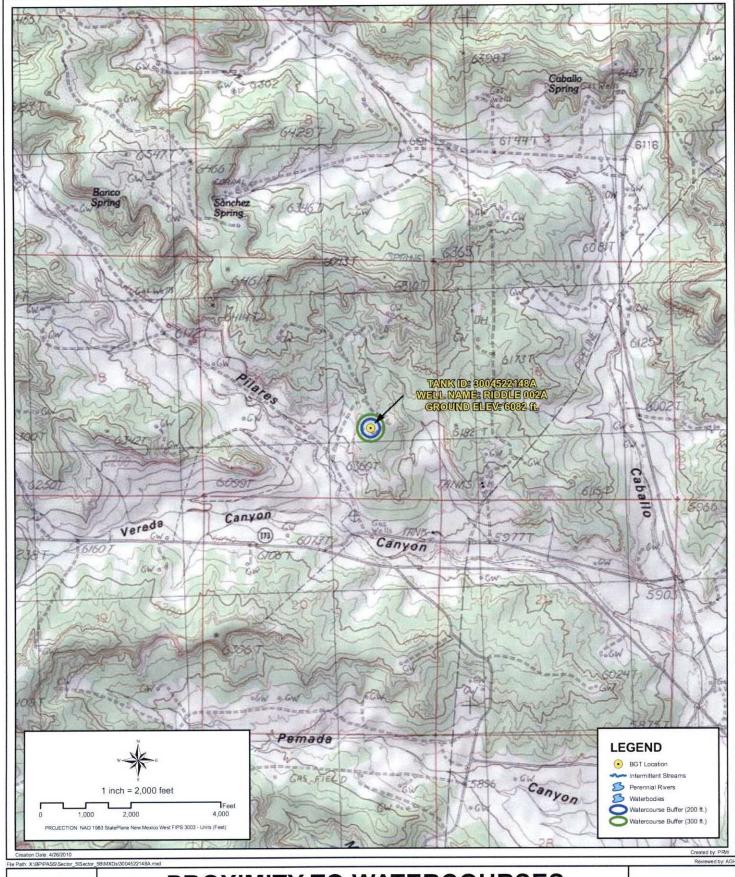
PROXIMITY TO WATERCOURSES

Figure 2: Proximity to Watercourses

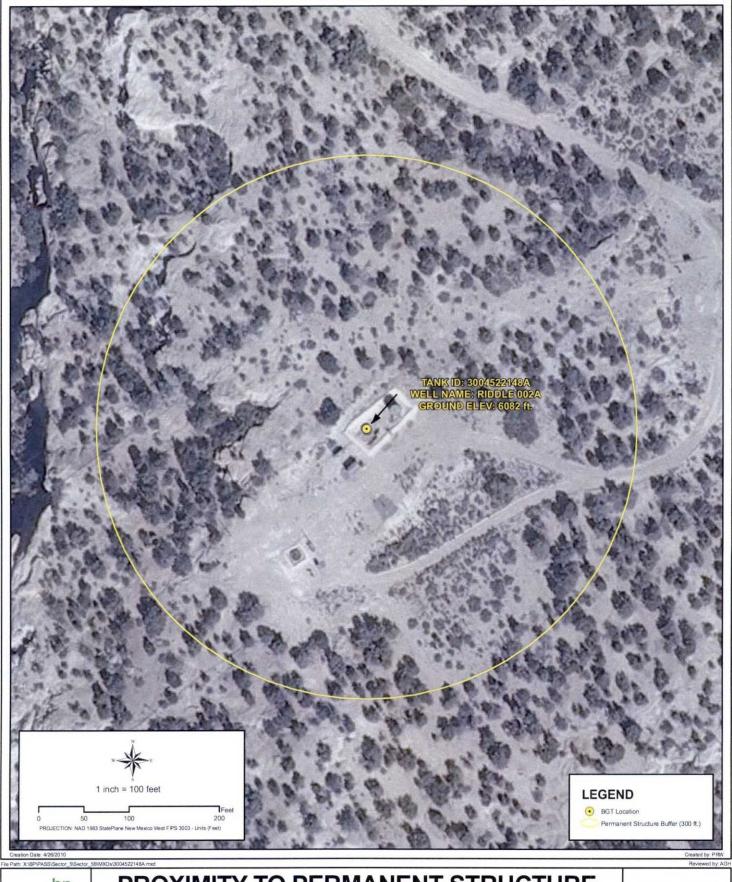
PROXIMITY TO PERMANENT STRUCTURE

Figure 3: Proximity to Permanent Structure

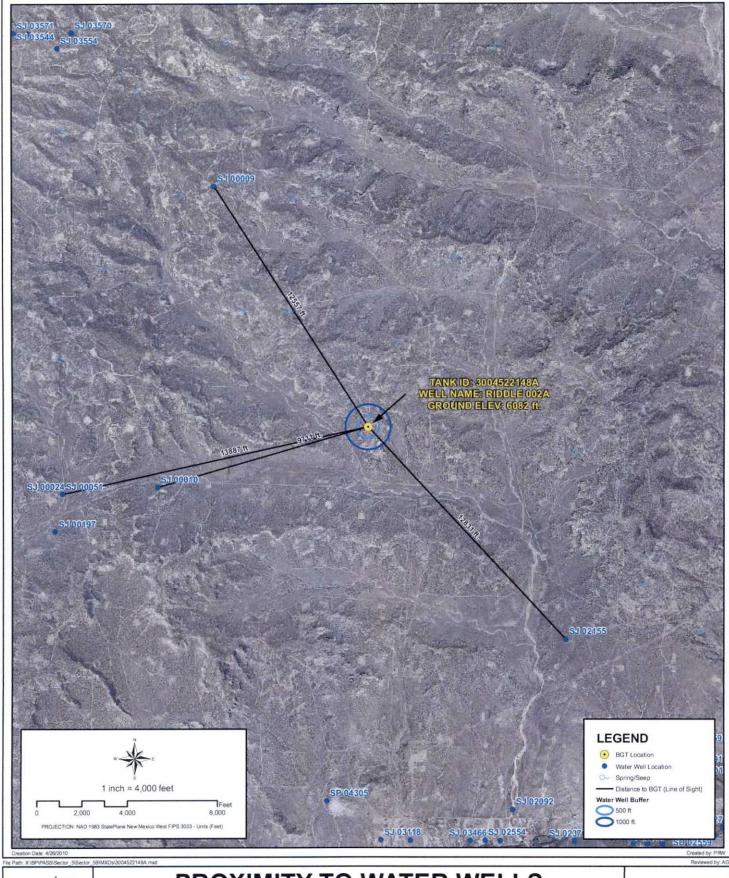
PROXIMITY TO WATER WELLS

Figure 4: Proximity to Water Wells

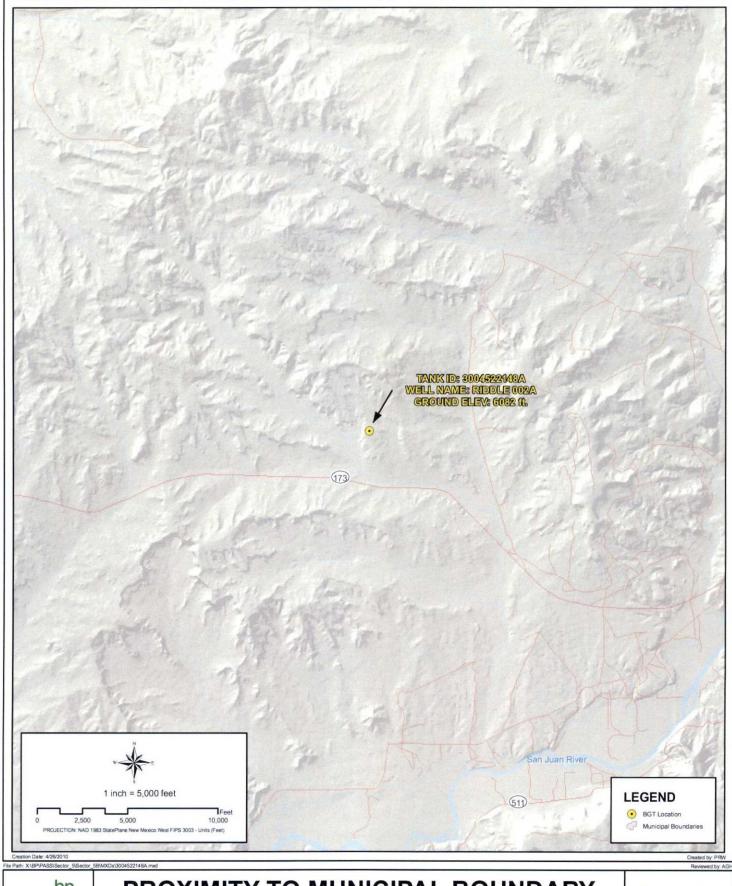
PROXIMITY TO MUNICIPAL BOUNDARY

Figure 5: Proximity to Municipal Boundary

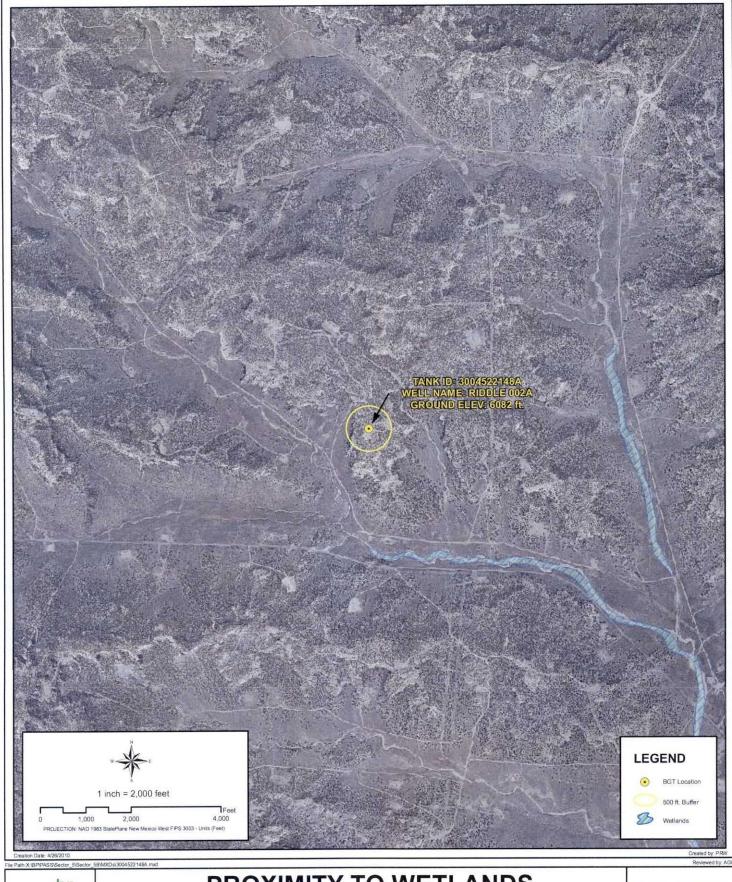
PROXIMITY TO WETLANDS

Figure 6: Proximity to Wetlands

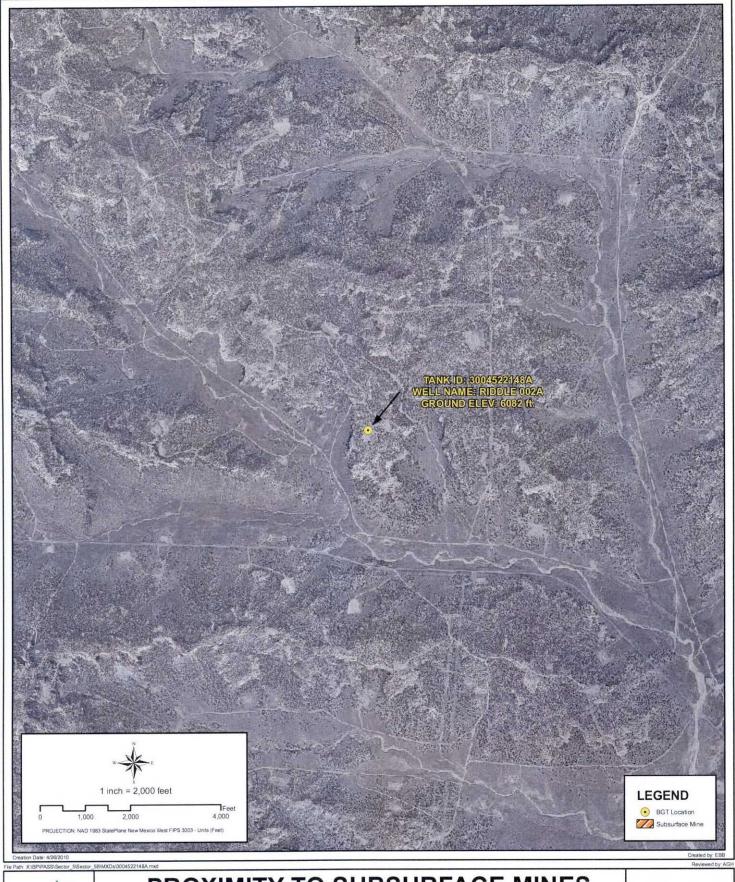
PROXIMITY TO SUBSURFACE MINES

Figure 7: Proximity to Subsurface Mine

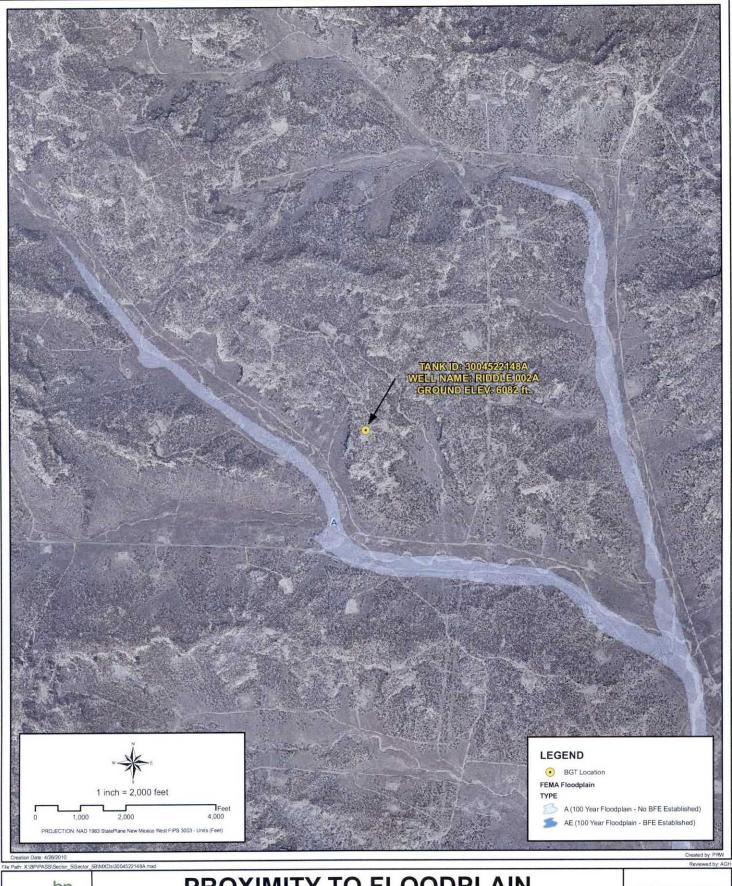
PROXIMITY TO FLOODPLAIN

Figure 8: Proximity to FEMA Floodplain

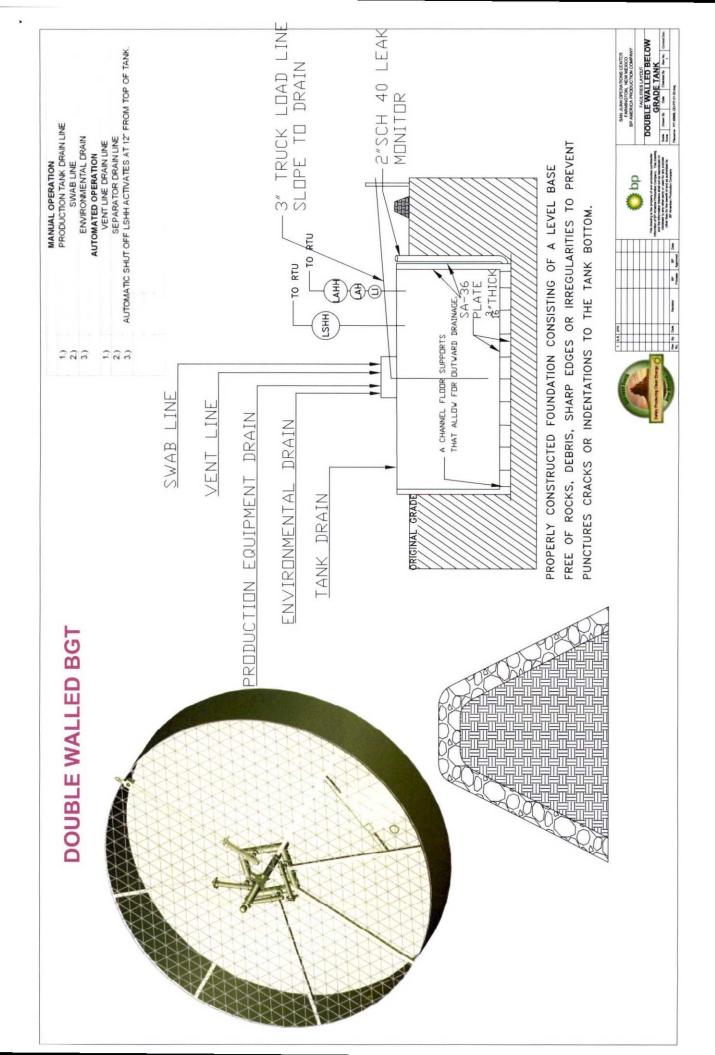
- 14. The general specifications for the design and construction of the BGT have been provided in the attached BP design and construction schematic.

- 8. BP's BGTs shall have a properly constructed earthen foundation consisting of a level base free of rocks, debris, sharp edges, or irregularities as to prevent punctures, cracks or indentations to the tank bottom as demonstrated on the design drawing.

- berms and leaving a portion of the BGT above the original grade as demonstrated on the design drawing.
- 10. BP will construct and operate the BGT to prevent overflow and overfilling of the BGT. Overflow will be prevented by use of an electronic high fluid level detector that will automatically engage an electronic shut-off valve when a 1 foot freeboard is reached. The Hi-level automatic alarm notifies well optimizers when liquid level has reached within a preset distance to the top of the BGT. The Hi Hi alarm will trigger the Hi-level automatic shutdown valve which will close in the well until the liquid level can be lowered.

- 11. BP will construct and install a double-walled tank design per Subparagraph (b) of Paragraph (4) of Subsection I of 19.15.17.11 NMAC with a two (2) inch diameter leak detection port. The floor supports located in the annular space of the tank bottom will be channeled to allow outward movement of liquid between the walls. Leak detection will be monitored per BP's Operating and Maintenance Plan. The walls of the BGT will be constructed of carbon steel that meets the ASTM A36 standard. BP's BGT design will insure containment of tank contents and protect underlying groundwater. The production equipment line drain is an automated drain that allows water level in production equipment (generally the separator) to be maintained within the equipment's operating parameters. The environmental drain is a manually operated drain that is used to drain liquids off of equipment. The tank drain is a manually operated drain, typically in the closed position that is used to rid the condensate tank of any water accumulation. The vent drain is a manually operated drain off the discharge of production equipment (usually the separator) and is used to blowdown the wellsite. The swab drain line is a manually operated drain originating between the wellhead and separator and is used during well workovers when large amounts of liquid are removed from the well and sent straight to the BGT.
