Pit, Closed-Loop System, Below-Grade Tank, or  
Proposed Alternative Method Permit or Closure Plan Application

BP AMERICA PRODUCTION COMPANY  
SAN JUAN BASIN, NORTHWEST NEW MEXICO

BELOW-GRADE TANK CLOSURE PLAN

**Florance # 26 – Tank ID: A**

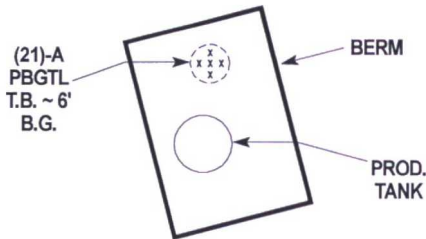
**SITE SKETCH** BGT Located: off /  on site PLOT PLAN circle: **attached**

W.H.  
⊕

**X - S.P.D.**
