Pit, Closed-Loop System, Below-Grade Tank, or Proposed Alternative Method Permit or Closure Plan Application

BP AMERICA PRODUCTION COMPANY

BELOW-GRADE TANK CLOSURE PLAN

Gallegos Canyon Unit # 135 - Tank ID: B
API #: 3004507885
Unit Letter F, Section 26, T29N, R13W

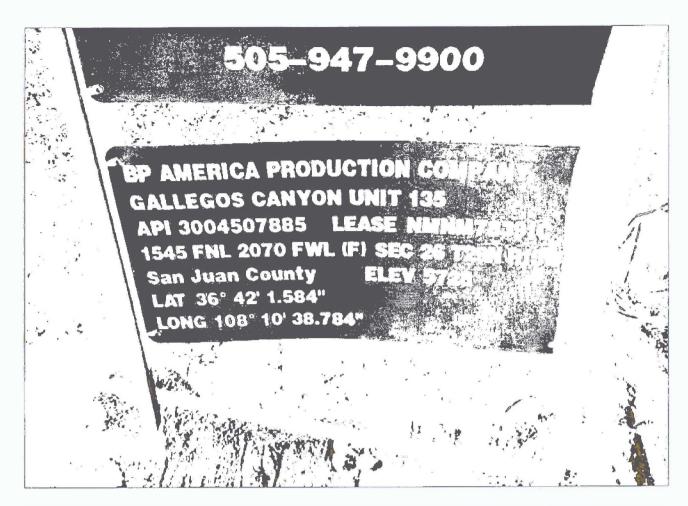
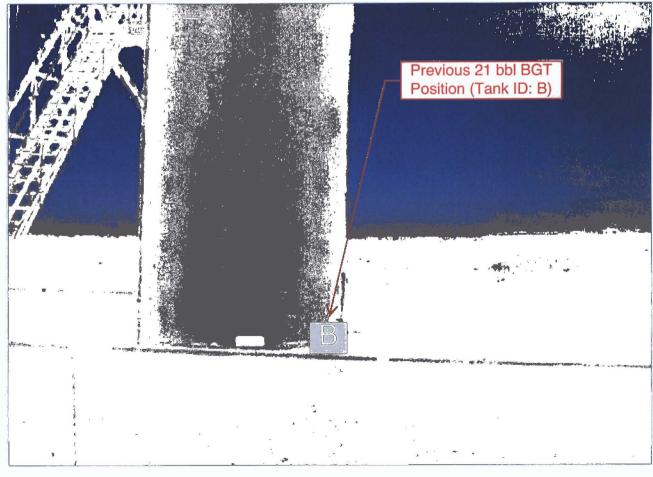
Closure report on C-144 form is included & contains a photo of the reclamation completion.
