Pit, Below-Grade Tank, or
Proposed Alternative Method Permit or Closure Plan Application

1.
Operator: BP America Production Company OGRID #: 778
Address: 200 Energy Court, Farmington, NM 87401
Facility or well name: GALLEGOS CANYON UNIT 109E
API Number: 3004526181 OCD Permit Number: _____
U/L or Qtr/Qtr E Section 18 Township 29N Range 12W County: San Juan
Center of Proposed Design: Latitude 36.72880 Longitude -108.14584 NAD: ☐ 1927 ☒ 1983
Surface Owner: ☐ Federal ☐ State ☒ Private ☐ Tribal Trust or Indian Allotment

BELOW-GRADE TANK CLOSURE PLAN

Gallegos Canyon Unit 109E
API No. 3004526181
Unit Letter E, Section 18, T29N, R12W

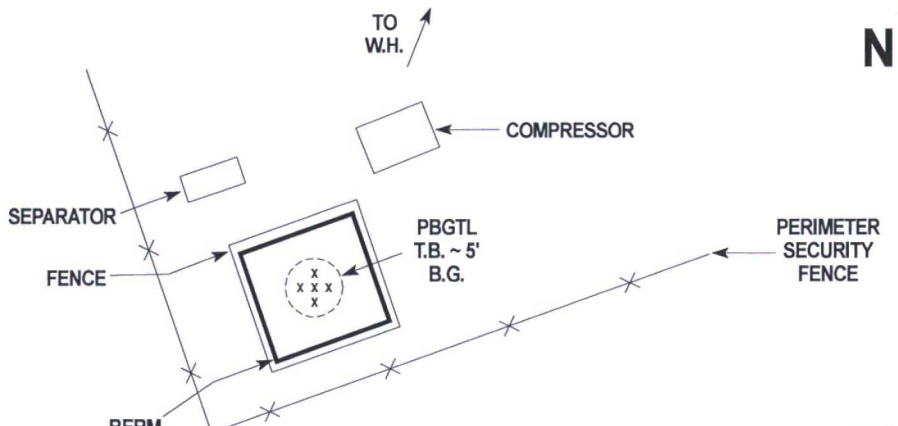
SOIL DESCRIPTION: SOIL TYPE: [SAND] [SILTY SAND] SILT / SILTY CLAY / CLAY / GRAVEL [OTHER] IMPORTED ROAD BASE BENEATH BGT. SOIL COLOR: DARK YELLOWISH ORANGE COHESION (ALL OTHERS): [NON COHESIVE] SLIGHTLY COHESIVE / COHESIVE / HIGHLY COHESIVE CONSISTENCY (NON COHESIVE SOILS): LOOSE [FIRM] DENSE / VERY DENSE MOISTURE: DRY [SLIGHTLY MOIST] MOIST / WET / SATURATED / SUPER SATURATED SAMPLE TYPE: GRAB [COMPOSITE] # OF PTS. 5 DISCOLORATION/STAINING OBSERVED: YES [NO] EXPLANATION - PLASTICITY (CLAYS): NON PLASTIC / SLIGHTLY PLASTIC / COHESIVE / MEDIUM PLASTIC / HIGHLY PLASTIC DENSITY (COHESIVE CLAYS & SILTS): SOFT / FIRM / STIFF / VERY STIFF / HARD HC ODOR DETECTED: YES [NO] EXPLANATION - ANY AREAS DISPLAYING WETNESS: YES [NO] EXPLANATION -		
SITE OBSERVATIONS: LOST INTEGRITY OF EQUIPMENT: YES [NO] EXPLANATION - APPARENT EVIDENCE OF A RELEASE OBSERVED AND/OR OCCURRED: YES [NO] EXPLANATION - EQUIPMENT SET OVER RECLAIMED AREA: YES [NO] EXPLANATION - OTHER: NMOCD REP. NOT PRESENT TO WITNESS CONFIRMATION SAMPLING. WELL PAD HAS PERIMETER SECURITY FENCE.

SOIL IMPACT DIMENSION ESTIMATION: NA ft. X NA ft. X NA ft. EXCAVATION ESTIMATION (Cubic Yards): NA DEPTH TO GROUNDWATER: <100' NEAREST WATER SOURCE: >1,000' NEAREST SURFACE WATER: <1,000' NMOCD TPH CLOSURE STD: 100 ppm		
SITE SKETCH BGT Located: off [on] site PLOT PLAN circle: attached

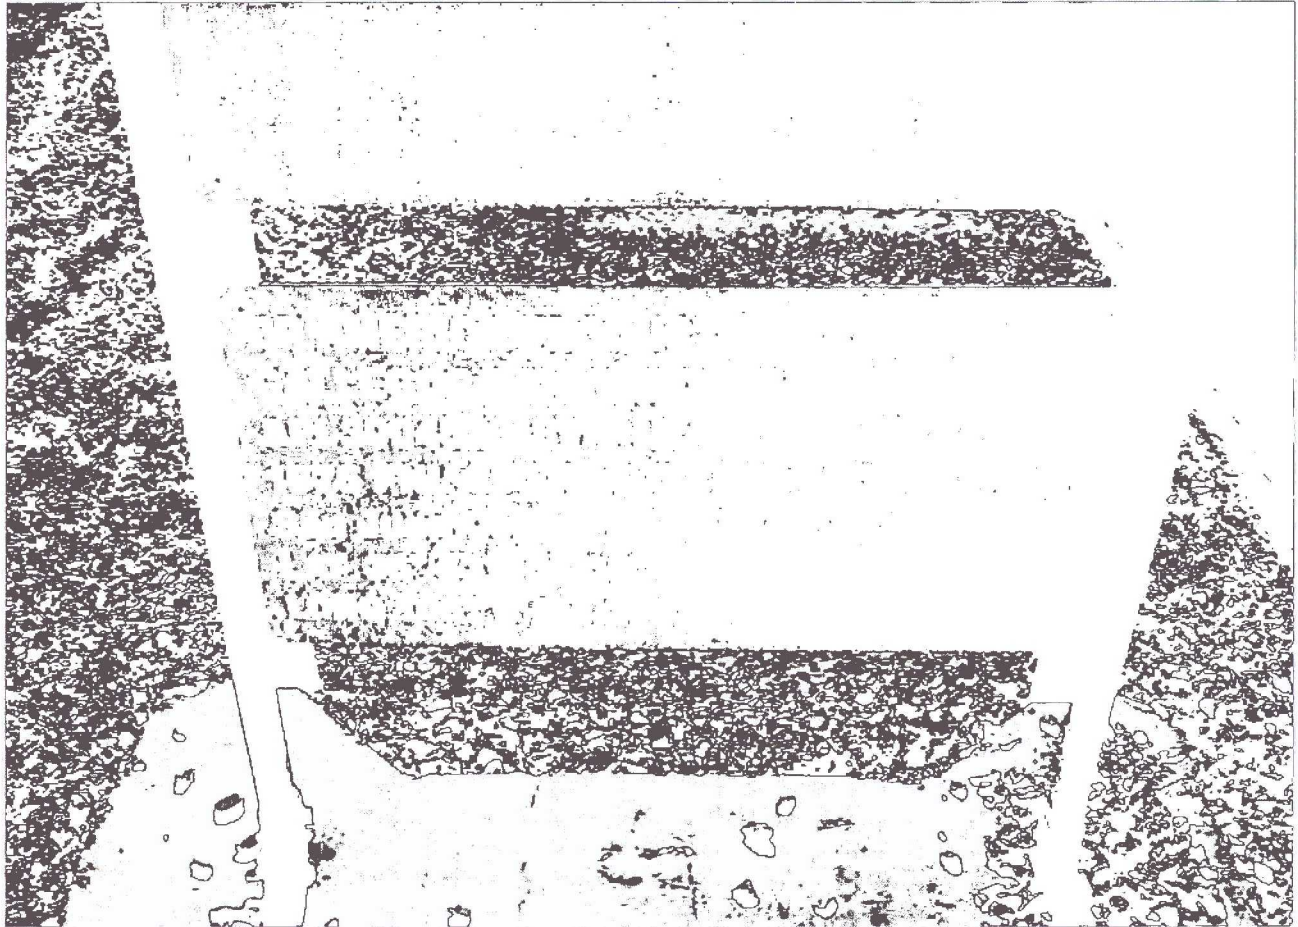
Closure report on C-144 form is included including photos of reclamation completion.
