Pit, Below-Grade Tank, or
Proposed Alternative Method Permit or Closure Plan Application

BP AMERICA PRODUCTION COMPANY
SAN JUAN BASIN, NORTHWEST NEW MEXICO

BELOW-GRADE TANK CLOSURE PLAN

Florance AB 031A
API No. 3004522116
Unit Letter I, Section 12, T29N, R08W

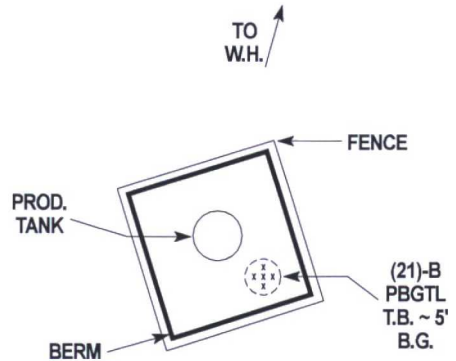
SITE SKETCH

SOIL DESCRIPTION:	SOIL TYPE: SAND / SILTY SAND / SILT SILTY CLAY CLAY / GRAVEL OTHER BEDROCK (SANDSTONE) SOIL COLOR: MOSTLY MODERATE BROWN PLASTICITY (CLAYS): NON PLASTIC / SLIGHTLY PLASTIC / COHESIVE / MEDIUM PLASTIC / HIGHLY PLASTIC COHESION (ALL OTHERS): NON COHESIVE / SLIGHTLY COHESIVE / COHESIVE HIGHLY COHESIVE DENSITY (COHESIVE CLAYS & SILTS): SOFT / FIRM / STIFF / VERY STIFF HARD CONSISTENCY (NON COHESIVE SOILS): LOOSE / FIRM / DENSE VERY DENSE HC ODOR DETECTED: YES NO EXPLANATION - STRONG APPARENT MOISTURE: DRY / SLIGHTLY MOIST MOIST WET SATURATED / SUPER SATURATED SAMPLE TYPE: GRAB COMPOSITE # OF PTS. 5 ANY AREAS DISPLAYING WETNESS: YES / NO EXPLANATION - MOST LIKELY FROM RECENT PRECIPITATION. DISCOLORATION/STAINING OBSERVED: YES NO EXPLANATION - LIGHT GRAY
-------------------	---

SITE OBSERVATIONS:	LOST INTEGRITY OF EQUIPMENT: YES NO EXPLANATION - APPARENT EVIDENCE OF A RELEASE OBSERVED AND/OR OCCURRED: YES NO EXPLANATION: APPEARS HISTORICAL IN ORIGIN. EQUIPMENT SET OVER RECLAIMED AREA: YES NO EXPLANATION - OTHER:
--------------------	--

BGT Located : off on site
