Pit, Below-Grade Tank, or
Proposed Alternative Method Permit or Closure Plan Application

BP AMERICA PRODUCTION COMPANY
SAN JUAN BASIN, NORTHWEST NEW MEXICO

BELOW-GRADE TANK CLOSURE PLAN

Florance 011R
API No. 3004527890
Unit Letter B, Section 30, T30N, R08W

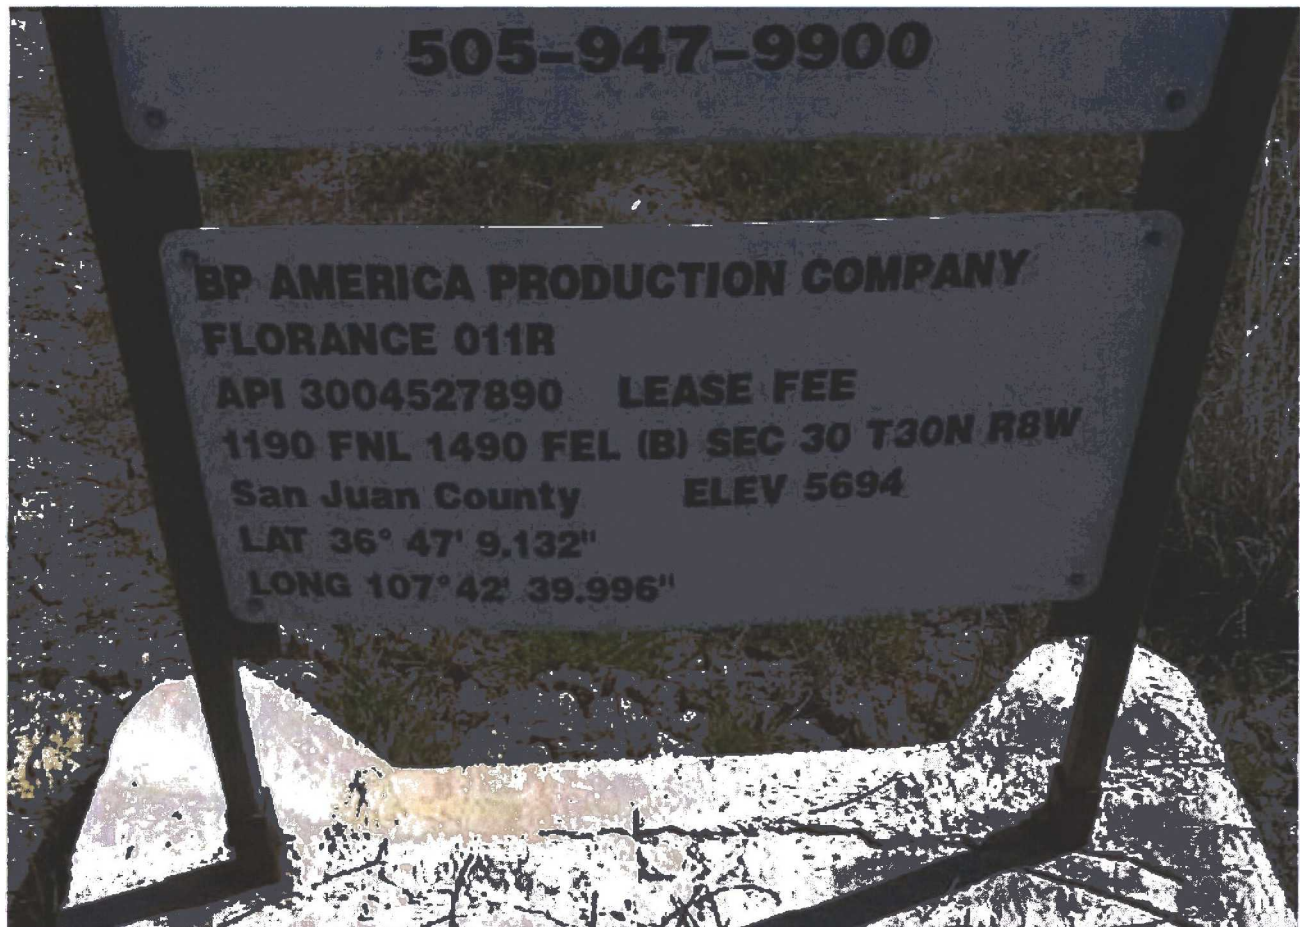
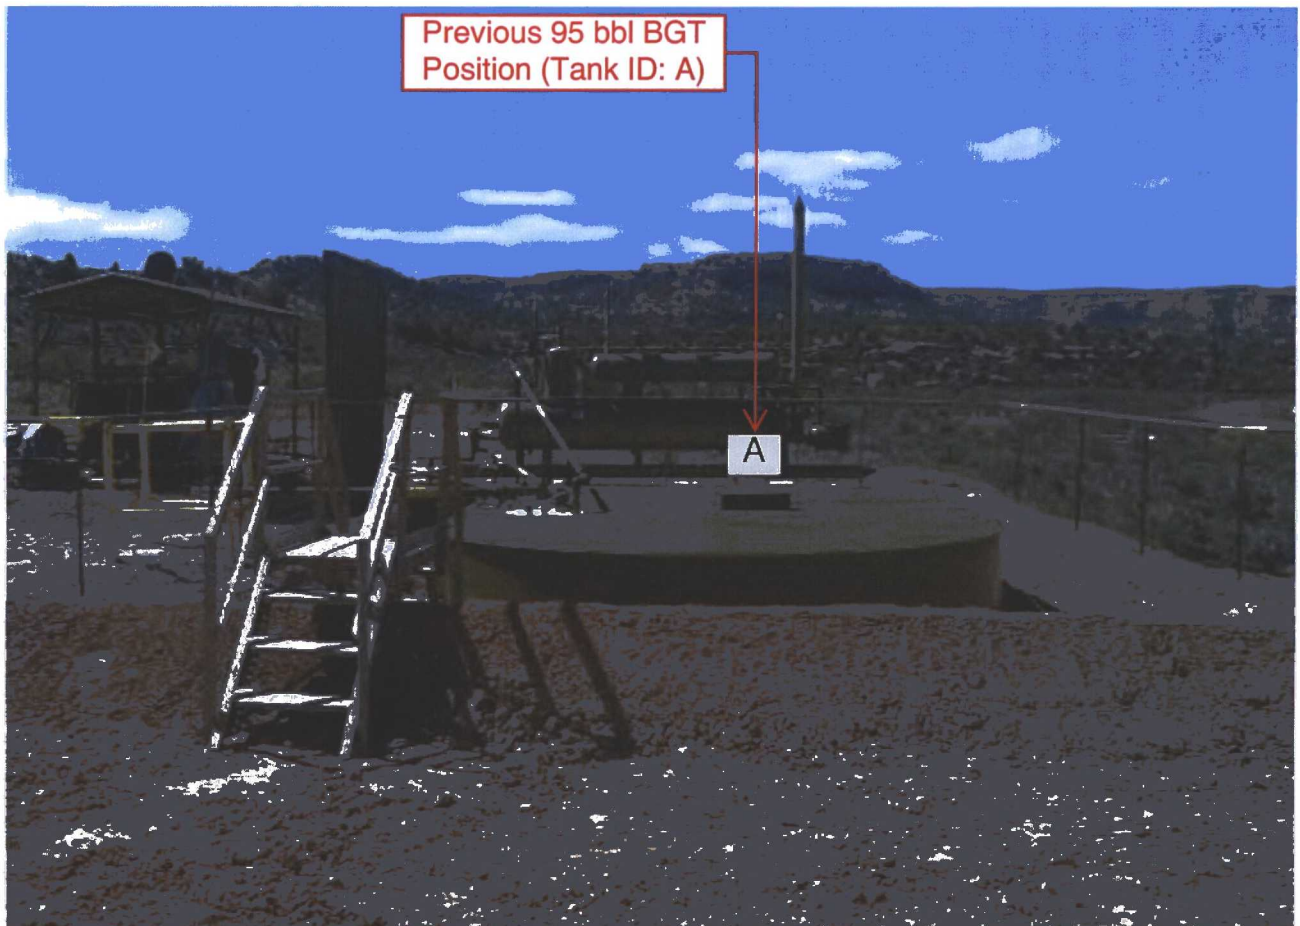
☐ Proof of Closure Notice (surface owner and division)
☐ Proof of Deed Notice (required for on-site closure for private land only)
☐ Plot Plan (for on-site closures and temporary pits)
☒ Confirmation Sampling Analytical Results (if applicable)
☐ Waste Material Sampling Analytical Results (required for on-site closure)
☒ Disposal Facility Name and Permit Number
☒ Soil Backfilling and Cover Installation
☐ Re-vegetation Application Rates and Seeding Technique
☒ Site Reclamation (Photo Documentation)

10. BP shall reclaim the BGT location and all areas associated with the BGT including associated access roads to a safe and stable condition that blends with the surrounding undisturbed area. BP shall substantially restore the impacted surface area to the condition that existed prior to oil and gas operations by placement of the soil cover as provided in Subsection H of 19.15.17.13 NMAC, re-contour the location and associated areas to a contour that approximates the original contour and blends with the surrounding topography and re-vegetate according to Subsection I of 19.15.17.13 NMAC.
The area has been backfilled. The location will be reclaimed when the well is plugged and abandoned.
