Pit, Below-Grade Tank, or
Proposed Alternative Method Permit or Closure Plan Application

BELOW-GRADE TANK CLOSURE PLAN

Barnes LS 002R

API No. 300451317

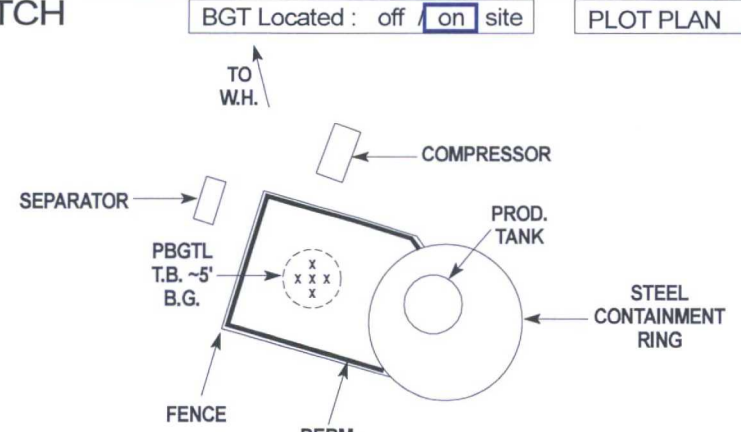
SITE SKETCH	BGT Located: off / <u>on</u> site PLOT PLAN circle: <u>attached</u>

SITE OBSERVATIONS:	LOST INTEGRITY OF EQUIPMENT: YES <u>NO</u> EXPLANATION - APPARENT EVIDENCE OF A RELEASE OBSERVED AND/OR OCCURRED: YES <u>NO</u> EXPLANATION: EQUIPMENT SET OVER RECLAIMED AREA: <u>YES</u> / <u>NO</u> EXPLANATION - 105 BBL SHALLOW LOW PROFILE ABOVE-GRADE TANK TO BE SET ATOP BGT LOCATION. OTHER: NMOC D OR BLM REPS. NOT PRESENT TO WITNESS CONFIRMATION SAMPLING.
---------------------------	--

SOIL IMPACT DIMENSION ESTIMATION: <u>NA</u> ft. X <u>NA</u> ft. X <u>NA</u> ft.	EXCAVATION ESTIMATION (Cubic Yards): <u>NA</u> DEPTH TO GROUNDWATER: <u>>100'</u> NEAREST WATER SOURCE: <u>>1,000'</u> NEAREST SURFACE WATER: <u><1,000'</u> NMOC D TPH CLOSURE STD: <u>1,000</u> ppm
---	---
