16014
Pit, Below-Grade Tank, or
Proposed Alternative Method Permit or Closure Plan Application

BELOW-GRADE TANK CLOSURE PLAN

FLORANCE GAS COM D 004A

API No. 3004522147

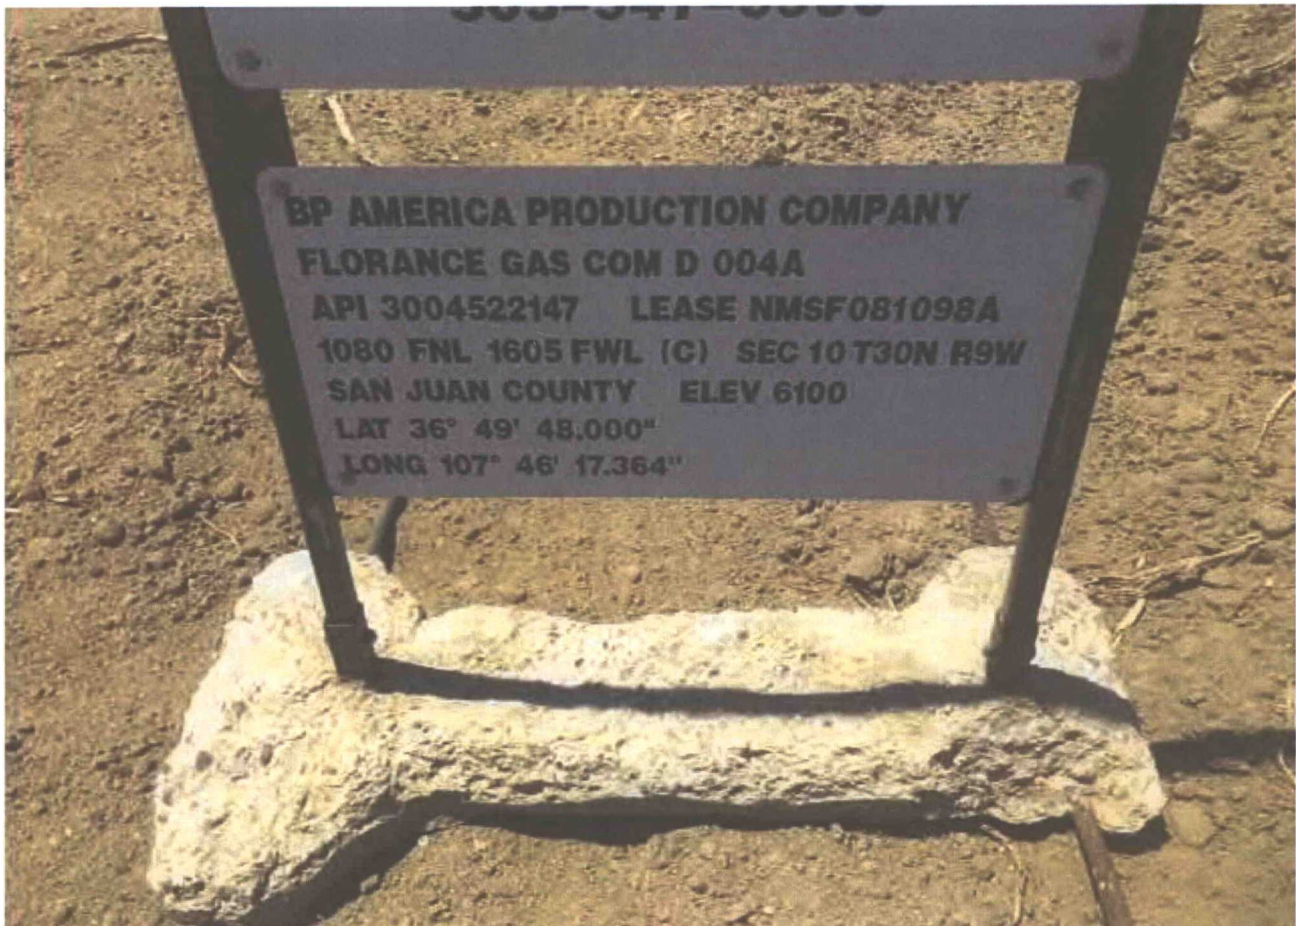
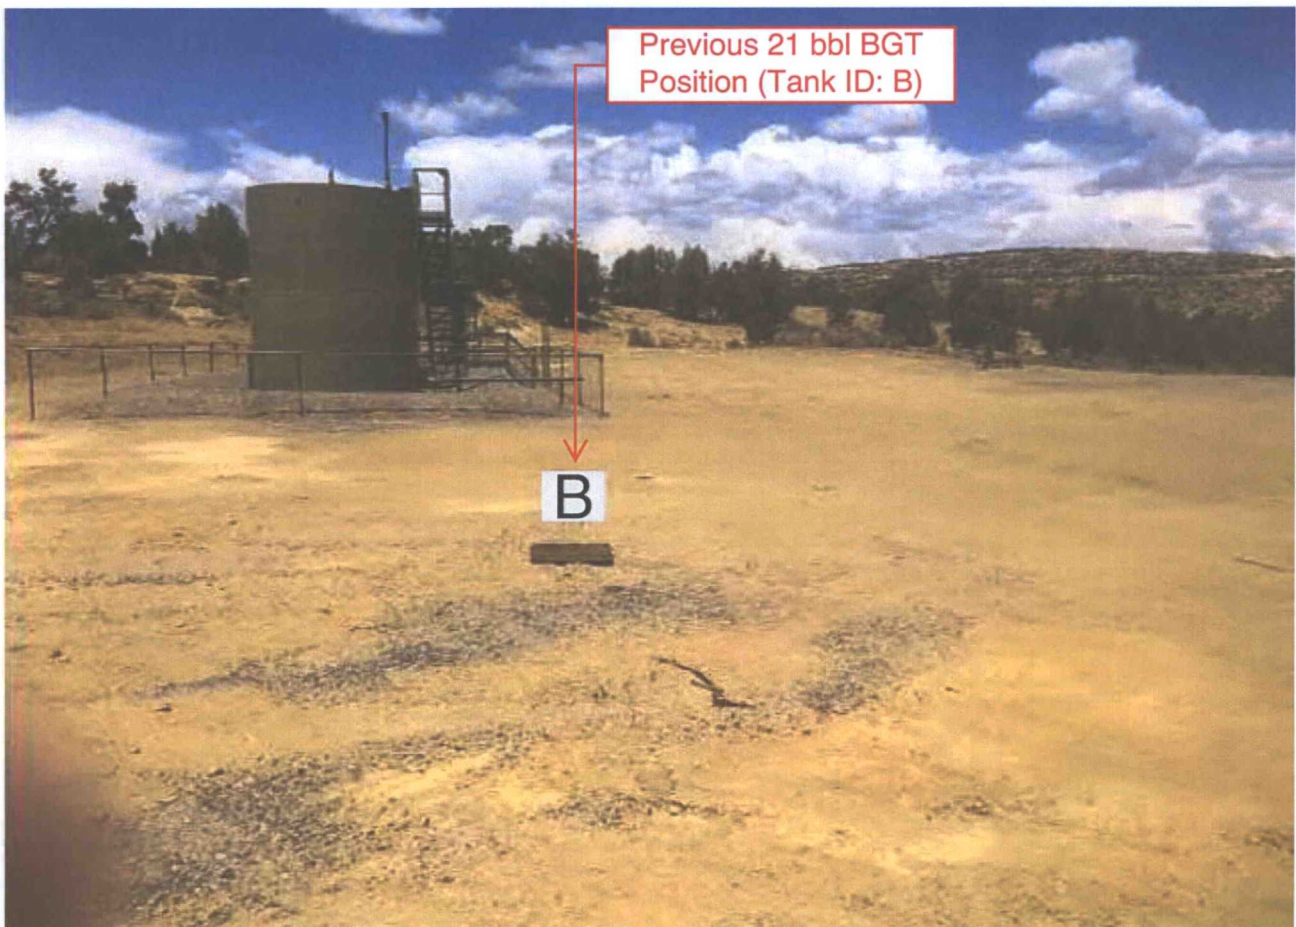
Closure report on C-144 form is included including photos of reclamation completion.

10. BP shall reclaim the BGT location and all areas associated with the BGT including associated access roads to a safe and stable condition that blends with the surrounding undisturbed area. BP shall substantially restore the impacted surface area to the condition that existed prior to oil and gas operations by placement of the soil cover as provided in Subsection H of 19.15.17.13 NMAC, re-contour the location and associated areas to a contour that approximates the original contour and blends with the surrounding topography and re-vegetate according to Subsection I of 19.15.17.13 NMAC.
The area has been backfilled and will be reclaimed once the well has been plugged and abandoned.
