Pit, Below-Grade Tank, or
Proposed Alternative Method Permit or Closure Plan Application

BP AMERICA PRODUCTION COMPANY
SAN JUAN BASIN, NORTHWEST NEW MEXICO

BELOW-GRADE TANK CLOSURE PLAN

TAPP #4

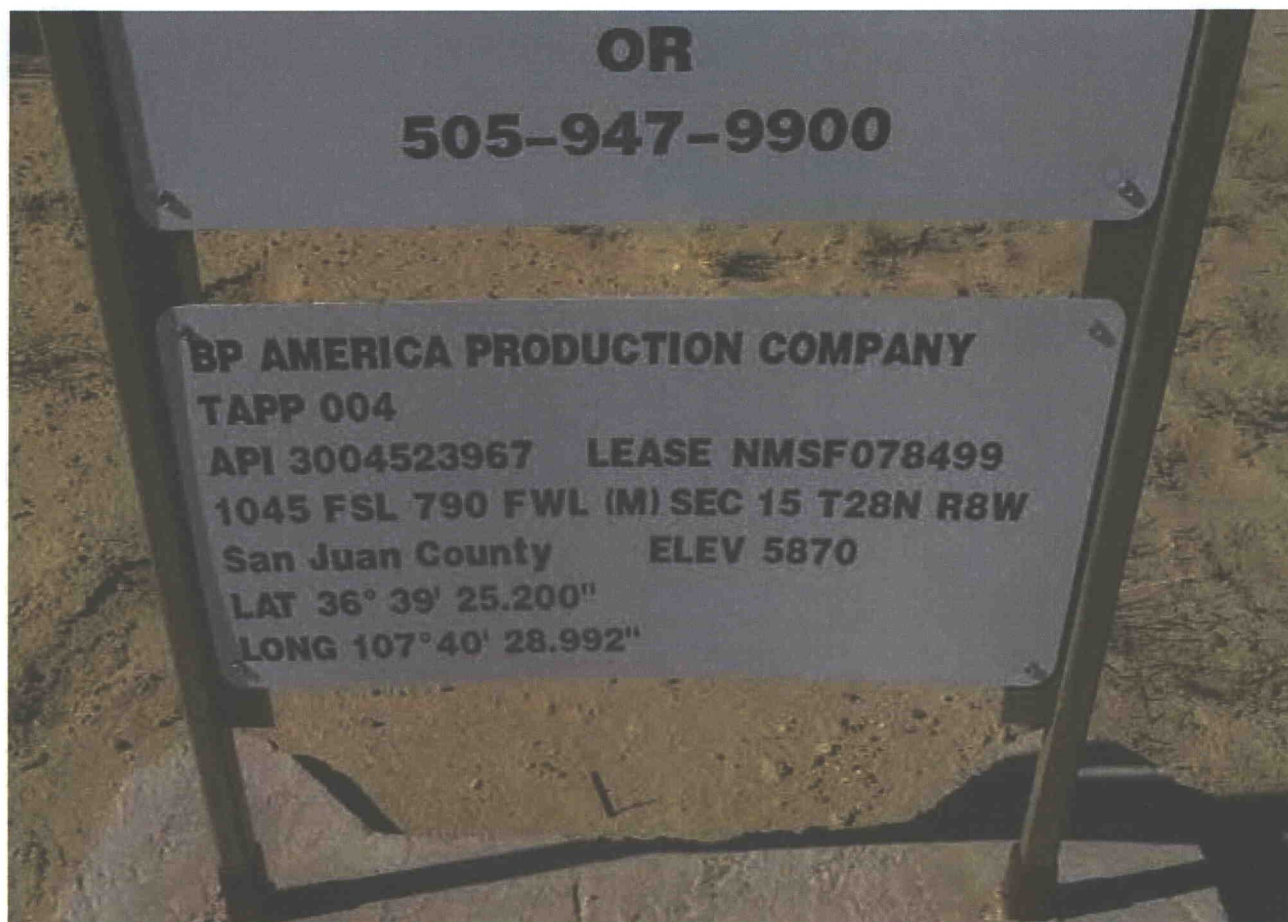
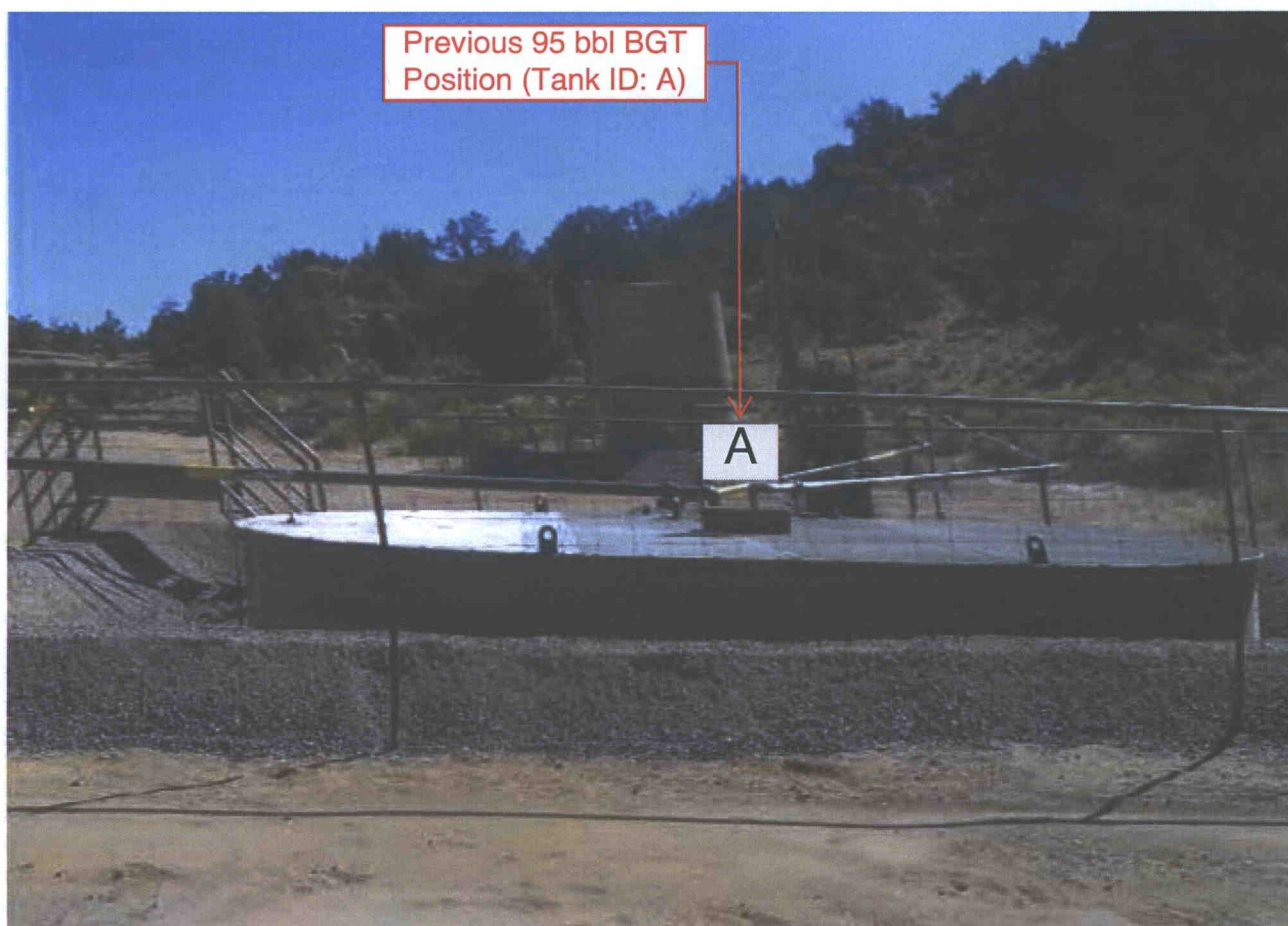
The area has been backfilled and a 105 BBL shallow low profile above-grade tank set on top. The location will be reclaimed once the well is plugged and abandoned.
