Pit, Below-Grade Tank, or
Proposed Alternative Method Permit or Closure Plan Application

1.
Operator: BP America Production Company OGRID #: 778
Address: 200 Energy Court, Farmington, NM 87401
Facility or well name: ATLANTIC B LS # 3B
API Number: 3004532078 OCD Permit Number: _____
U/L or Qtr/Qtr K Section 04 Township 30N Range 10W County: San Juan
Center of Proposed Design: Latitude 36.838667 Longitude -107.889272 NAD: ☐ 1927 ☒ 1983
Surface Owner: ☒ Federal ☐ State ☐ Private ☐ Tribal Trust or Indian Allotment

BELOW-GRADE TANK CLOSURE PLAN

ATLANTIC BLS # 3B

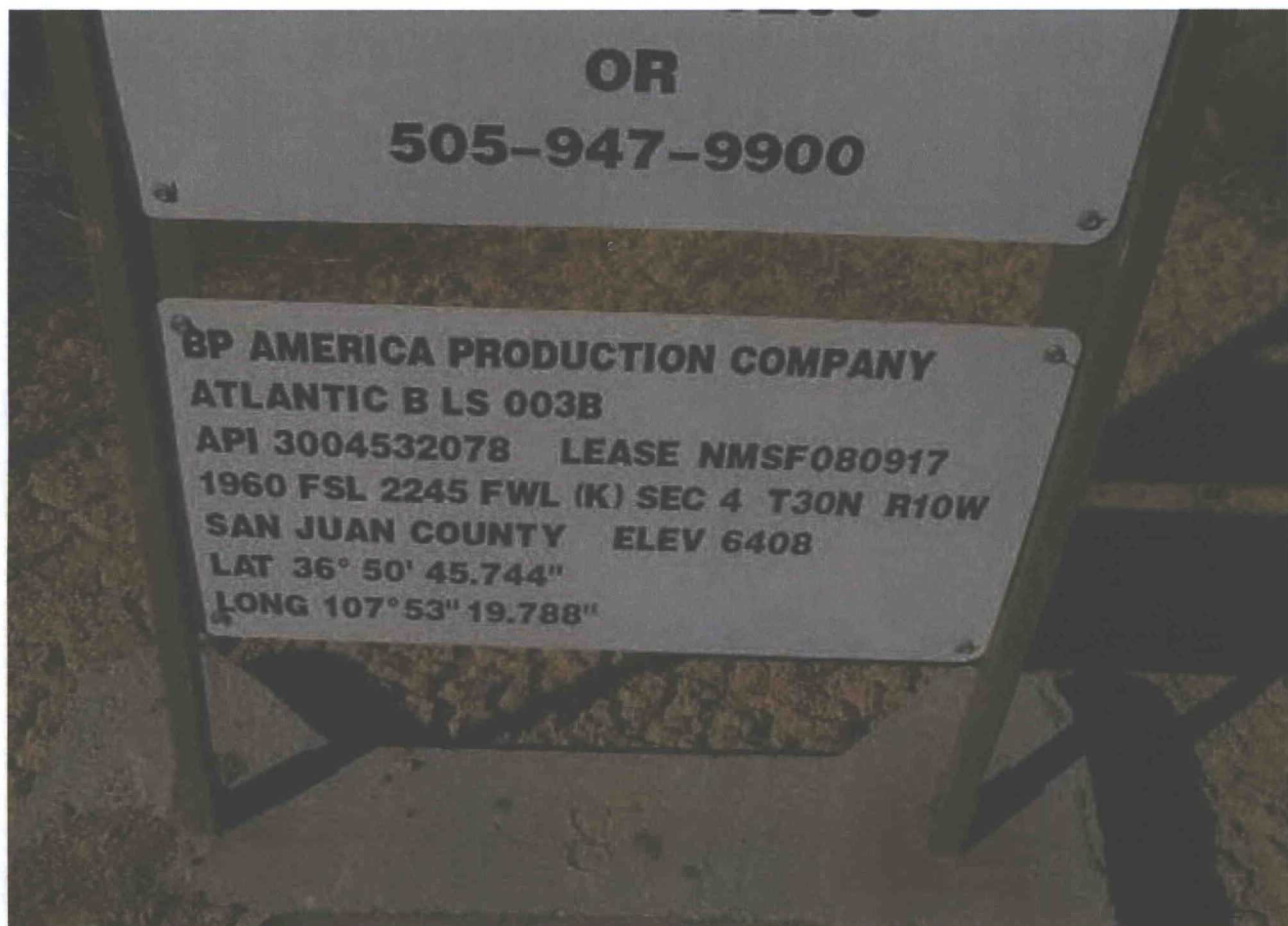
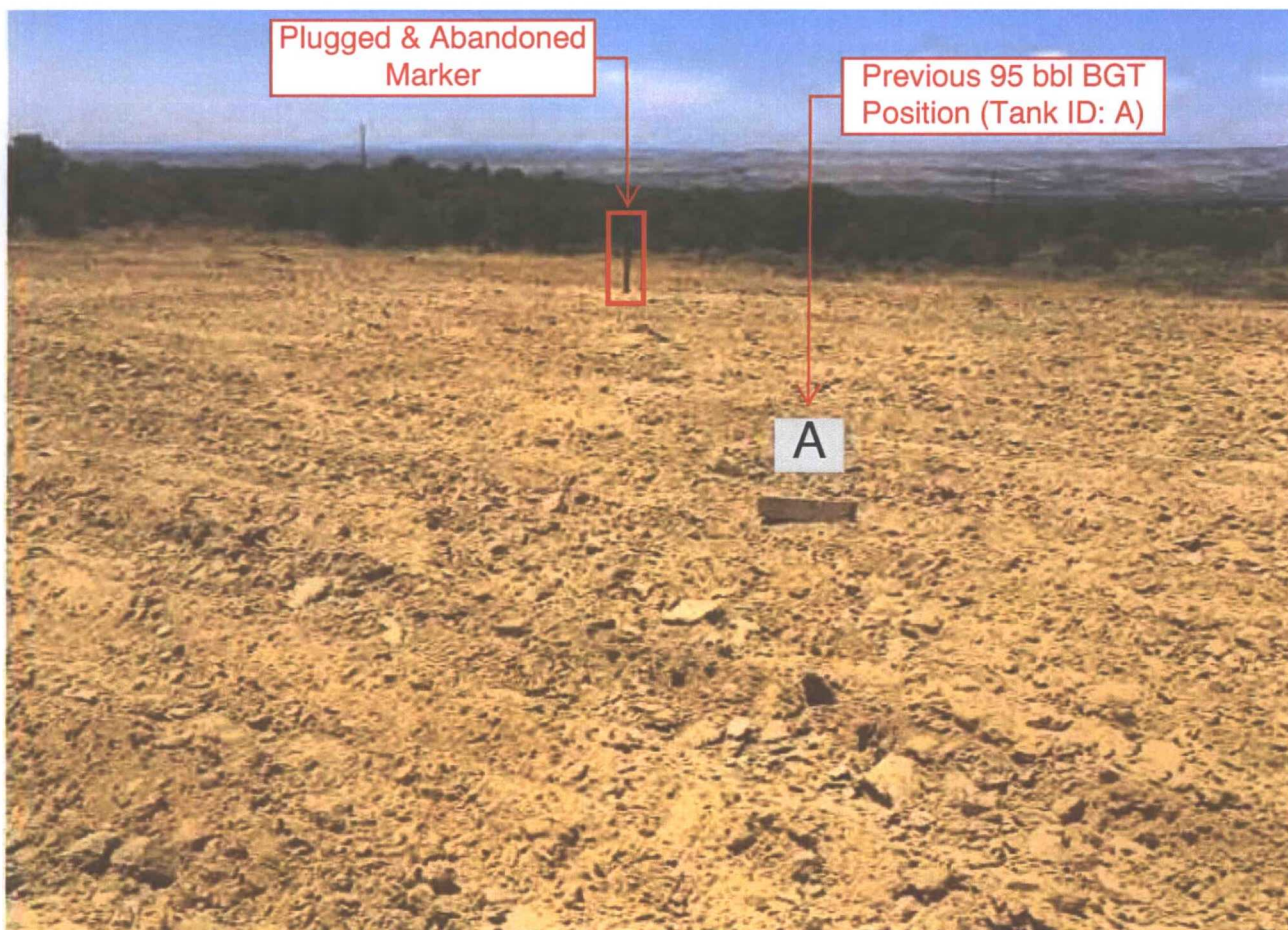
BP did not meet the 60 closure completion requirement due to an error in internal tracking. Closure report on C-144 form is included including photos of reclamation completion.

The area over the BGT will be part of the final reclamation since the well has been plugged and abandoned.
