Pit, Below-Grade Tank, or
Proposed Alternative Method Permit or Closure Plan Application

BP AMERICA PRODUCTION COMPANY
SAN JUAN BASIN, NORTHWEST NEW MEXICO

BELOW-GRADE TANK CLOSURE PLAN

ATLANTIC BLS # 3C

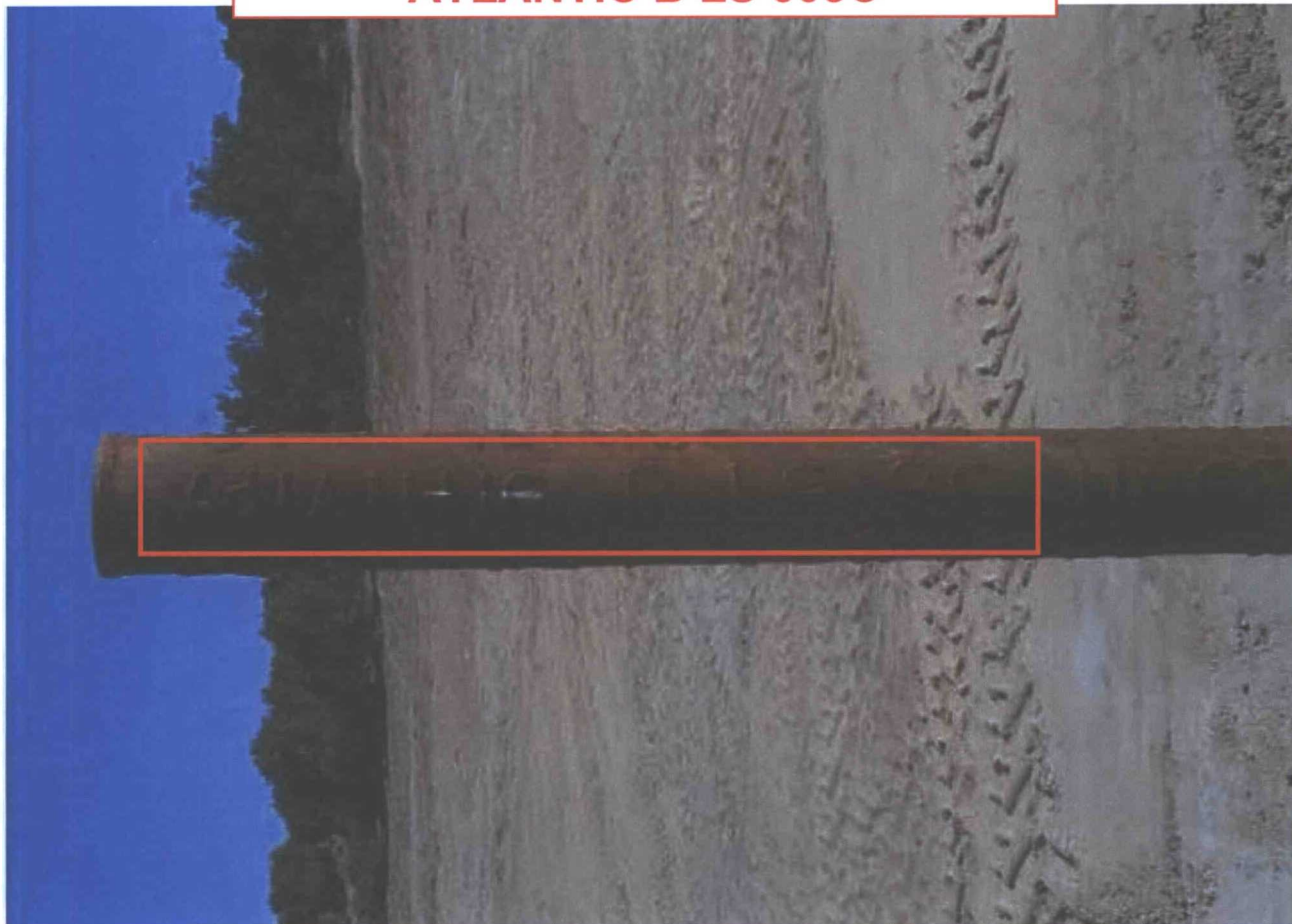
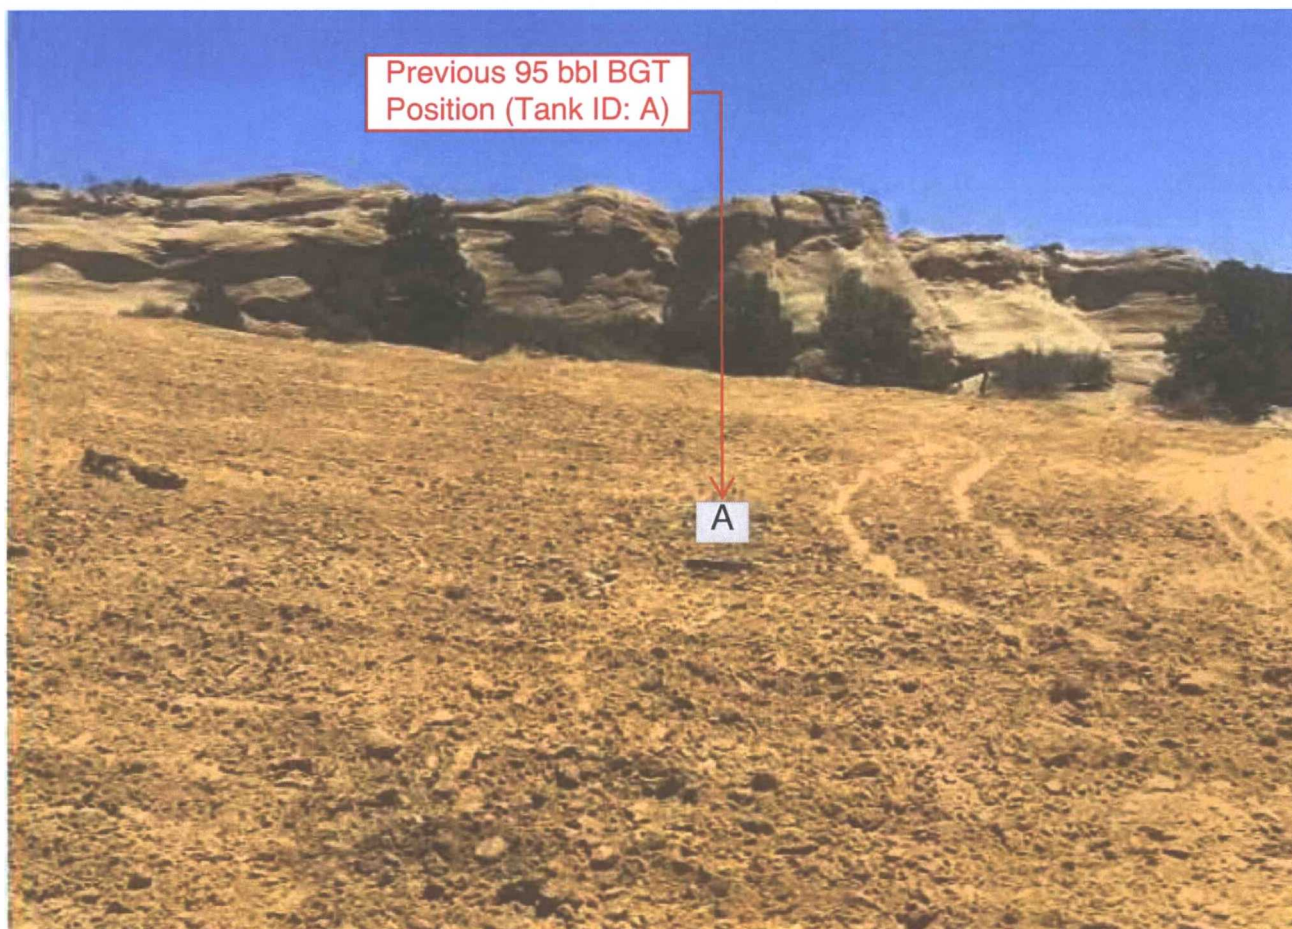
ATLANTIC B LS 003C

BP did not meet the 60 closure completion requirement due to an error in internal tracking. Closure report on C-144 form is included including photos of reclamation completion.
