Pit, Below-Grade Tank, or
Proposed Alternative Method Permit or Closure Plan Application

BELOW-GRADE TANK CLOSURE PLAN

Gallegos Canyon Unit #190

API No. 3004507057

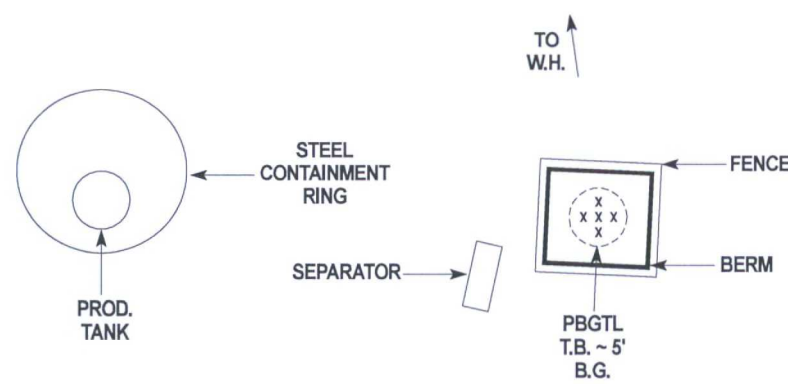
CLIENT: BP	BLAGG ENGINEERING, INC. P.O. BOX 87, BLOOMFIELD, NM 87413 (505) 632-1199	API #: 3004507057 TANK ID (if applicable): A								
FIELD REPORT: (circle one) BGT CONFIRMATION / RELEASE INVESTIGATION / OTHER:		PAGE #: 1 of 1								
SITE INFORMATION: SITE NAME: GCU #190 QUAD/UNIT: C SEC: 32 TWP: 28N RNG: 12W PM: NM CNTY: SJ ST: NM 1/4 -1/4/FOOTAGE: 1,190'N / 1,640'W NE/NW LEASE TYPE: FEDERAL / STATE / FEE / INDIAN LEASE #: SF079346A PROD. FORMATION: DK CONTRACTOR: STRIKE MBF - R. POWELL		DATE STARTED: 06/13/17 DATE FINISHED: ENVIRONMENTAL SPECIALIST(S): NJV								
REFERENCE POINT: WELL HEAD (W.H.) GPS COORD.: 36.62277 X 108.13851 GL ELEV.: 5,572' 1) 95 BGT (DW/DB) GPS COORD.: 36.622.36 X 108.13847 DISTANCE/BEARING FROM W.H.: 157', S8E 2) GPS COORD.: DISTANCE/BEARING FROM W.H.: 3) GPS COORD.: DISTANCE/BEARING FROM W.H.: 4) GPS COORD.: DISTANCE/BEARING FROM W.H.:										
SAMPLING DATA: CHAIN OF CUSTODY RECORD(S) # OR LAB USED: HALL 1) SAMPLE ID: 5PC - TB @ 5' (95) SAMPLE DATE: 06/13/17 SAMPLE TIME: 1403 LAB ANALYSIS: 8015B/8021B/300.0 (CI) OVM READING (ppm): NA 2) SAMPLE ID: SAMPLE DATE: SAMPLE TIME: LAB ANALYSIS: 3) SAMPLE ID: SAMPLE DATE: SAMPLE TIME: LAB ANALYSIS: 4) SAMPLE ID: SAMPLE DATE: SAMPLE TIME: LAB ANALYSIS: 5) SAMPLE ID: SAMPLE DATE: SAMPLE TIME: LAB ANALYSIS:										
SOIL DESCRIPTION: SOIL TYPE: SAND / SILTY SAND / SILT / SILTY CLAY / CLAY / GRAVEL / OTHER SOIL COLOR: DARK YELLOWISH BROWN COHESION (ALL OTHERS): NON COHESIVE / SLIGHTLY COHESIVE / COHESIVE / HIGHLY COHESIVE CONSISTENCY (NON COHESIVE SOILS): LOOSE / FIRM / DENSE / VERY DENSE MOISTURE: DRY / SLIGHTLY MOIST / MOIST / WET / SATURATED / SUPER SATURATED SAMPLE TYPE: GRAB / COMPOSITE # OF PTS. 5 DISCOLORATION/STAINING OBSERVED: YES NO EXPLANATION - PLASTICITY (CLAYS): NON PLASTIC / SLIGHTLY PLASTIC / COHESIVE / MEDIUM PLASTIC / HIGHLY PLASTIC DENSITY (COHESIVE CLAYS & SILTS): SOFT / FIRM / STIFF / VERY STIFF / HARD HC ODOR DETECTED: YES NO EXPLANATION - ANY AREAS DISPLAYING WETNESS: YES NO EXPLANATION -										
SITE OBSERVATIONS: LOST INTEGRITY OF EQUIPMENT: YES NO EXPLANATION - APPARENT EVIDENCE OF A RELEASE OBSERVED AND/OR OCCURRED: YES NO EXPLANATION - EQUIPMENT SET OVER RECLAIMED AREA: YES NO EXPLANATION - OTHER: NMOCOD OR BLM NOT PRESENT TO WITNESS CONFIRMATION SAMPLING.										
EXCAVATION DIMENSION ESTIMATION: NA ft. X NA ft. X NA ft. EXCAVATION ESTIMATION (Cubic Yards): NA DEPTH TO GROUNDWATER: <50' NEAREST WATER SOURCE: >1,000' NEAREST SURFACE WATER: <1,000' NMOCOD TPH CLOSURE STD: 100 ppm										
SITE SKETCH BGT Located : off on site PLOT PLAN circle: attached

NOTES: BGT = BELOW-GRADE TANK; E.D. = EXCAVATION DEPRESSION; B.G. = BELOW GRADE; B = BELOW; T.H. = TEST HOLE; ~ = APPROX.; W.H. = WELL HEAD; T.B. = TANK BOTTOM; PBGTL = PREVIOUS BELOW-GRADE TANK LOCATION; SPD = SAMPLE POINT DESIGNATION; R.W. = RETAINING WALL; NA = NOT APPLICABLE OR NOT AVAILABLE; SW - SINGLE WALL; DW - DOUBLE WALL; SB - SINGLE BOTTOM; DB - DOUBLE BOTTOM. X - S.P.D.		OVM CALIB. READ. = NA ppm RF=0.52 OVM CALIB. GAS = NA ppm TIME: NA am/pm DATE: NA MISCELL. NOTES WO: REF #: P - 851 VID: VHIXONEV11 PJ #: Permit date(s): 06/14/10 OCD Appr. date(s): 05/09/17
