#### BP AMERICA PRODUCTION COMPANY

#### BELOW-GRADE TANK CLOSURE PLAN

#### **HOWELL 002A**

API No. 3004522024

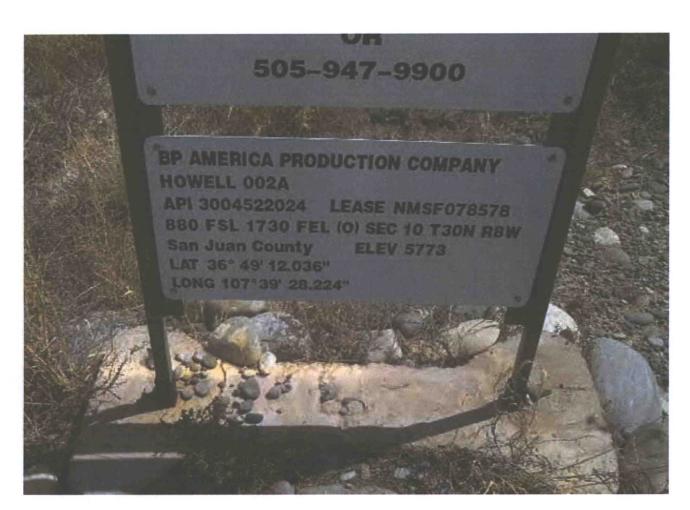
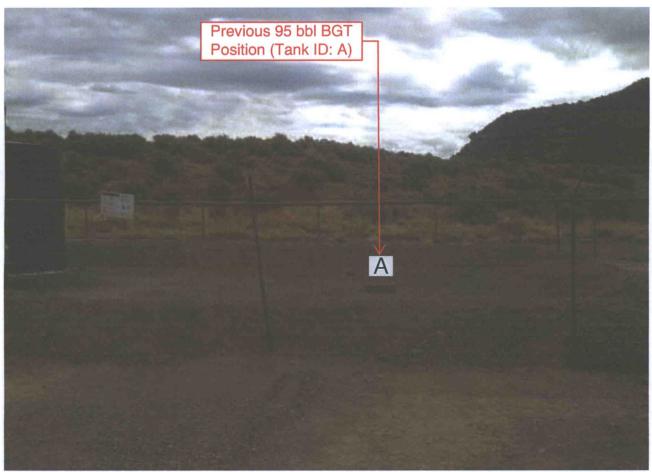
BP did not meet the 60 closure completion requirement due to an error in internal tracking. Closure report on C-144 form is included including photos of reclamation completion.

## The area has been backfilled. The location will be reclaimed once the well is plugged and abandoned.
